Building Performance Study for Education

Arch 571/Building Performance Evaluation/ Spring 2018

Ruth Opatola and Sainaz Bajracharya

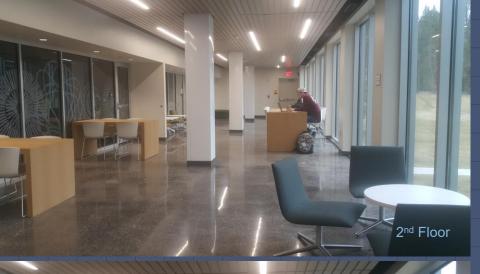
21st March 2018, 8:53 am Cloudy Day

Daylight not enough The ceiling light illuminated to 60%.

The shiny finish materials creates more reflectance

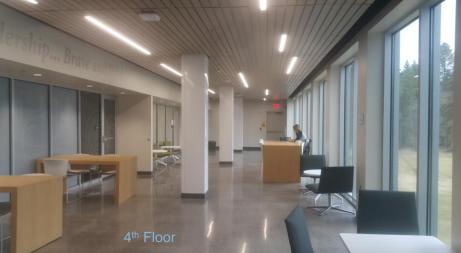
29th March 2018, 4:11 am Partial Cloudy

Daylight enough but not evenly spread, some light fixtures off The ceiling light illuminated to 30%. Glare through shiny materials, white table and reflected columns West wall requires added shading to mitigate uneven lighting and glare issues

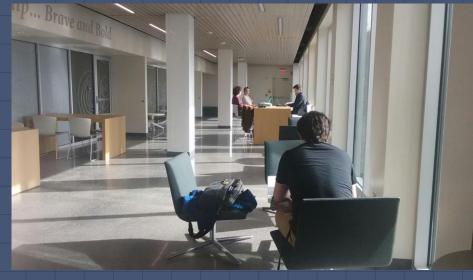
19th April 2018, 4:02 pm Sunny

Daylight enough, some light fixtures off(sensor working well) The ceiling light illuminated to 20%. Glare through shiny materials, white table and reflected columns West wall requires added shading to mitigate uneven lighting and glare issues

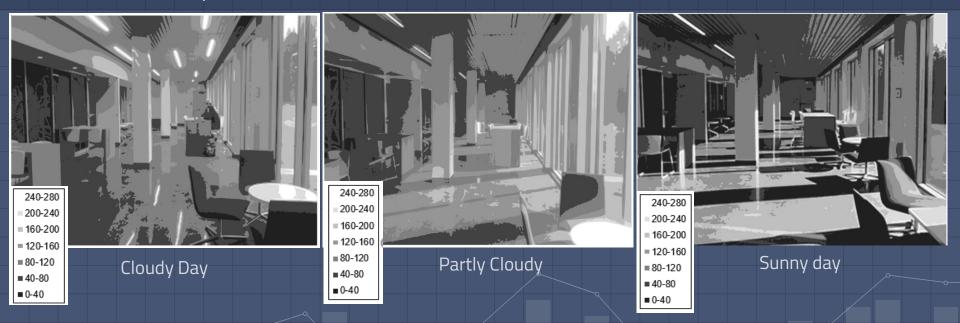
The windows requires shadings as it penetrate lot of unwanted light producing glare during A bright day. The LED ceiling lights reflects from shiny, glossy finishes in a cloudy day.

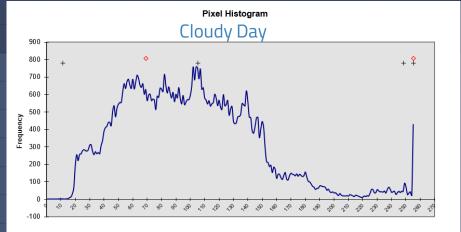
Overall Image		Inc	diviual P	ixel			
Weighted Ave Pixel Intensity	116.10	Inc	Individual Pixel Value			40	
Total Number of Pixels	76800	Co	Corresponding Luminance		108.00	footlamberts	
Background Bell Curve		Sp	oike				
Low End Pixel Value	11	Lo	w End P	ixel Value		248	
High End Pixel Value	105	Hig	High End Pixel Value		255		
Background Median Value	69	Sp	Spike Median Value		255		
Number of Background Pixel	s 44894	N	umbor of	Cniko Divo	le	752	
0			Number of Spike Pixels				
Background Percentage of V	/iew 58.46 ^o	% Sp	Spike Percentage of View		0.98	%	
Spike	to Background	Ratio					
Mediar	n Spike to Media	an Backgroun	nd	3.70	TO 1		
Schiler	Glare ?			YES

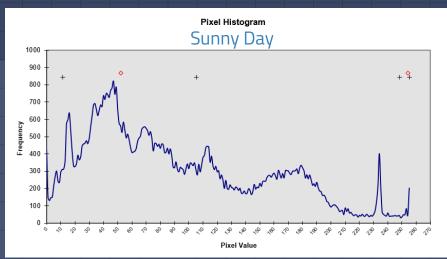
_
Overall Image				Indiviual I	Pixel				
Weighted Ave Pixel Intensity		107.24		Individual Pixel Value			40		
Total Number of Pixe	s	76800		Correspor	nding Lumin	ance	86.83	footlamber	ts
Background Bell C	urve			Spike					
Low End Pixel Value		11		Low End F	Pixel Value		248		
High End Pixel Value	1	105		High End	Pixel Value		255		
Background Median	Value	52		Spike Med	dian Value		254		
Number of Backgrou	nd Pixels	46369		Number of	f Spike Pixe	ls	533		
Background Percent	age of View	60.38	%	Spike Per	centage of V	View	0.69	%	
	Spike to E	Backgroun	d Ratio						
	Median Sp	ike to Med	ian Backgr	ound	4.88	TO 1			
	Schiler Gla	are ?			YES
