WWAMI Building Performance Analysis

General Building Information

ARCHITECT:
FLAD Architects

LOCATION:
U of Idaho, Moscow, ID

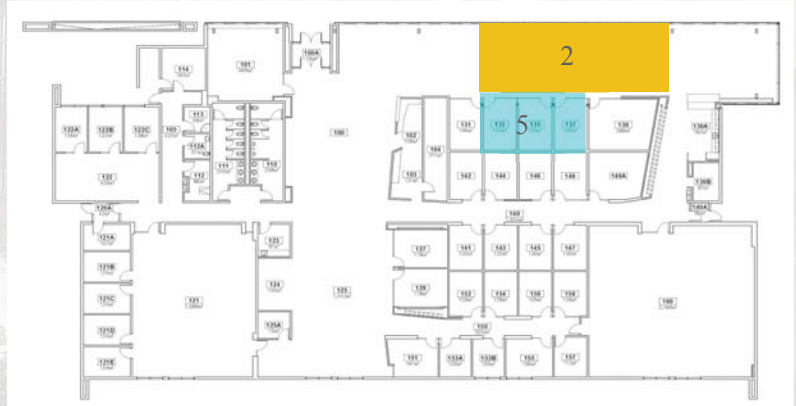
This Shows a huge difference in the amount of sunlight that is reaching these spaces.

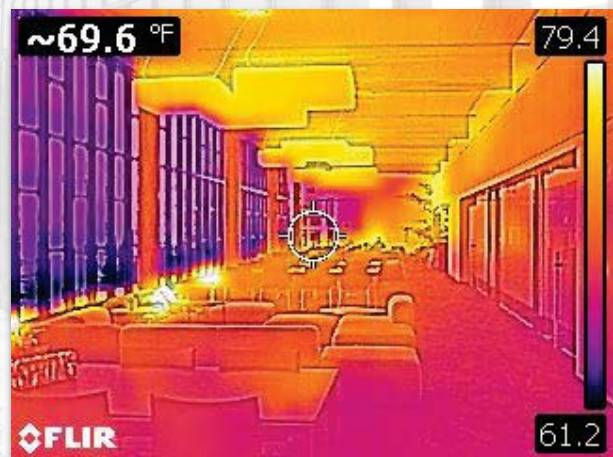
It appears that the glass curtain wall is struggling to hold in heat as it is the coldest surface in the room.

The window mullions are the coldest surface in the room and seem to be thermal bridges allowing the heat from the inside to escape.

This may result in increased usage of the heating systems and a slightly colder space.

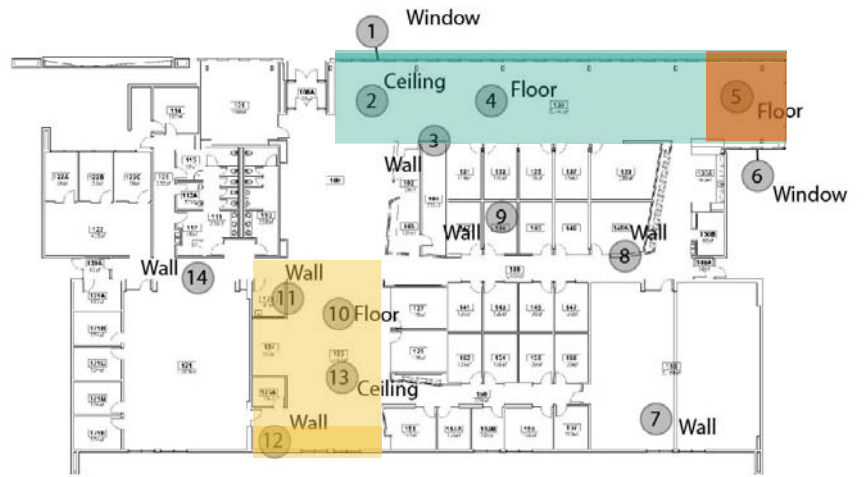
Temp on weekends shows building without mechanical control systems

Easternmost room has significantly higher temps

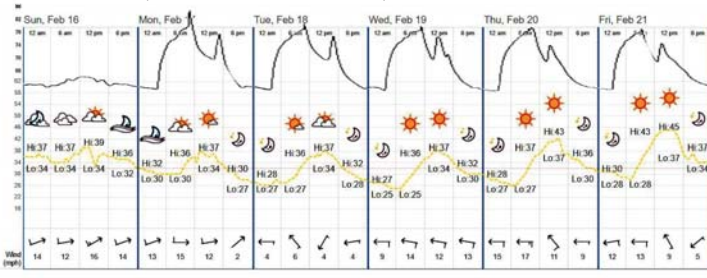
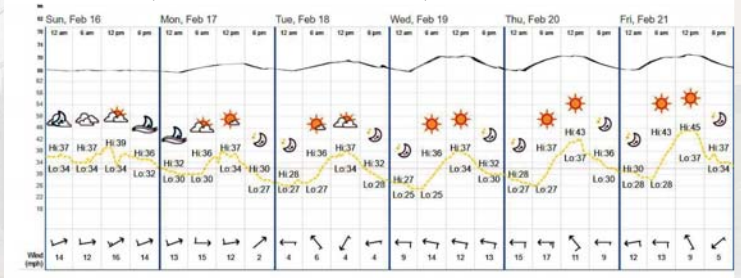
HOBO 1(NORTH LOUNGE)

HOBO 7(CENTER BUILDING)

The north lounge temperature changes throughout the week are much more volatile than center building

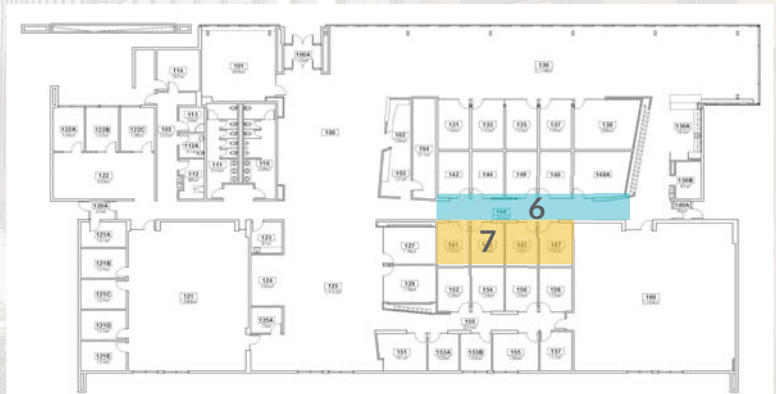
When we compare the hallway under the skylights to the interior of the offices, it shows that they don't get a sufficient amount of daylight from the skylights.

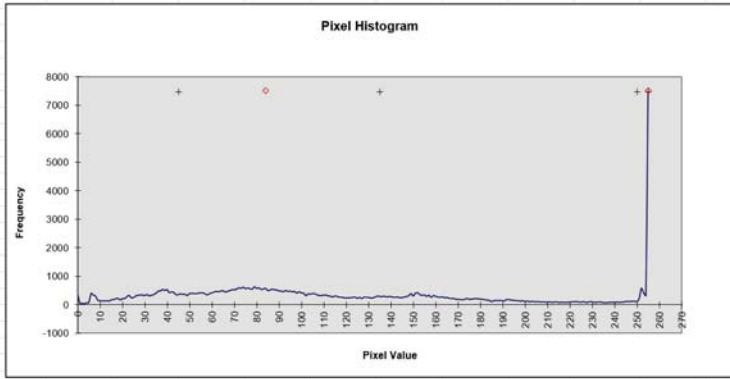
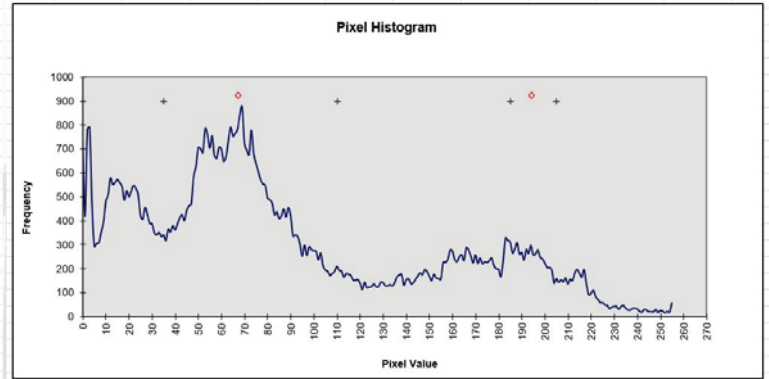
3.04 TO 1
YES

2.90 TO 1
MAYBE

- On cloudy days sky produces little to almost no glare in the space
- Work spaces could be quite uncomfortable to work in on sunny days
- Should consider shading strategy on east/south facing curtain walls in north lounge

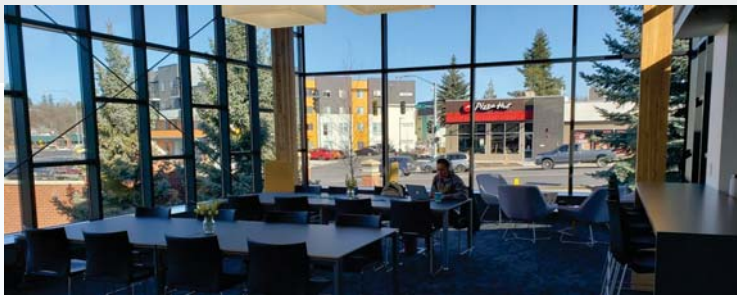
The brightest areas come from surrounding buildings not the sky
