CLEVELAND TOOL DAY

CLEVELAND ENVIRONMENTAL CENTER

Preliminary Observations:

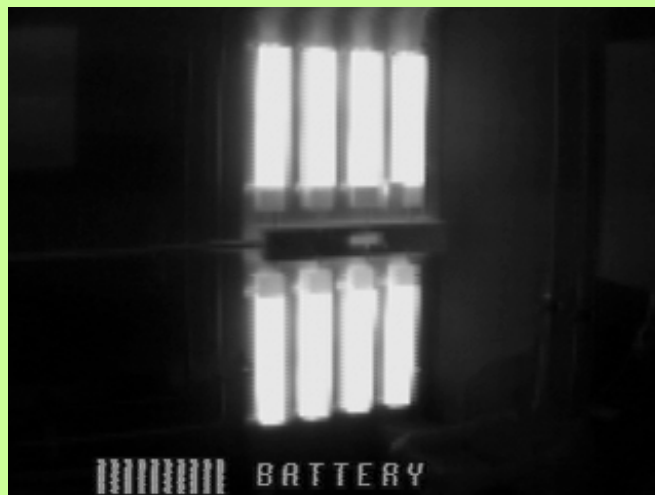
Lamp Ballasts

Bottom, second from left leaking epoxy
