Art + Architecture

CASE STUDY

The Art and Architecture North building has been serving students at the University of Idaho since 1966. As the college has grown the building has moved from housing Architecture and Interior Design studios, to including Art, Virtual Technology & Design, and some faculty offices. Today Art and Architecture North (AAN) serves as studio spaces and computer labs for over 800 students at the university. he only major remodel to affect the space was the inclusion of 2 level sky bridge to connect AAN to an elevator as well as the neighboring Art and Architecture South. Then in 2008 a large scale lighting systems upgrade took place across campus changing out all T-12 fluorescent bulbs for the more efficient T-8 bulbs.

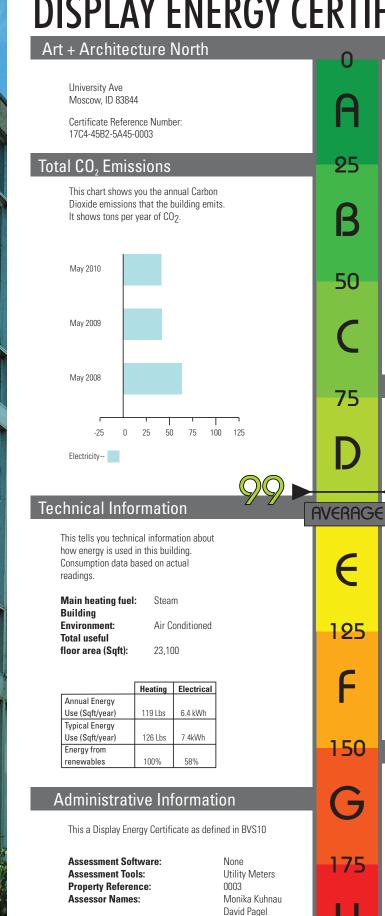
DISPLAY ENERGY CERTIFICATE

The sliding chart in the middle describes how efficiently energy has been used in the building of note. These numbers do not represent actual units of energy consumed but are adjusted numbers based on the Energy Use Intensity (EUI) for comparison to the average energy use from buildings of this type. 100 is the adjusted average.

$X^*Y = 100$ (A/B) * Y = Energy Performance Rating where, X= Average EUI for this building type (KBTU/sqft)

- Y= Adjustment Factor (sqft/KBTU)
- A= Total Energy Usage for one year in the building of note (KBTU)
- B= Total Floor Area in the building of note(sqft)

This tells you how efficiently energy has been used in this building over the last three accounting periods.

Building Performance certificate for the building under study as displayed in the studio space.

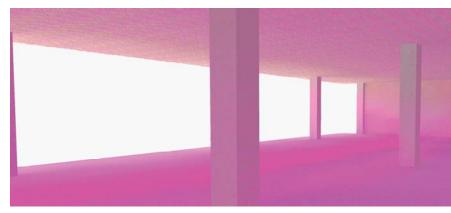
Digital model analysis of how natural daylighting penetrates into the 2nd floor studio space.
