Art And Architecture

This article was written by a group of students for an Architecture Graduate class 571 for the University of Idaho. Fall 2010. The group members are Blanca Rodriguez, Katy Ruegsegger, Robert Pruneda and Alonso Torres.

BUILDING AT A GLANCE

NAME: ART AND ARCHITECTURE.

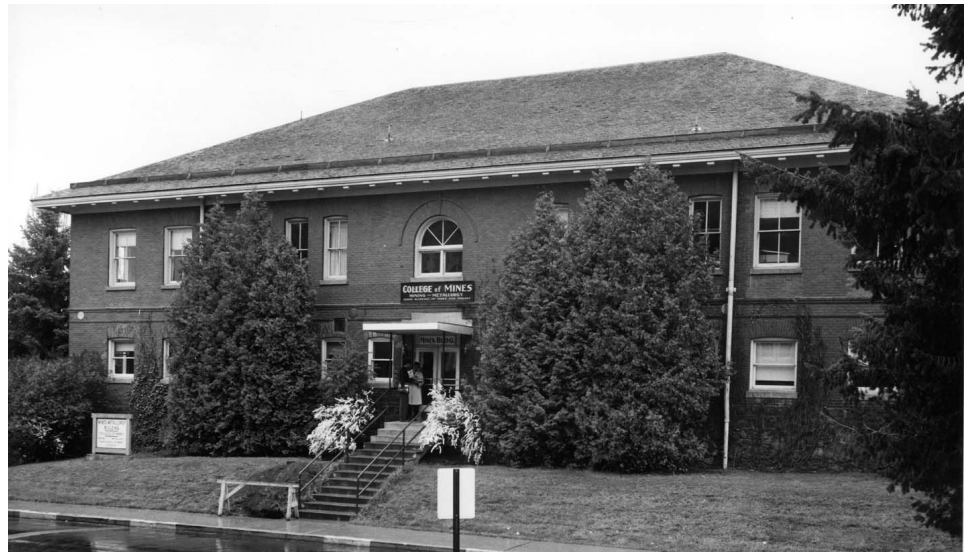
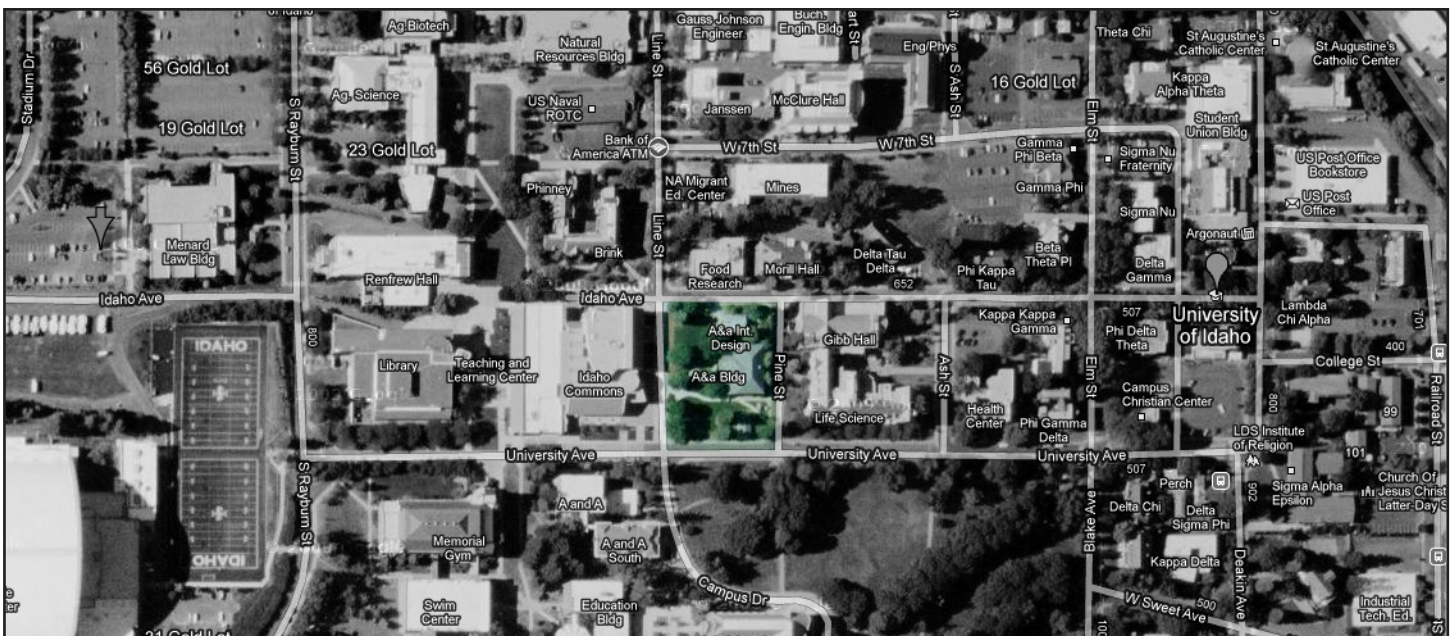
The image above is a smaller model of the building showing the structural components of the building. The section is through the basement and staircase. To the right, the image is taken of the back of the building. The image below is showing the relationship of the building and it's connected site compared to the rest of campus. The image below was taken directly from GoogleMaps after the construction of the Commons building to the West.

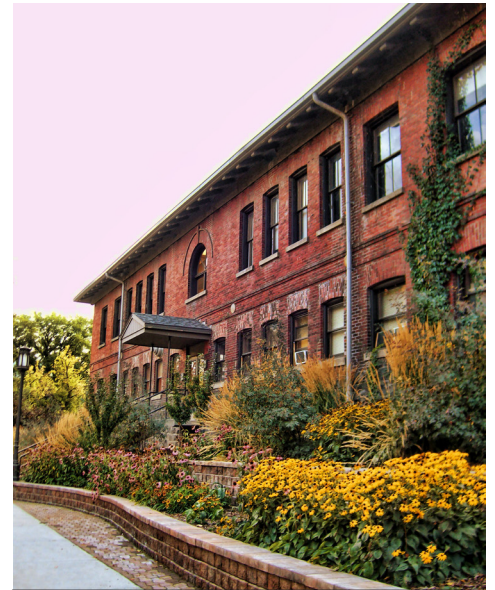
This image shows a newer renovation done by the University Facilities Team in 2008. The retaining walls include native foliage to keep a year round elegance.

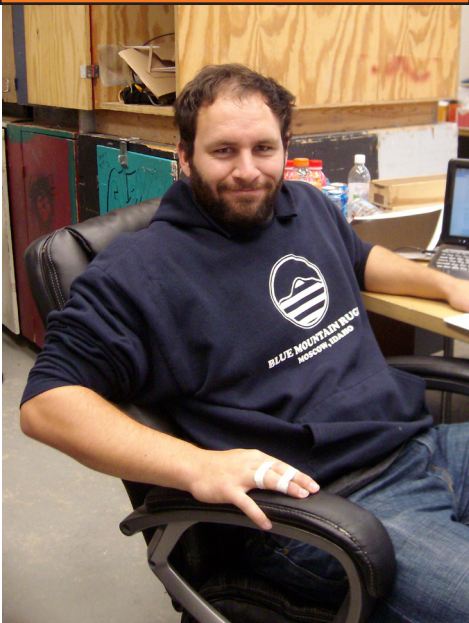
The Materials lab is used by students of the College of Art and Architecture. Materials are used for research when working on projects for classes.

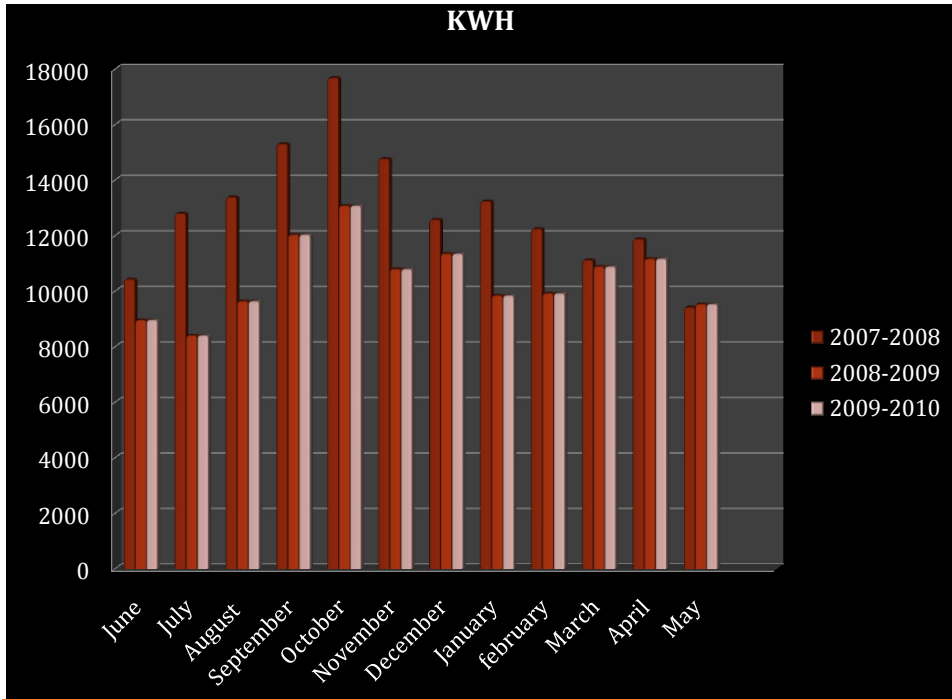
The way the energy usage was analyzed was through meter readings from the building of three fiscal years that were analyzed (2007-2010). Through the observation and conversion of all of these three years, it is apparent that the lowest month energy usage is the month of July. This is due to the reduction of energy use during the summer. The month with the highest is October because of the increase in the need for mechanical lighting. The increase in mechanical lighting comes because of the reduction of day light as the days get shorter. In addition there is a significant drop in energy usage from the fiscal year 2007-2008 to 2008-2010 because between these years the types of lighting fixtures were changed to more efficient ones.

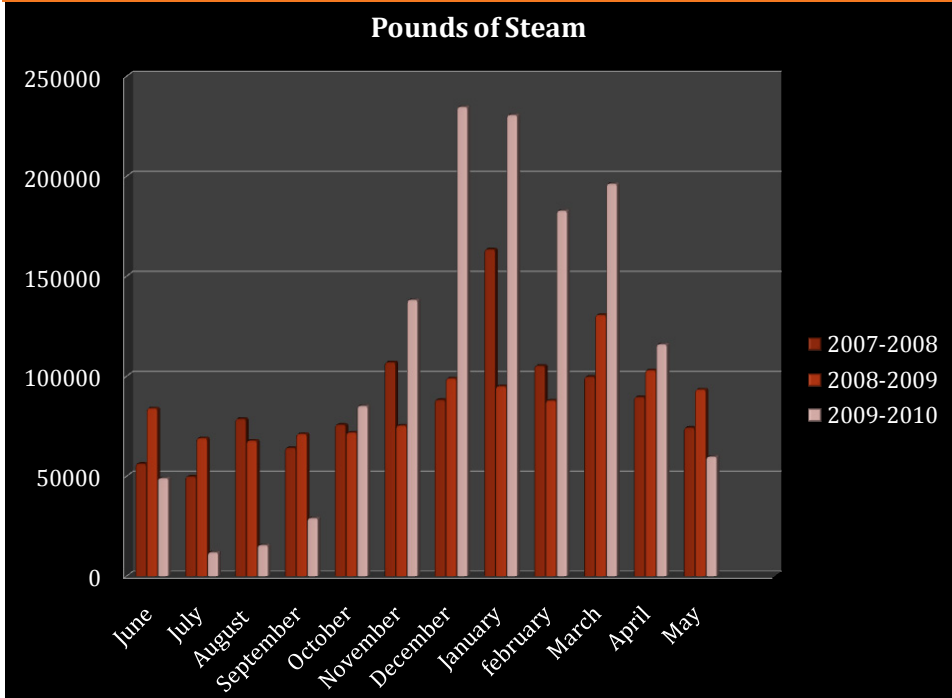
The same strategy was used to analyze steam usage. This steam is produced through a steam plant on campus that provides steam for heating to a large number of buildings through a series of ducts. The AA is one of these buildings. Throughout these three years the year with the most usage is 2009-2010 because during that year renovations were made and more steam was available. The month with the greatest usage is December because of the increase in heating requirements and July is the month with the lowest as it is summer and heating is not required.

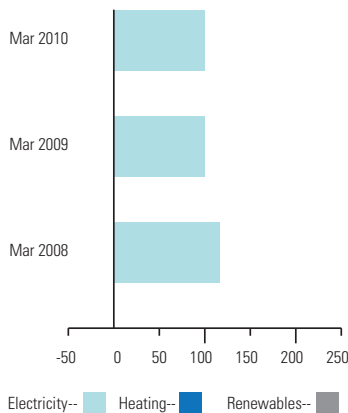
Total CO₂ Emissions

This chart shows you the annual Carbon Dioxide emissions that the building emits. It shows tons per year of CO₂.

The total CO2 emissions of the Art and Architecture building were compared over three years on the month of March for each year. The years were; 2008, 2009, and 2010. The graph shows two different sources that produce CO2 if the energy that is used to produce these sources. The third source on the graph is renewable energy, which indicates such resources as wind and hydro power. As seen in this graph the only source that produces CO2 levels in the Art and Architecture building is electricity. Heating does not produce CO2 because steam-powered energy from the Steam Plant (located on the campus) is used to heat the building. Currently the university is not implementing any form of renewable resources.

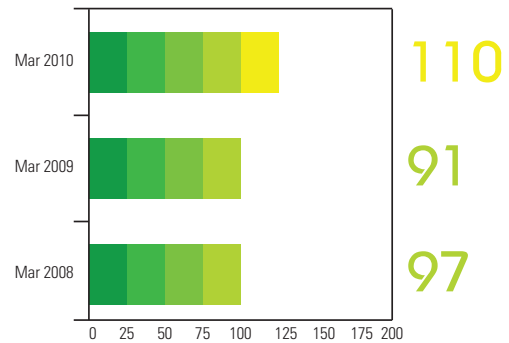
Previous Operational Ratings

This tells you how efficiently energy has been used in this building over the last three accounting periods.

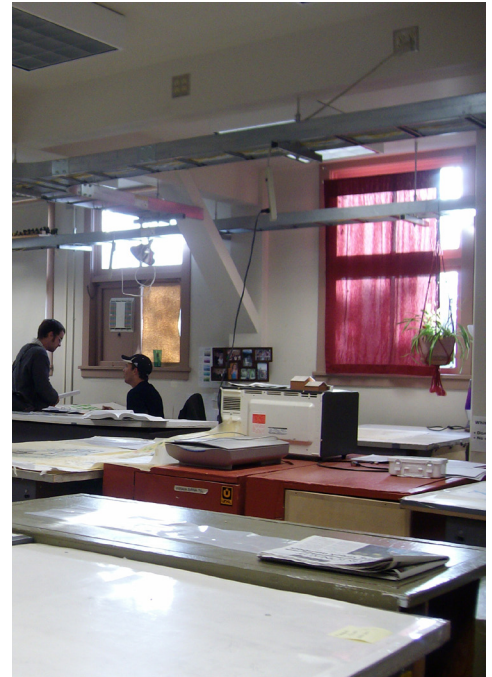
There are windows in on the west façade as well as the north and south. The west façade has a total of 12 windows which provide sufficient day lighting throughout the day. The north facade does not recieve direct day light but it still

filtered light into the space during daylight hours. In addition the southern façade also provides enough daylight through three windows. If used correctly these windows provide sufficient light to work without the need for mechanical lighting. The windows are also shaded with internal shades do to the fact that some of these windows give out a lot of glare to the many computers that are within the studio spaces.

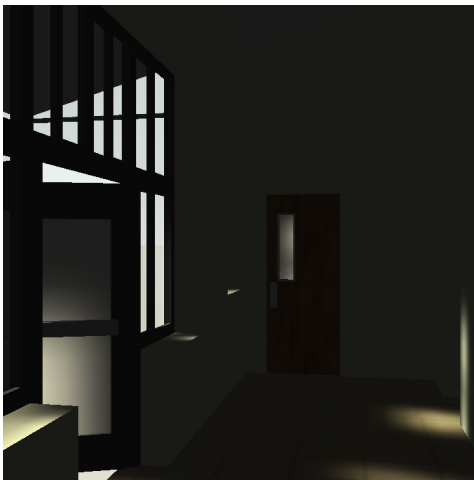
LIGHT UP

The lighting analysis for the digital 3D model was primarily done with LightUp for Sketchup which is a plugin that adds realistic, real-time lighting to Sketchup models. LightUp helped us produce pseudo colored renderings of the college of Art & Architecture showing the distribution of light throughout the building. From those rendered images we gathered lux (lumens per square meter) data. They revealed the the distribution of direct local

light in the model and provided us with a real time light meter to take spot lux measurements. The insolation analysis of this plug-in took into account the Geo-Location of our model as well as the current time of year, to produce a daily Kwh/m²/day visualization. In addition, the light meter gave us spot results for the surface being hovered over, while also tracking the value of the surface to aid in the solar energy analysis.

As you may see in these first renderings of the current conditions of the building, the light levels are that on the low spectrum. Not enough sunlight is distributed further into the rooms, which in turn makes the space look rather dark where there are no windows (back of the room). One other problem we noticed while researching was that the height and position of the windows created a glare issue directly on the students work spaces.

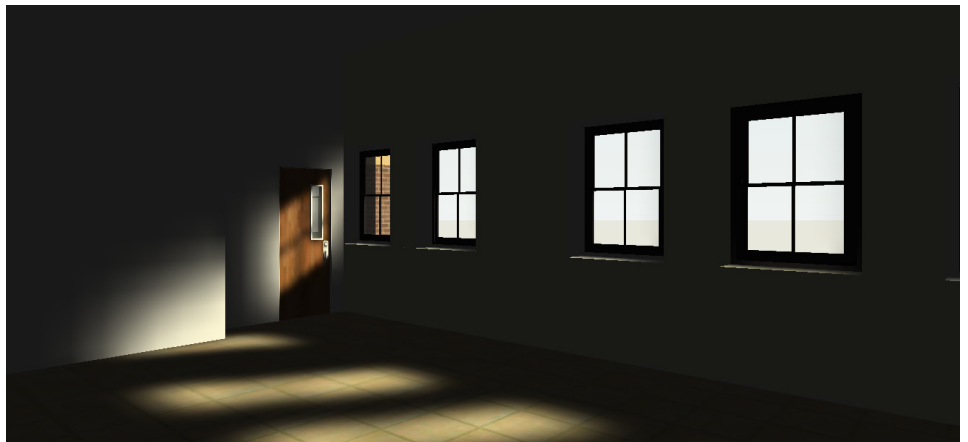
The rendering above shows the entrance of the Bio Regional studio space showing the amounts of light entering the space on October 5, 2010 3:03pm.

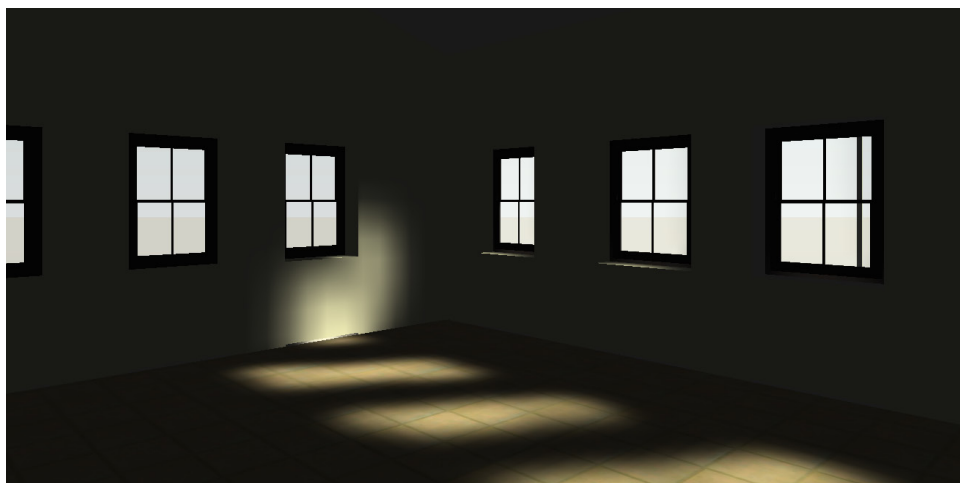
Images derived from the North East studio space where Bio Regional Students reside as well as the South West studio where graduate Architecture students reside.

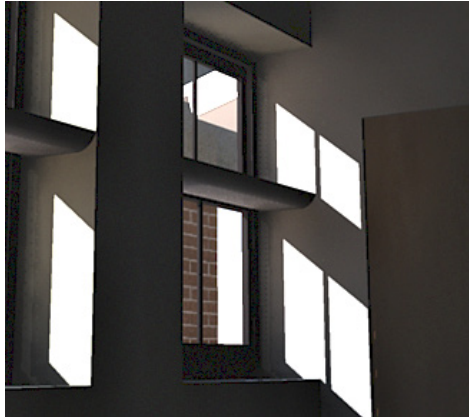
To solve the present issues, we decided to implement two redesign strategies to further distribute light into the rooms, whilst eliminating the glare problems on the student work areas. First we incorporated operable skylights to the design which in turn brought in a little more daylight, but not as much as needed; the operability of the skylights also provided a heat release mechanism for the summer. To further distribute light into the rooms, we attached light shelves to the windows which definitely brought light further in the spaces and completely eliminated the glare problem. The lux levels on these renderings are noticeably higher than the previous renderings on the current design. The integration of the skylights and the light shelves were a complete success; not only did they bring in more light and eliminate glare problems, but they were also useful to exhaust hot air through the roof during the summer.

This image shows the lightshelves that were installed as part of our redesign.

simulate existing situations and strategic placements of skylights as a possible solution to the problem of overusing electrical lighting, we discovered that skylights were not enough. We implemented light shelves in addition to the skylights -- this dispersed the light more evenly and further back in the spaces. The latter solution deemed satisfactory in alleviating a major issue of energy usage in this building. Two of the four walls have no direct access to natural light, consequently, allowing light from above is the most feasible option in supplying sufficient light for those students sitting in that area. Because of these tactical simulations, the strategies discussed previously could potentially be implemented with a better understanding of how it will affect the everyday occupants. We believe that these matters of the overuse of electricity for even just these two spaces of one building on our campus could shed some light on how straightforward such ideas could be executed in an aesthetically pleasing manner.

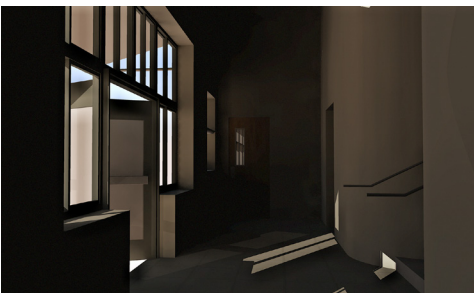
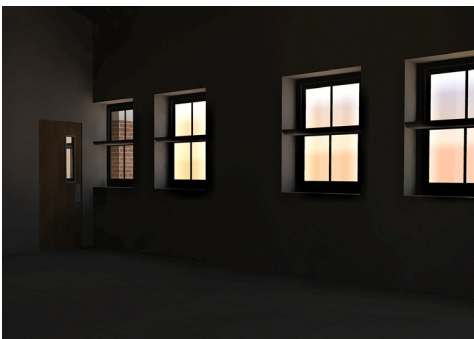
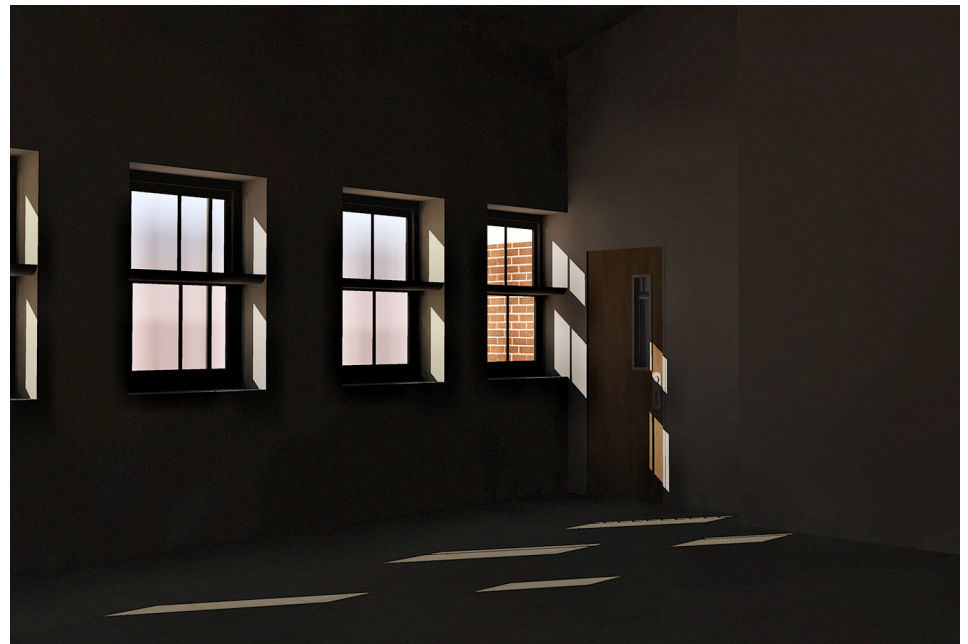
We also used digital models to
