# GLARE AND MATERIALS

A STUDY OF THE MATERIAL FINISHES ON COLLEGE OF EDUCATION BUILDING

Miranda Freeman and Mae Baja

ARCH 571: Building Performance Evaluation

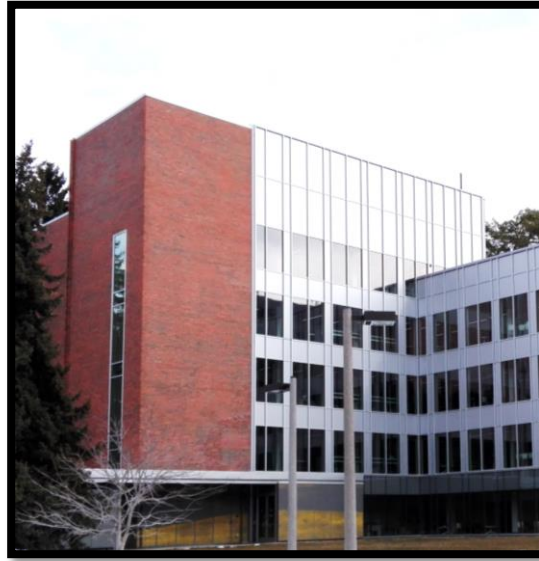
## Exterior Finishes:

- Aluminum composite panel cladding
- Brick wall
- Double insulated glass

## Interior Finishes:

- Polished concrete floor
- Painted wall finish
- Painted aluminum panels for columns
- Variety of colored fabrics used in furniture

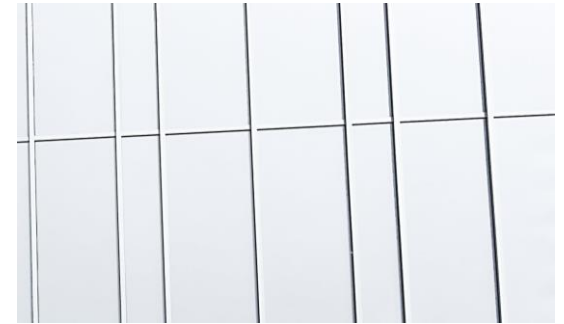
## Aluminum composite panel cladding

Actual material photo from COE building

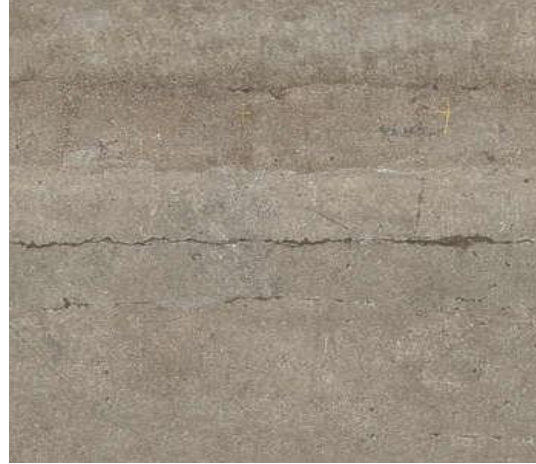
## Polished concrete floor

### Disadvantages:

- Once set, defects are difficult to rectify.
- Cannot be satisfactorily repaired by patchwork.
- Poor insulation against sound and heat.

### Advantages:

- Durable. A properly constructed floor will outlast most of the other components of the building.
- It is designed to carry the imposed loading; will not deflect under applied load.
- It possess high thermal mass and can be used to improve the internal environment and reduce energy demand.
- It is nonabsorbent and resistant to dampness. Can be used for water retaining floors as well as water storage.
- Non-combustible material.

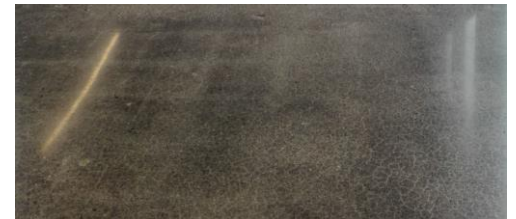
Actual material photo from COE building

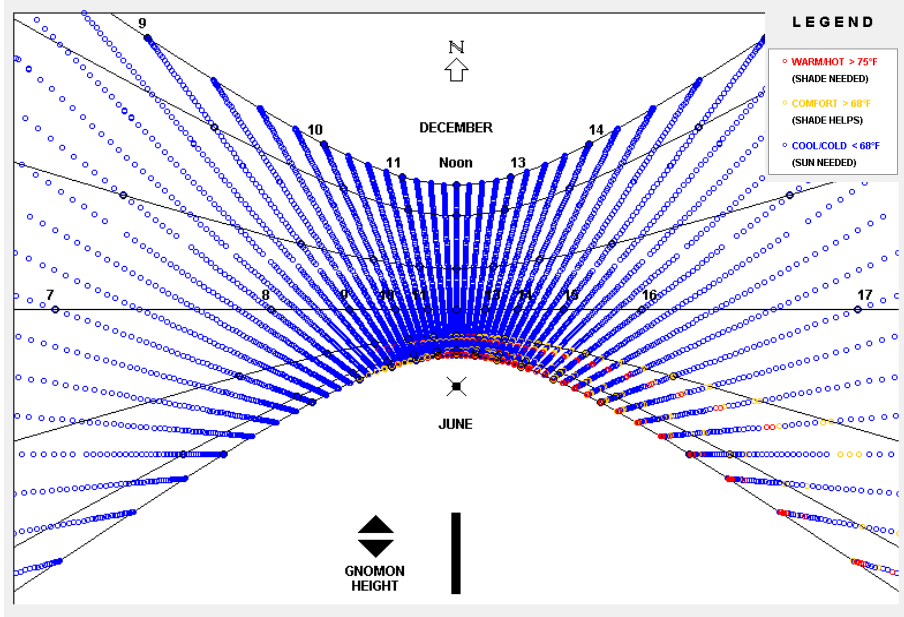
## Sun Path Diagram (Winter – Spring)

- Comfort levels during daytime start in April, and will stay cool at nighttime. Approximately 68 deg. F and up.
- Warm/hot levels will rise up to 75 deg. F and higher in mid June as the summer season starts.

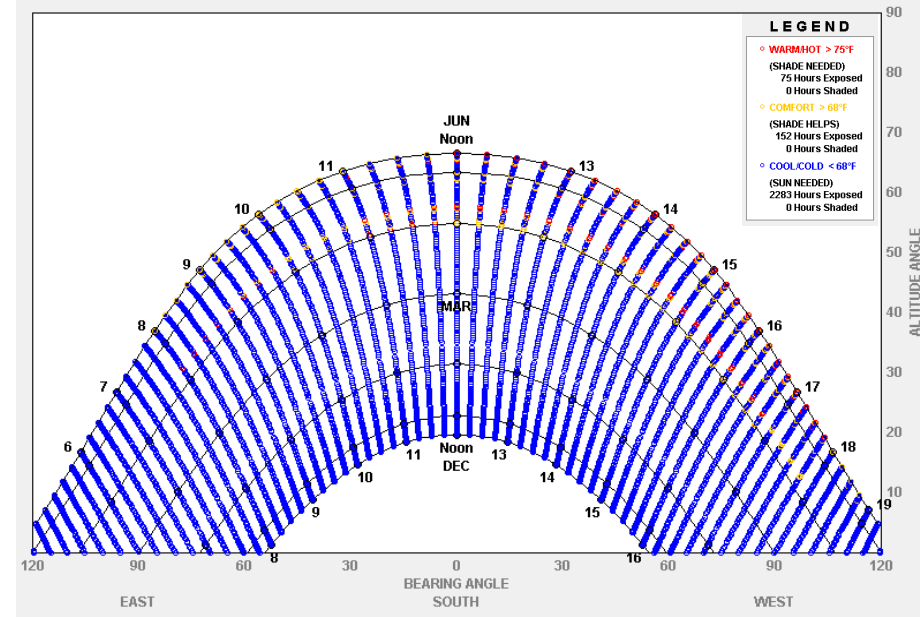
## Sun Shading Diagram (Winter – Spring)

- April to June is exposed to the sun with warm/hot level of 75 deg. F and higher, approximately 75 hours. Shade is needed to reduce the amount of exposure from the sun.
- 152 hours of comfort. Shade can help reduce the amount of exposure from the sun.
- 2283 hours of cool/cold. Sun is needed in order to balance thermal comfort.

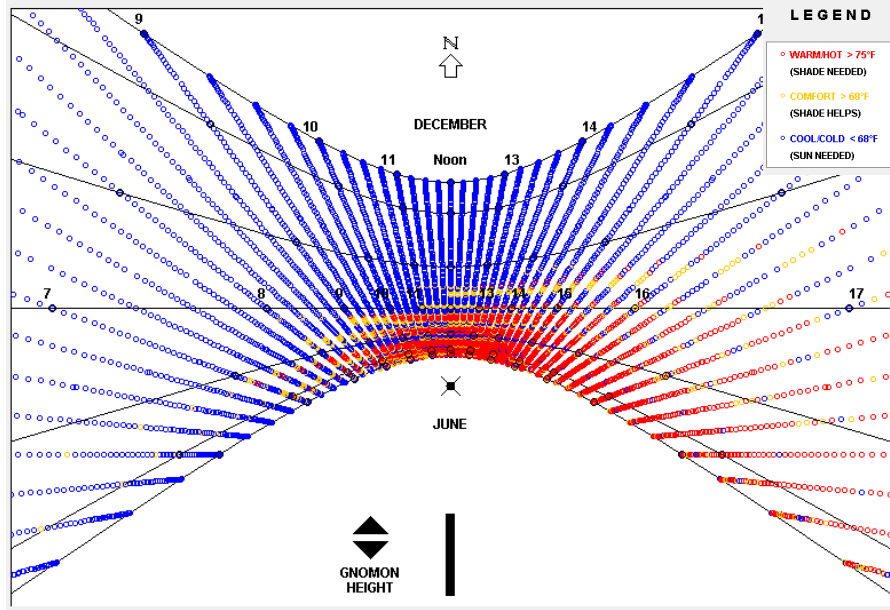
## Sun Path Diagram (Summer – Fall)

- Comfort levels during daytime occurs at certain time and days. Approximately 68 deg. F and up.
- Warm/hot levels will rise up to 75 deg. F and higher from June to September.

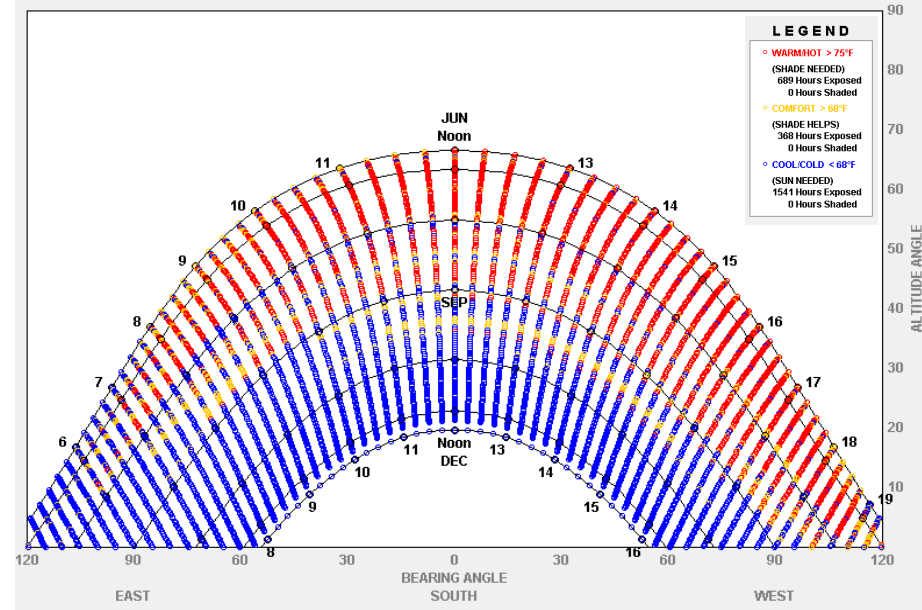
## Sun Shading Diagram (Summer – Fall)

- June to September is exposed to the sun with warm/hot level of 75 deg. F and higher, approximately 689 hours. Shade is needed to reduce the amount of exposure from the sun.
- 368 hours of comfort. Shade can help reduce the amount of exposure from the sun.
- 1541 hours of cool/cold. Sun is needed in order to balance thermal comfort.

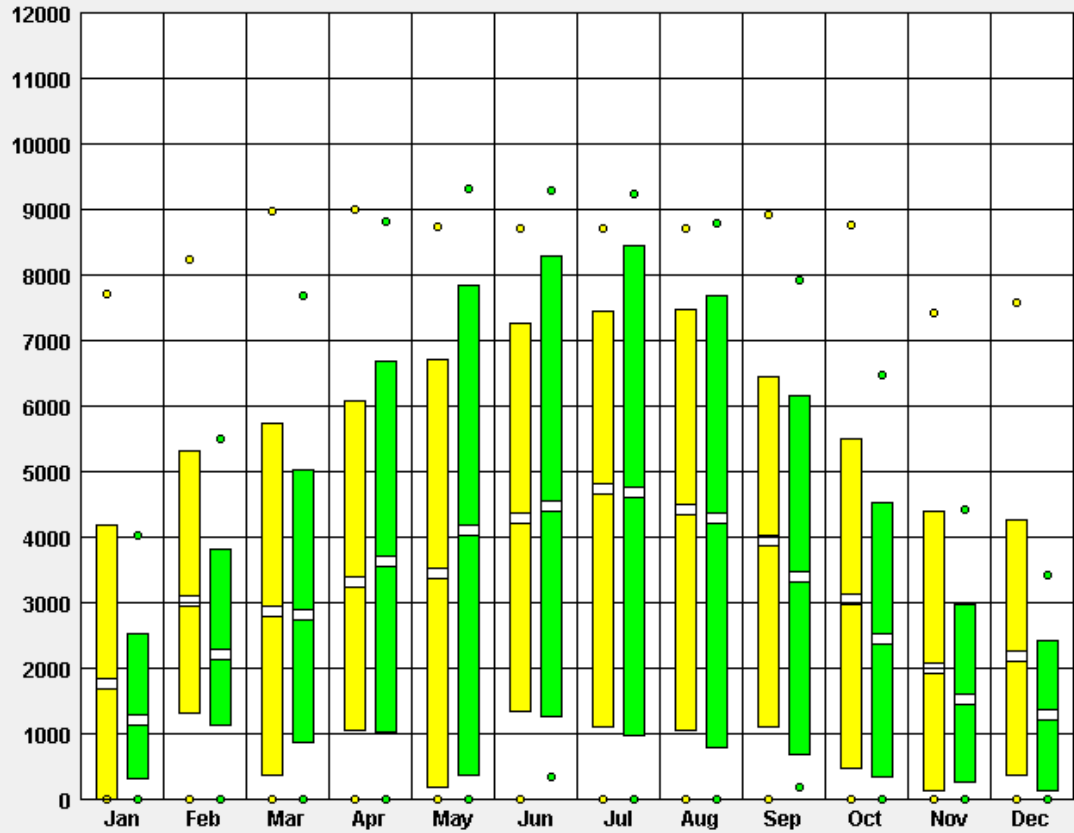
# Illumination range

- Average high illuminance ranges from 4000 to 7000. Average lowest illuminance ranges from 0 to 1000.
- The recorded high illuminance is at the months of March, April and September.

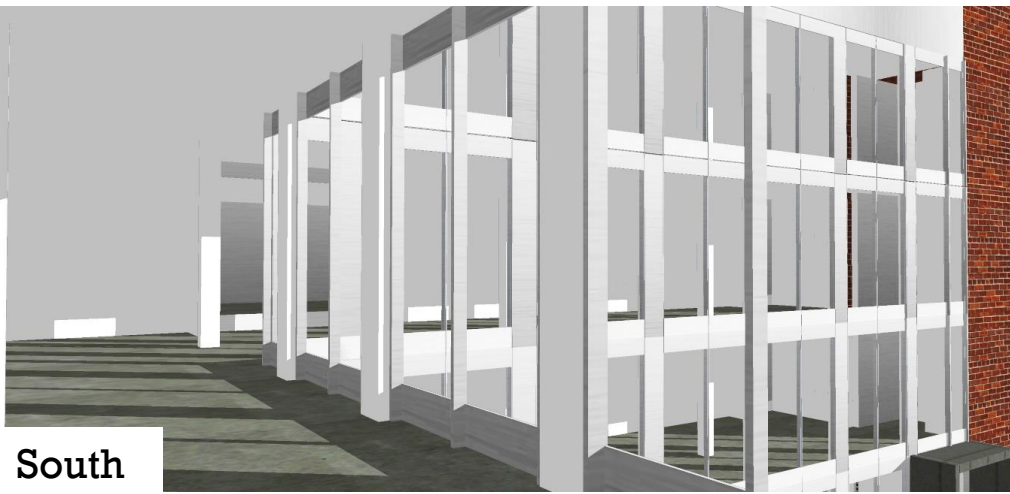
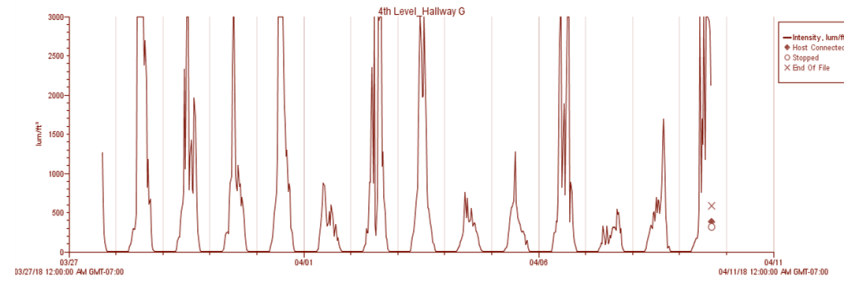
South

**HOBO Test: Light Intensity**

Date of test = March 27 to April 09, 2018 (13 days)  
 Maximum = 2,998.9 lum/ft<sup>2</sup>  
 Minimum = 1.1 lum/ft<sup>2</sup>  
 Average = 433.2 lum/ft<sup>2</sup>

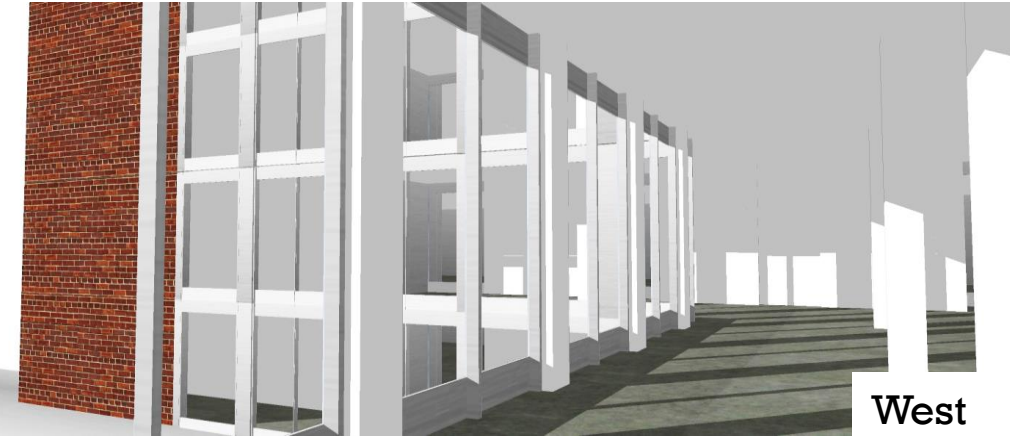
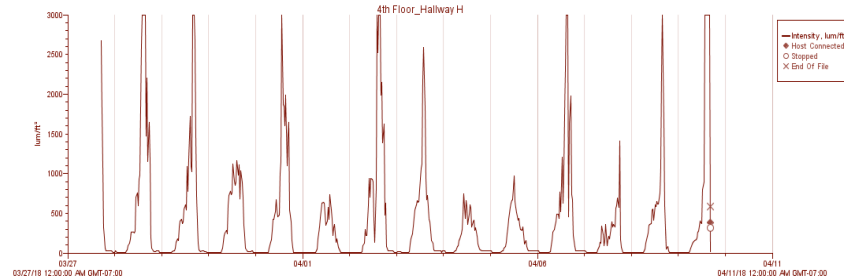
West

**HOBO Test: Light Intensity**

Date of test = March 27 to April 09, 2018 (13 days)  
 Maximum = 2,998.9 lum/ft<sup>2</sup>  
 Minimum = 0.4 lum/ft<sup>2</sup>  
 Average = 380.6 lum/ft<sup>2</sup>

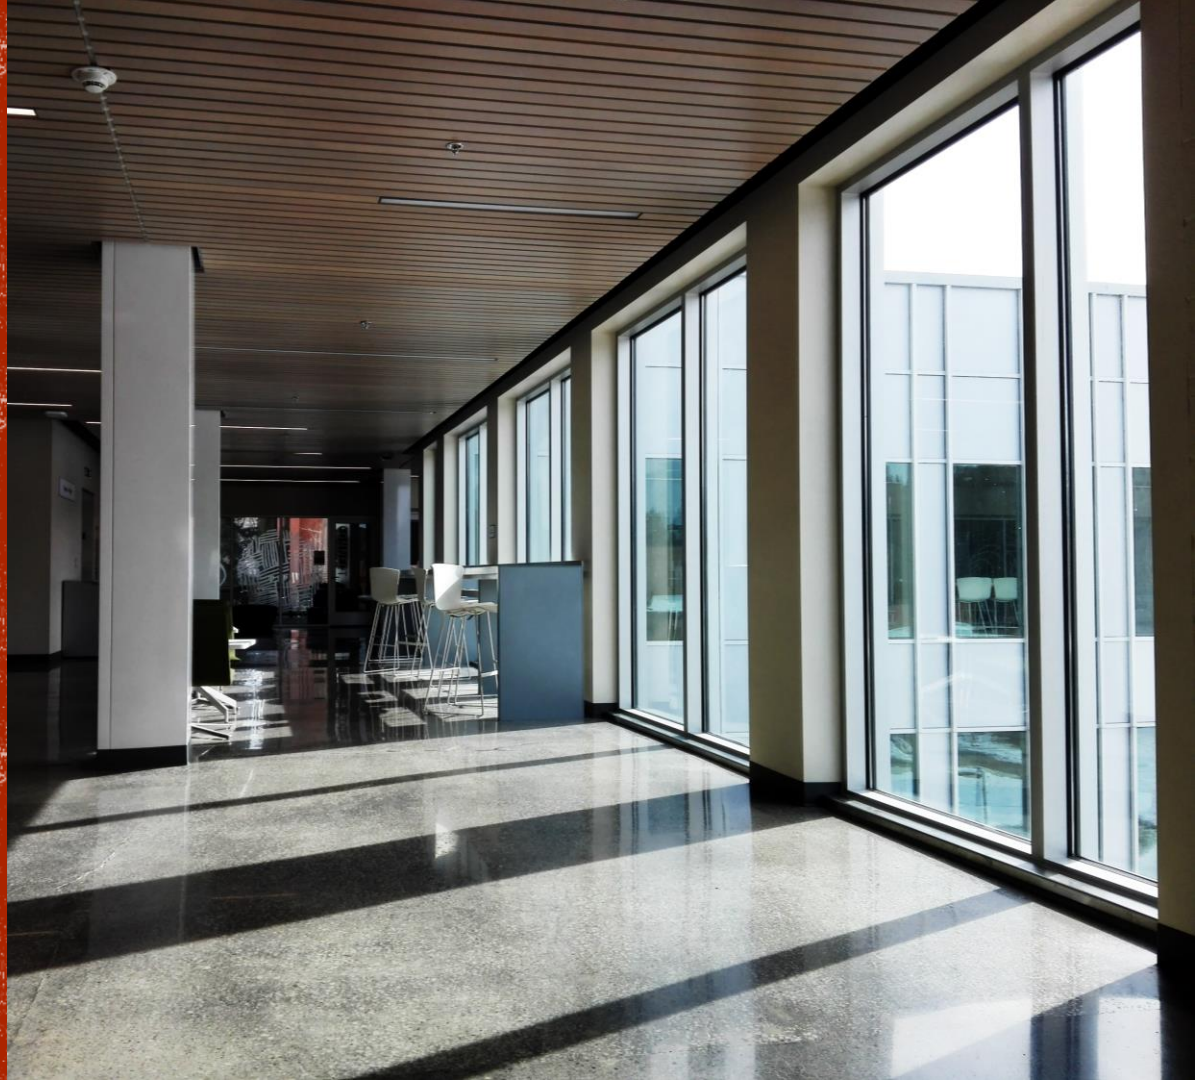
# Concrete

- Absorbs and stores heat energy.
- Increases reflectivity value when polished.
- High exposure to sunlight and lateral movement can cause damage to the surface.

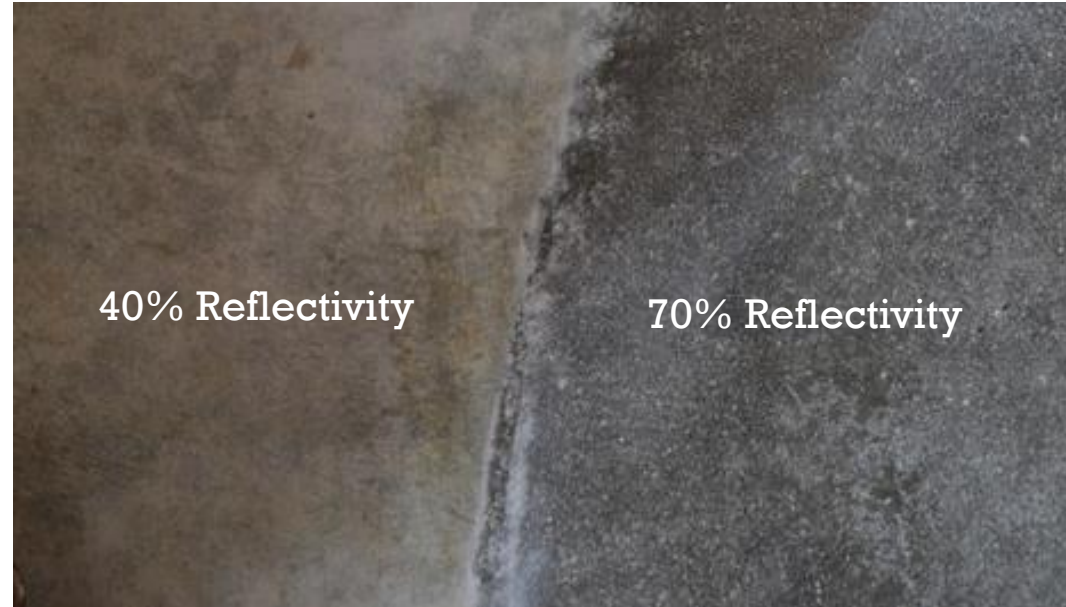
Rough finish

Polished finish

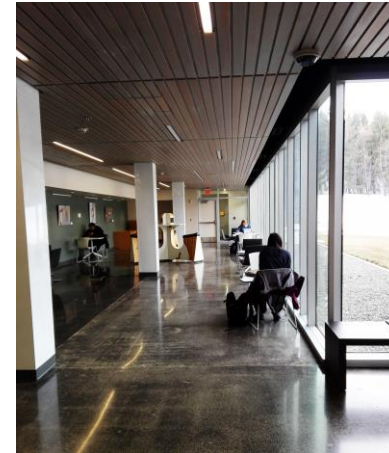
Ground floor

Actual photo

Infrared camera

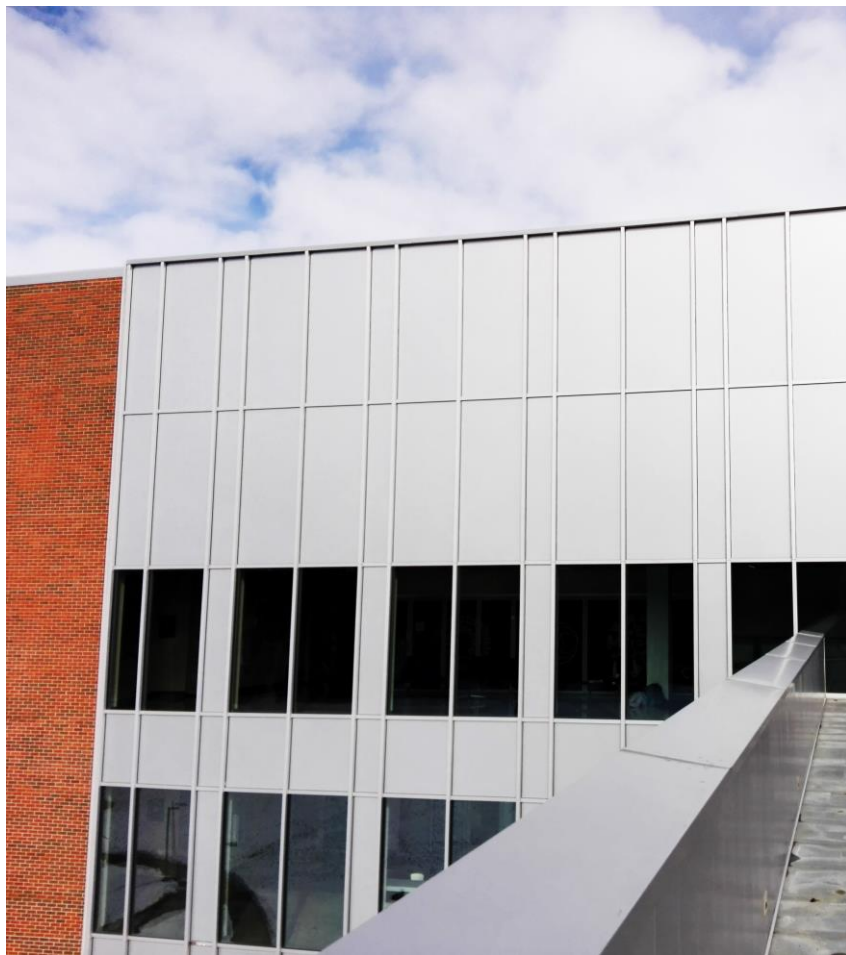
**WHAT WE LEARNED**

- Building form and orientation are relevant to the selection of finishing materials (e.g. exterior walls and windows). High reflective materials may be inappropriate in areas of direct sunlight.
- Sun shading devices can help reduce heat and glare from the sun.
- The shape of the building, combined with aluminum composite panel finish selection, causes reflected sunlight to scatter. The result is visual discomfort from glare.
- Seat occupancy data (as little as 4% or 5% in the worst glare areas) shows that user discomfort will render parts of building almost unusable.

Our careful analysis and observation of luminosity, glare, sun angles, and seat usage support our hypothesis that the glare caused by the highly reflective surfaces causes discomfort for the building occupants. A potential solution to this problem would be to implement more matte material finishes, thus significantly reducing the light's ability to glare off the surfaces. Overall, this exploration of glare and materiality was a worthwhile exercise in the post occupancy evaluation of the Education Building.
