## ODOT Long-Life Pavement Design & Construction

René A. Renteria, P.E.  
ODOT Pavement Design Engineer  
Salem, Oregon

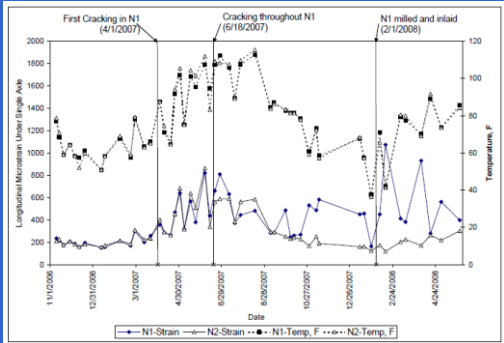
### NCAT Bottom Strain vs. Time

Longitudinal Microstrain Under Single Axle

Temperature, F

Date

Legend: N1-Strain, N2-Strain, N1-Temp, F, N2-Temp, F

- First Cracking in N1 (4/1/2007)
- Cracking throughout N1 (6/18/2007)
- N1 milled and inlaid (2/1/2008)

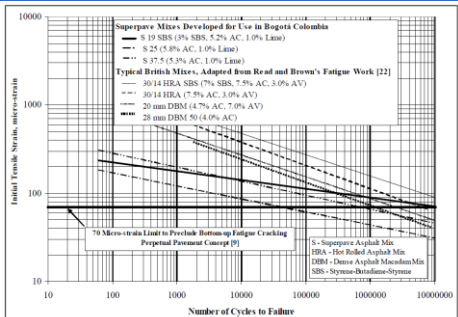
Figure 3. Fatigue Characteristics of Typical British Asphalt Mixes and New Colombian Superpave Mixes Determined Using the Nottingham Asphalt Tester

Initial Tensile Strain, microstrain

Number of Cycles to Failure

- Superpave Mixes Developed for Use in Bogota Colombia
  - S 19 SBS (9% SBS, 5.2% AC, 1.0% Lime)
  - S 25 (5.8% AC, 1.0% Lime)
  - S 37.5 (5.3% AC, 1.0% Lime)
- Typical British Mixes, Adopted from Road and Brown's Fatigue Work [2]
  - 3014 HRA SBS (7% SBS, 7.5% AC, 3.0% AV)
  - 3014 HRA (7.5% AC, 3.0% AV)
  - 20 mm DBM (4.7% AC, 7.0% AV)
  - 20 mm DBM 50 (4.0% AC)

70 Microstrain Limit to Prevent Bottom-Up Fatigue Cracking Perpetual Pavement Concept [9]

S - Superpave Asphalt Mix  
HRA - Hot Rolled Asphalt Mix  
DBM - Dense Asphalt Macadam Mix  
SBS - Styrene-Butadiene-Styrene
