NCAT Experience with Perpetual Pavements and High Polymer Mixtures

Danny Gierhart, P.E.
Regional Engineer
Asphalt Institute

CONFERENCE **OCTOBER 23-24, 2013**
MOSCOW, IDAHO

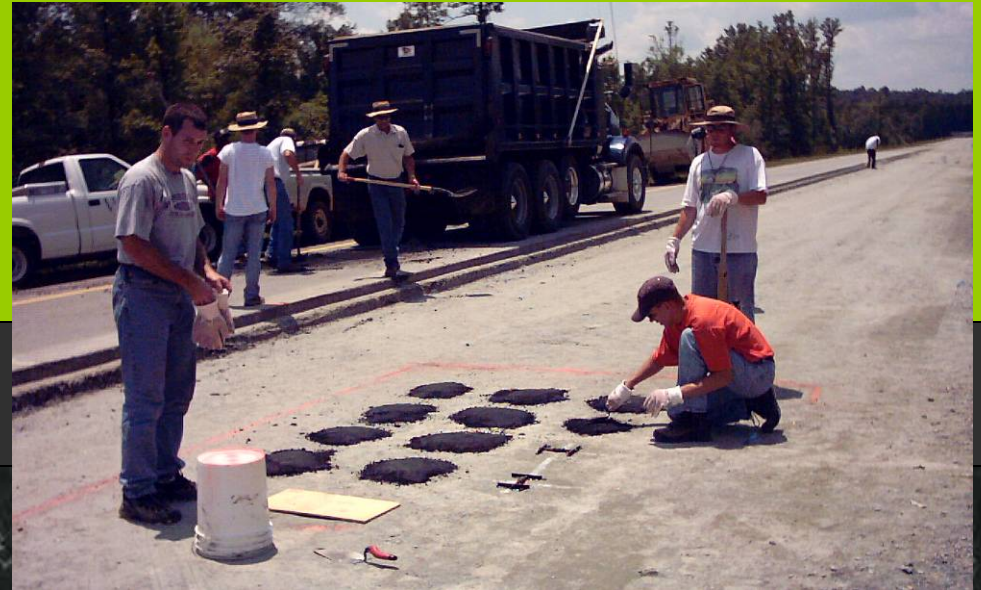
The maximum flexural strain was directly measured using a series of strain gauges installed at the bottom of the asphalt section.

1.5-3 in. PFC, SMA etc.

*High Modulus
Rut Resistant Material
(Varies As Needed)*

Max Flexural Strain

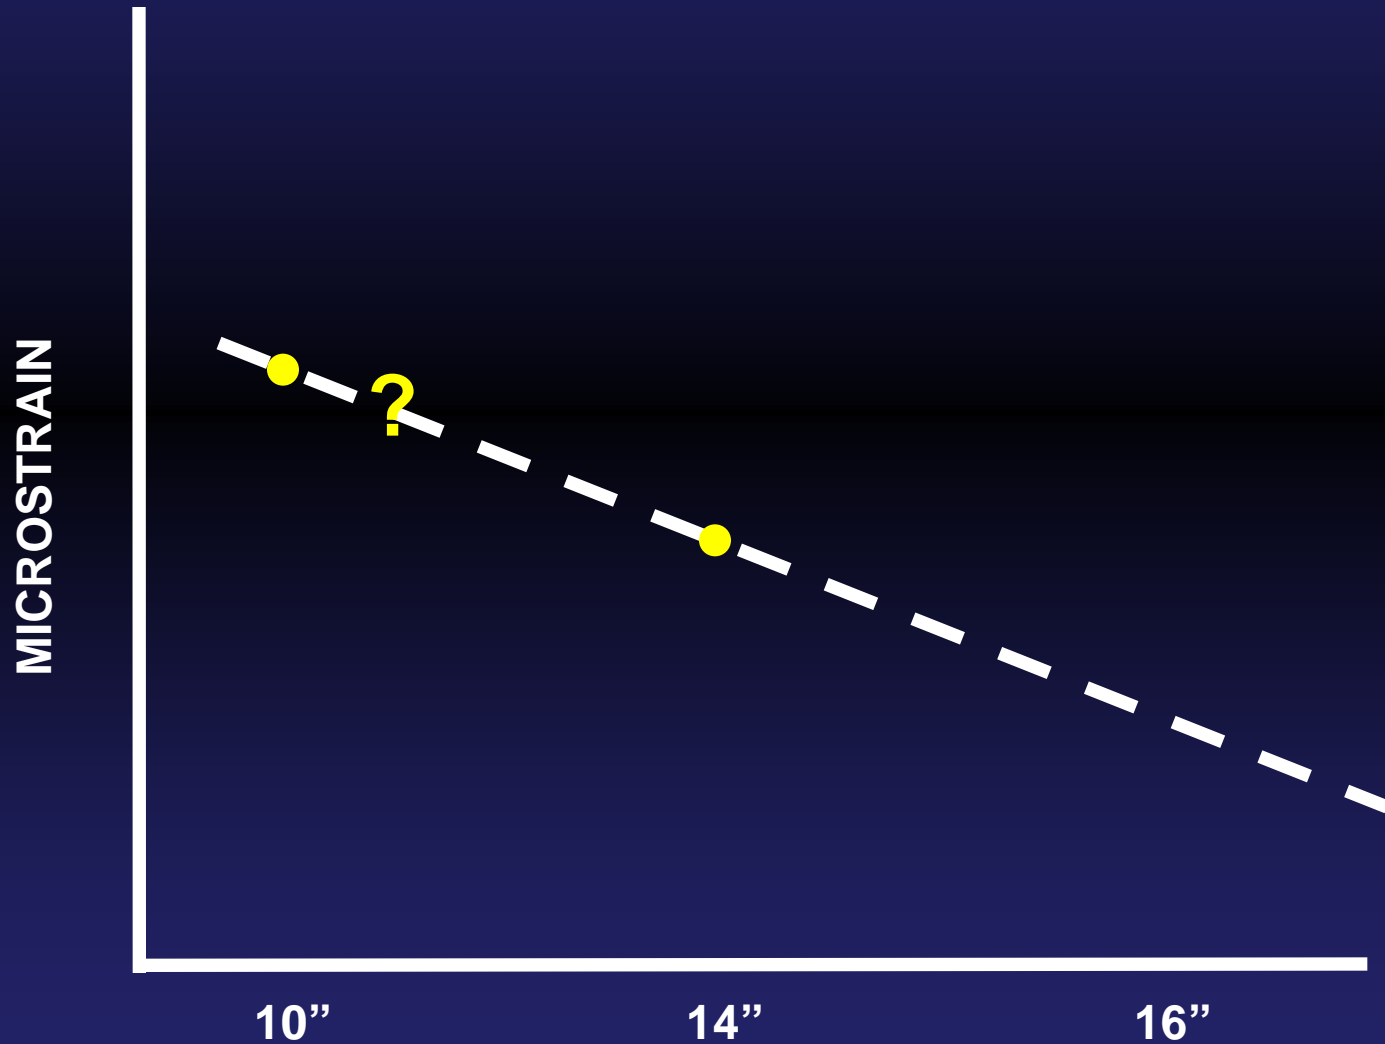
If we have determined the strain for a 10" and 14" thick pavement, the thickness at the critical strain level can be interpolated / extrapolated

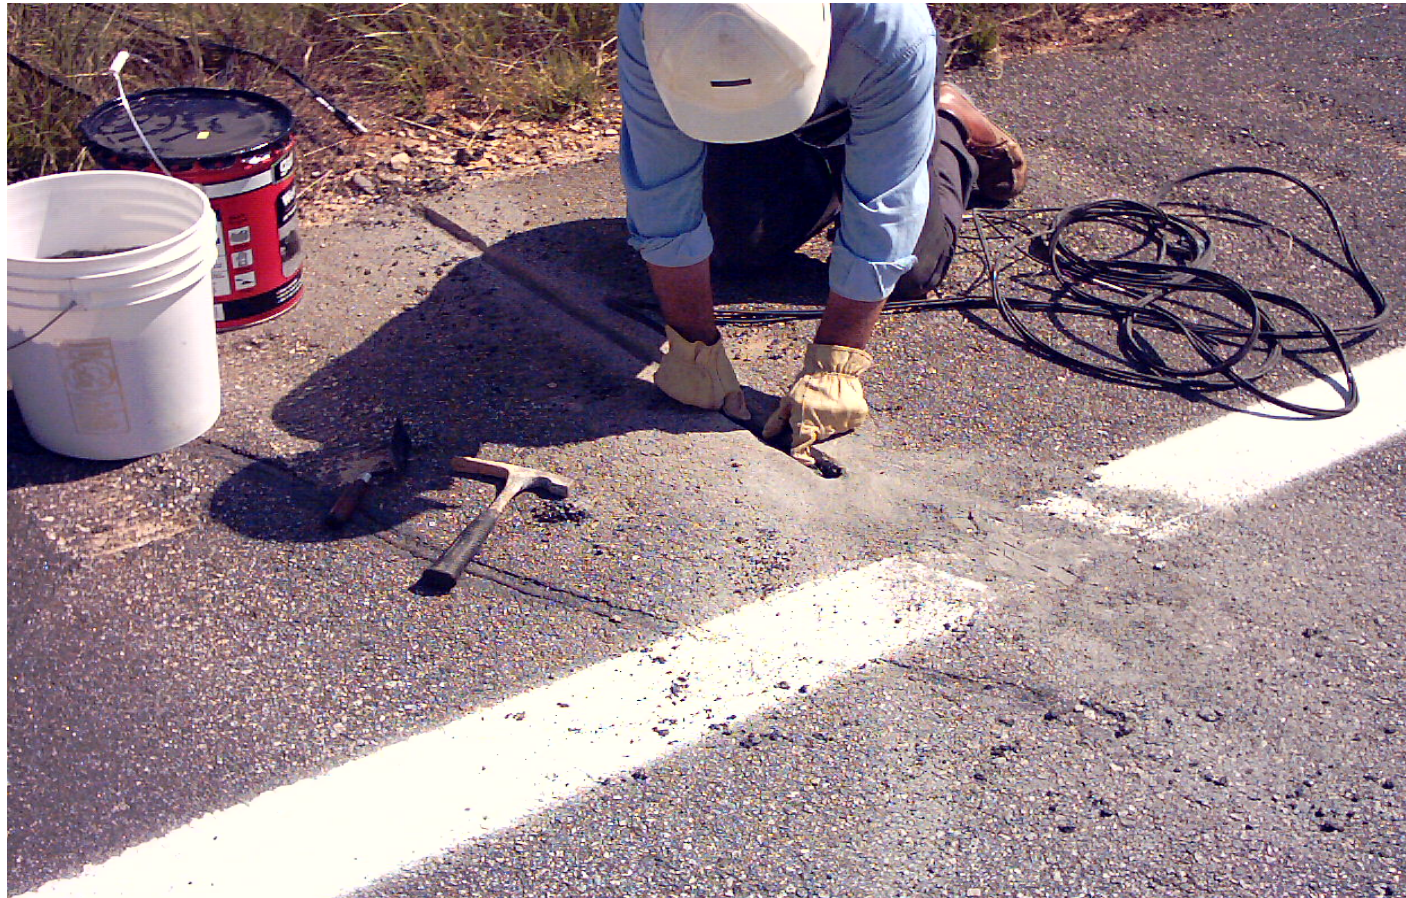
Temperature probes are placed in the pavement to continuously monitor temperature at various depths

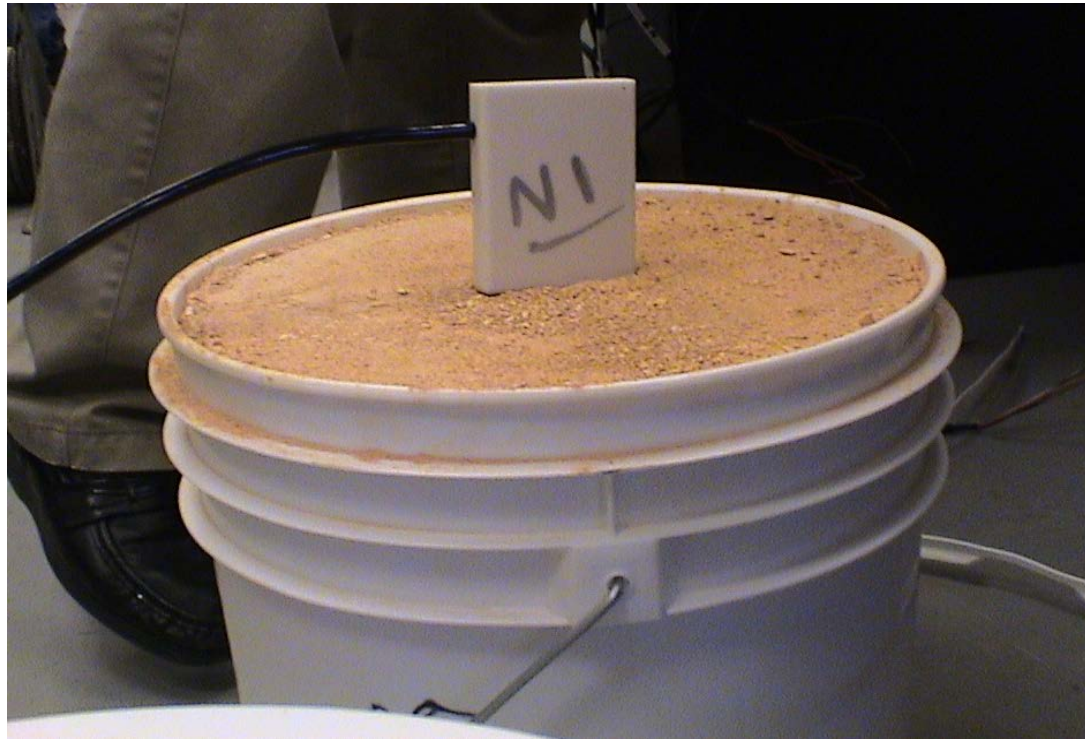
Moisture sensors were also placed in the subgrade to continuously monitor soil conditions

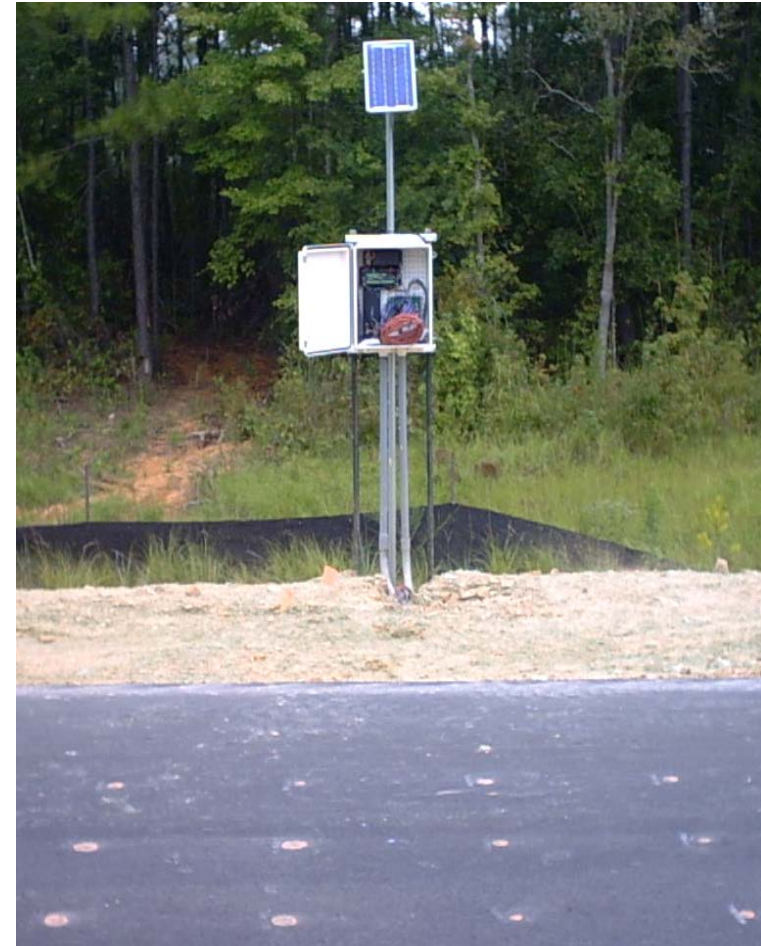
A datalogger was used to collect information from the different pavement sensors.

In addition to the normal “slow speed” mode that continuously gathers data, a “high speed” mode can be used to collect 40,000 data points per second.

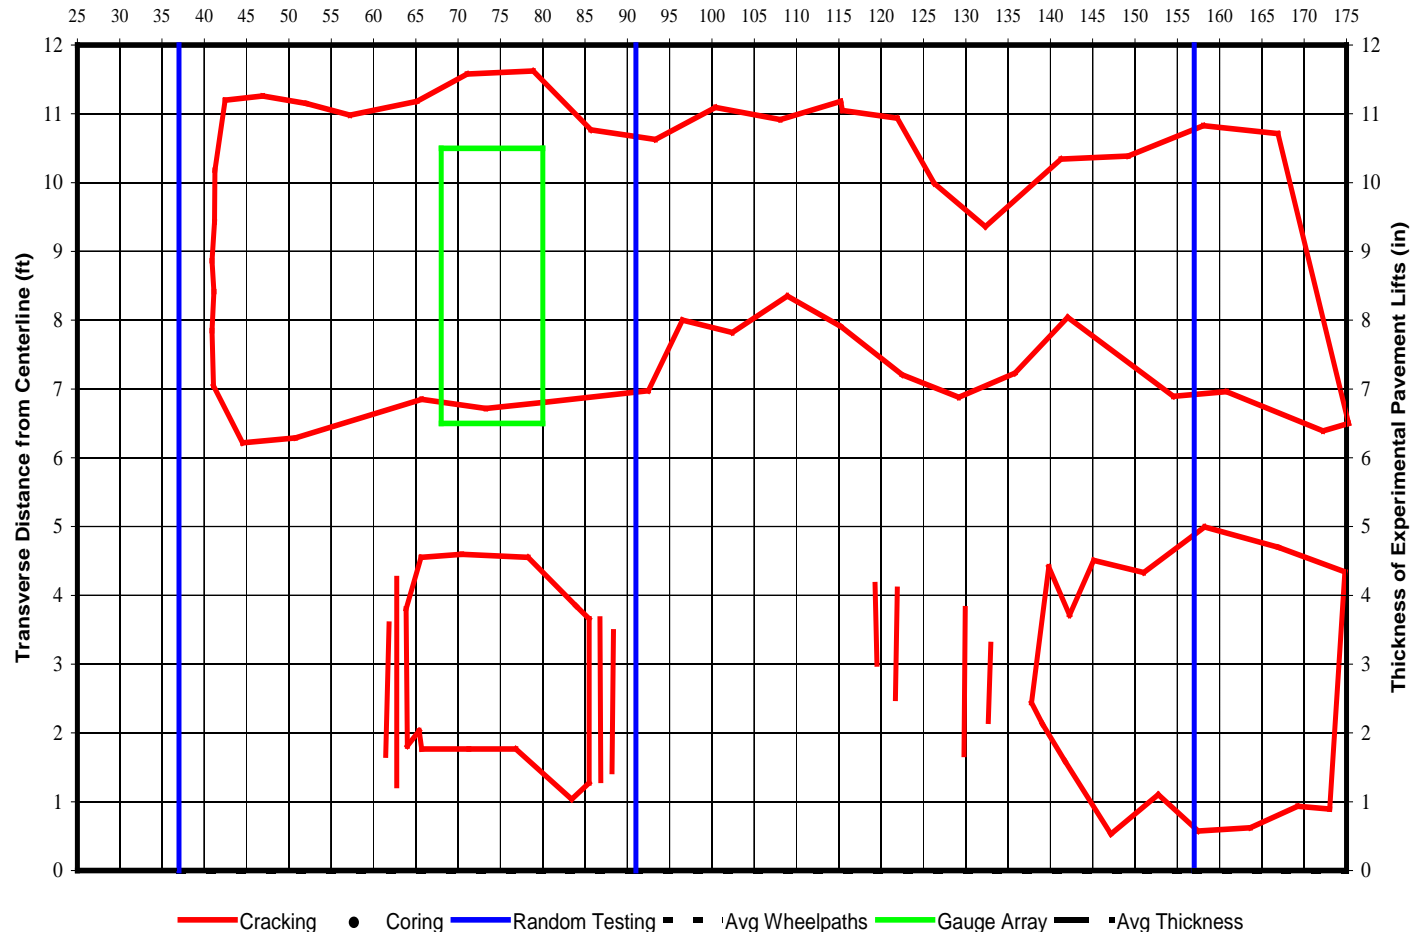
Additional Testing – Surface Map Cracking

N2

Longitudinal Distance from Far End of Section (ft)

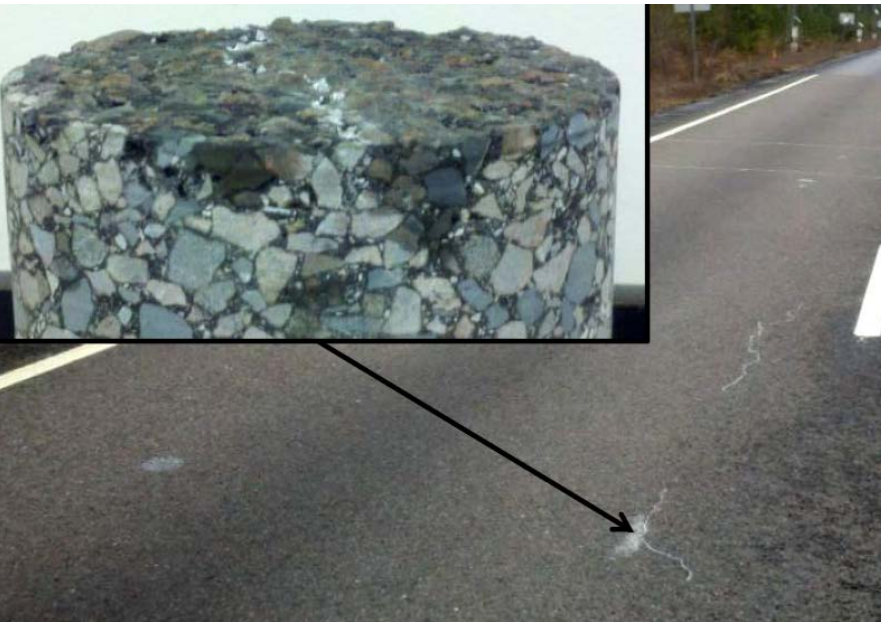
14" Section as of October 2013

Crack Map (Trucking Percent Complete via Height of Gray Map Date Box)

Top lift beginning to crack next to joint after 20 M ESALs

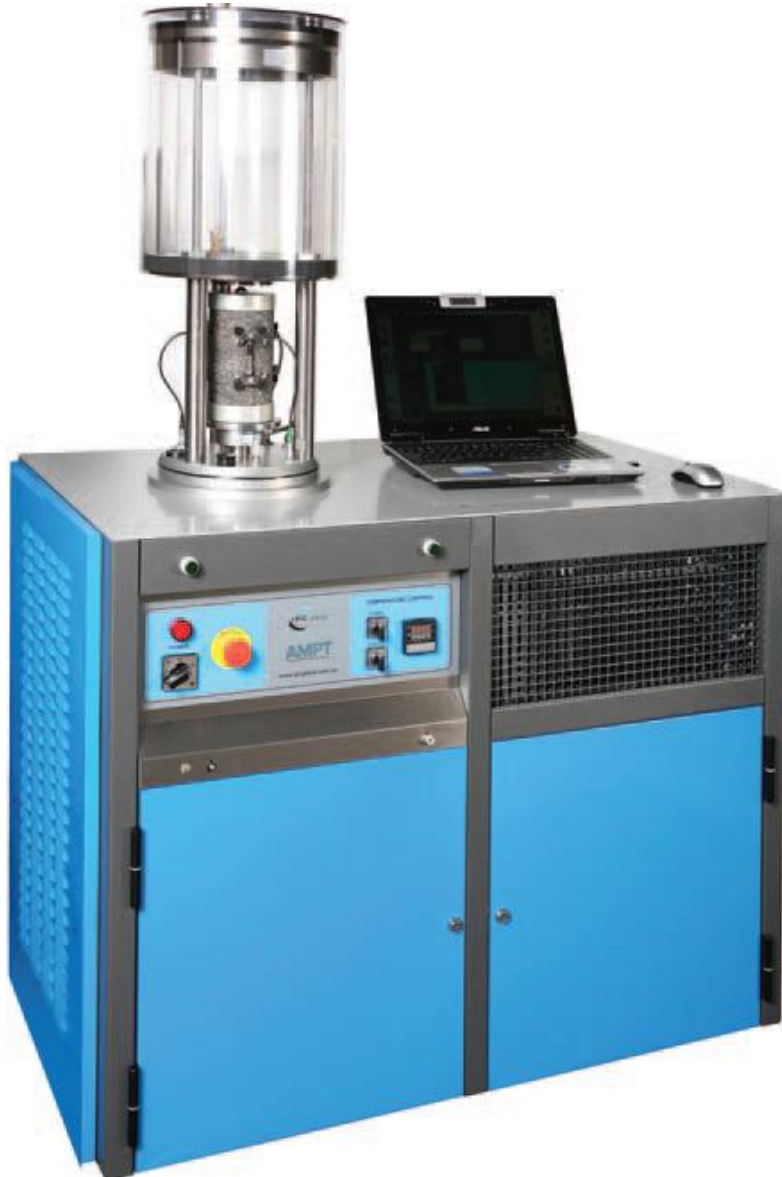
Simplified Viscoelastic Continuum Damage (S-VECD) Fatigue Testing

- Predicted fatigue life estimated 17x greater than control mixtures with PG 76-22
- Finding in agreement with previous beam fatigue testing

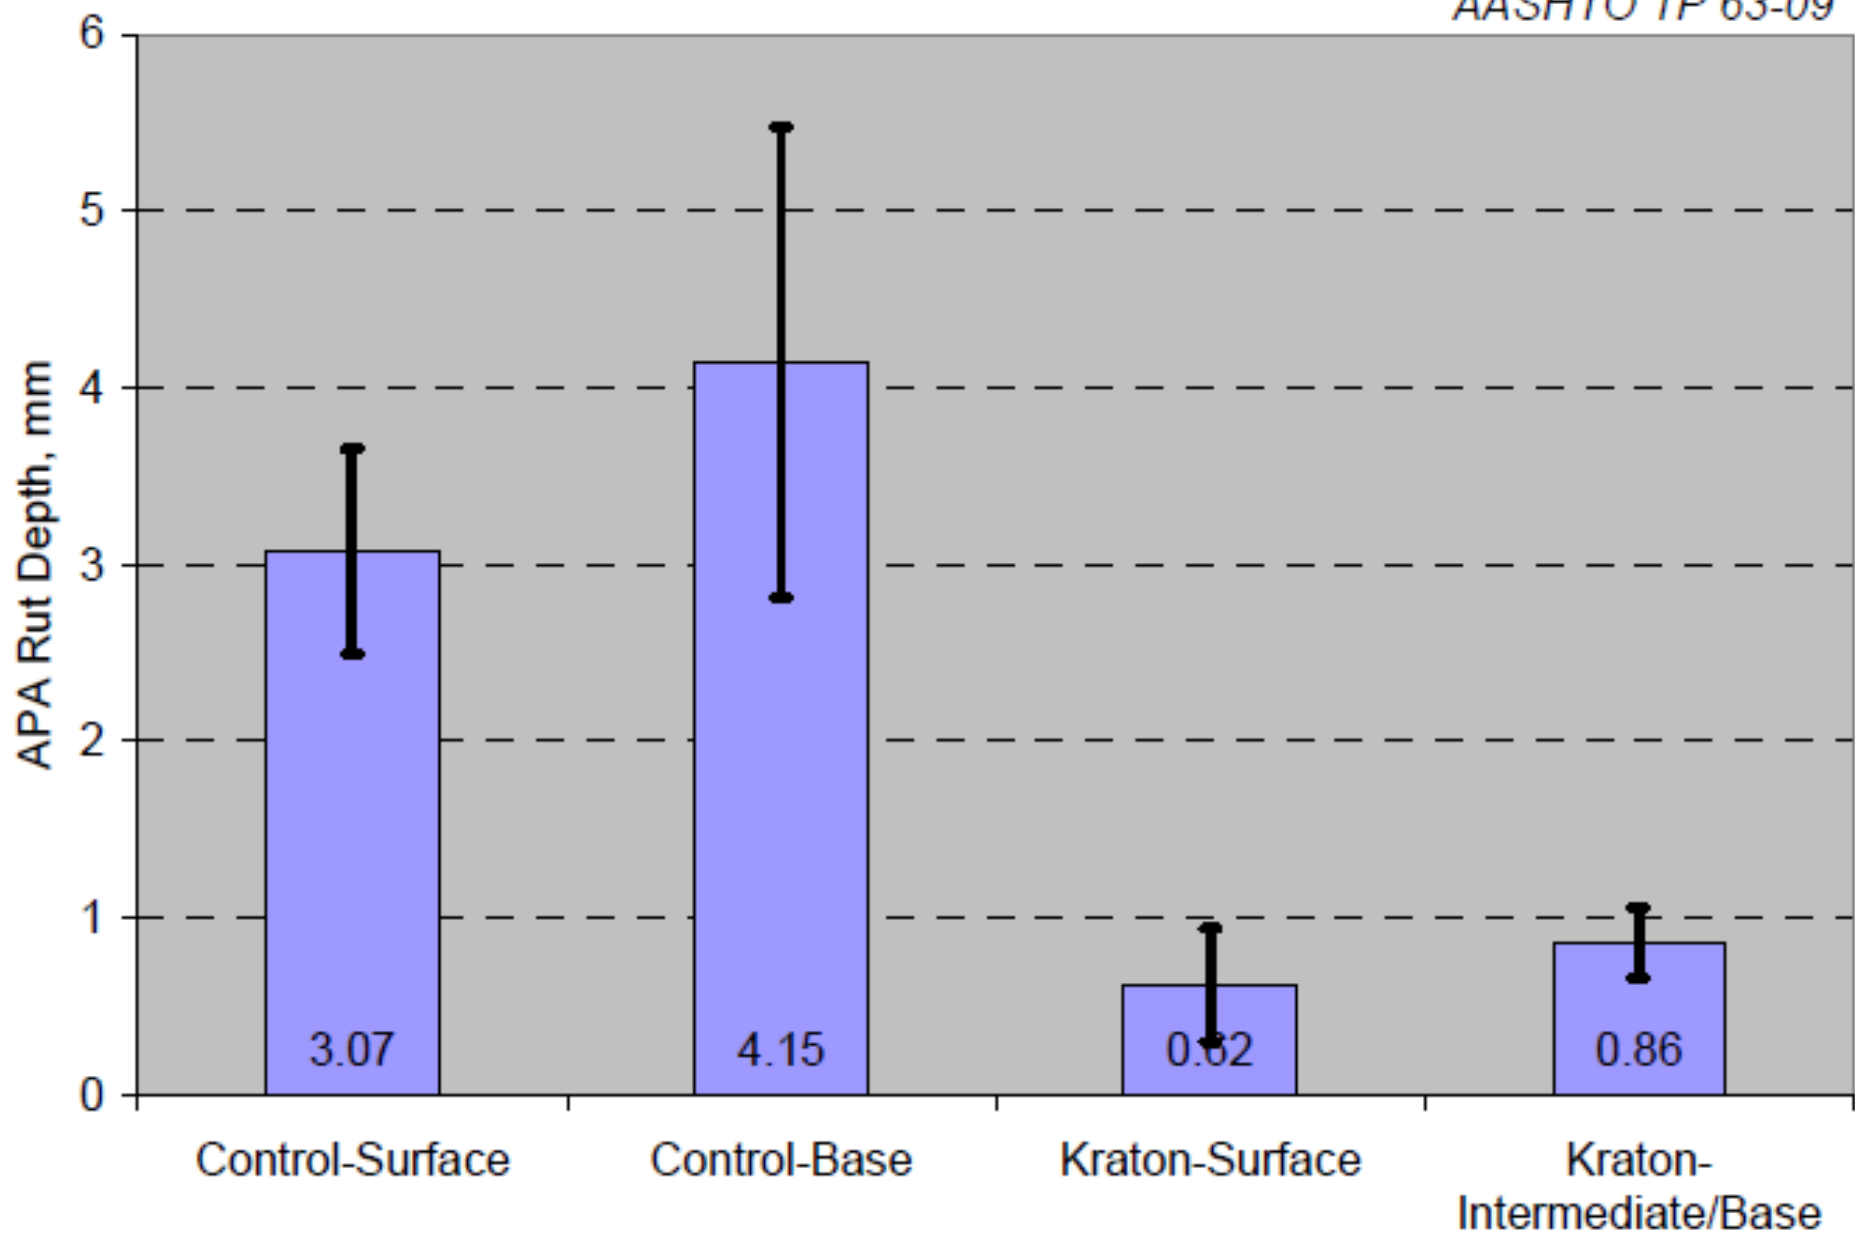
APA Rutting

AASHTO TP 63-09

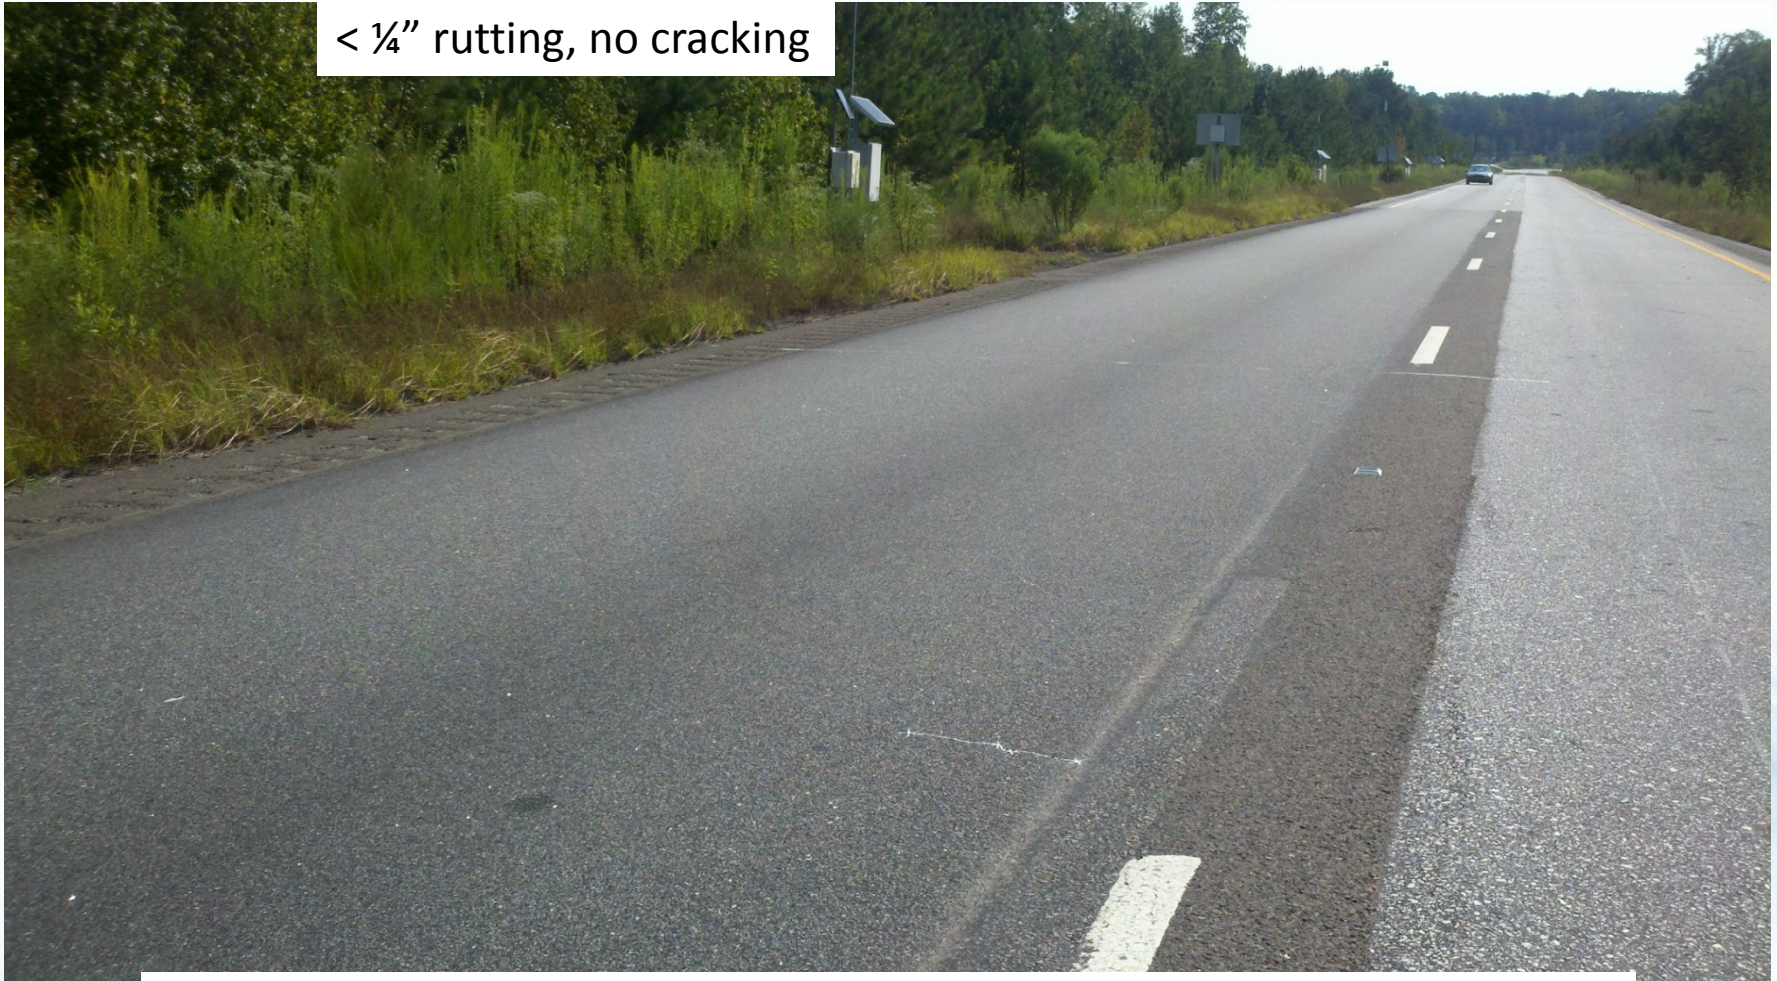
Section N8 - Sept. 12, 2011 - 5.27 MM ESALs as of 5/31/13 - 9.1 MM ESALs

< 1/4" rutting, no cracking

Similar crack appeared in first overlay at 2.7 MM ESALs
Oklahoma is sponsoring this section through the 2012 cycle to
monitor further deterioration and evaluate preservation strategies.
