Cronkite Internal Expedition to Second Floor Fan Room and Subsequent Quasi-Scientific Findings Thereof???

2010 ASES Tool Day

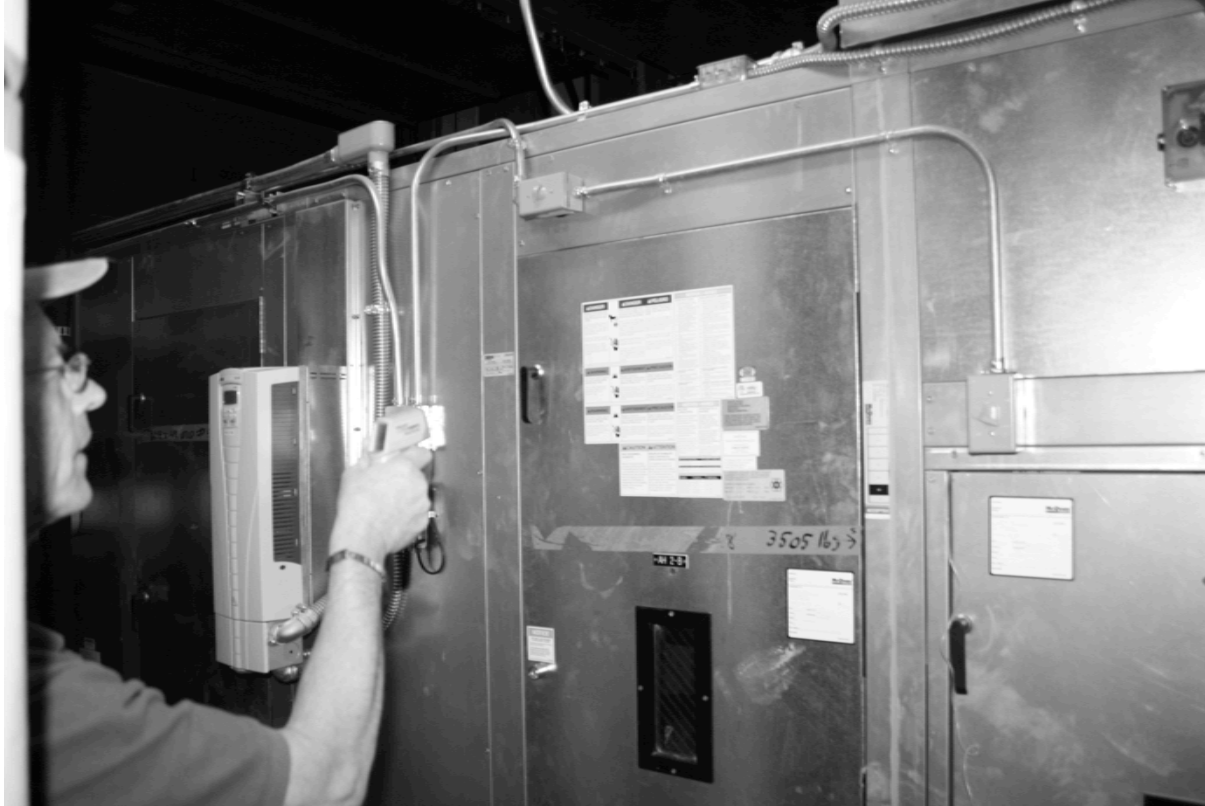
Methodology

1. Temperature Readings of Fan Room
2. Temperature Reading of Surfaces
3. Temperature Reading of Intended Occupied Spaces
4. Thermal Imaging of Surfaces

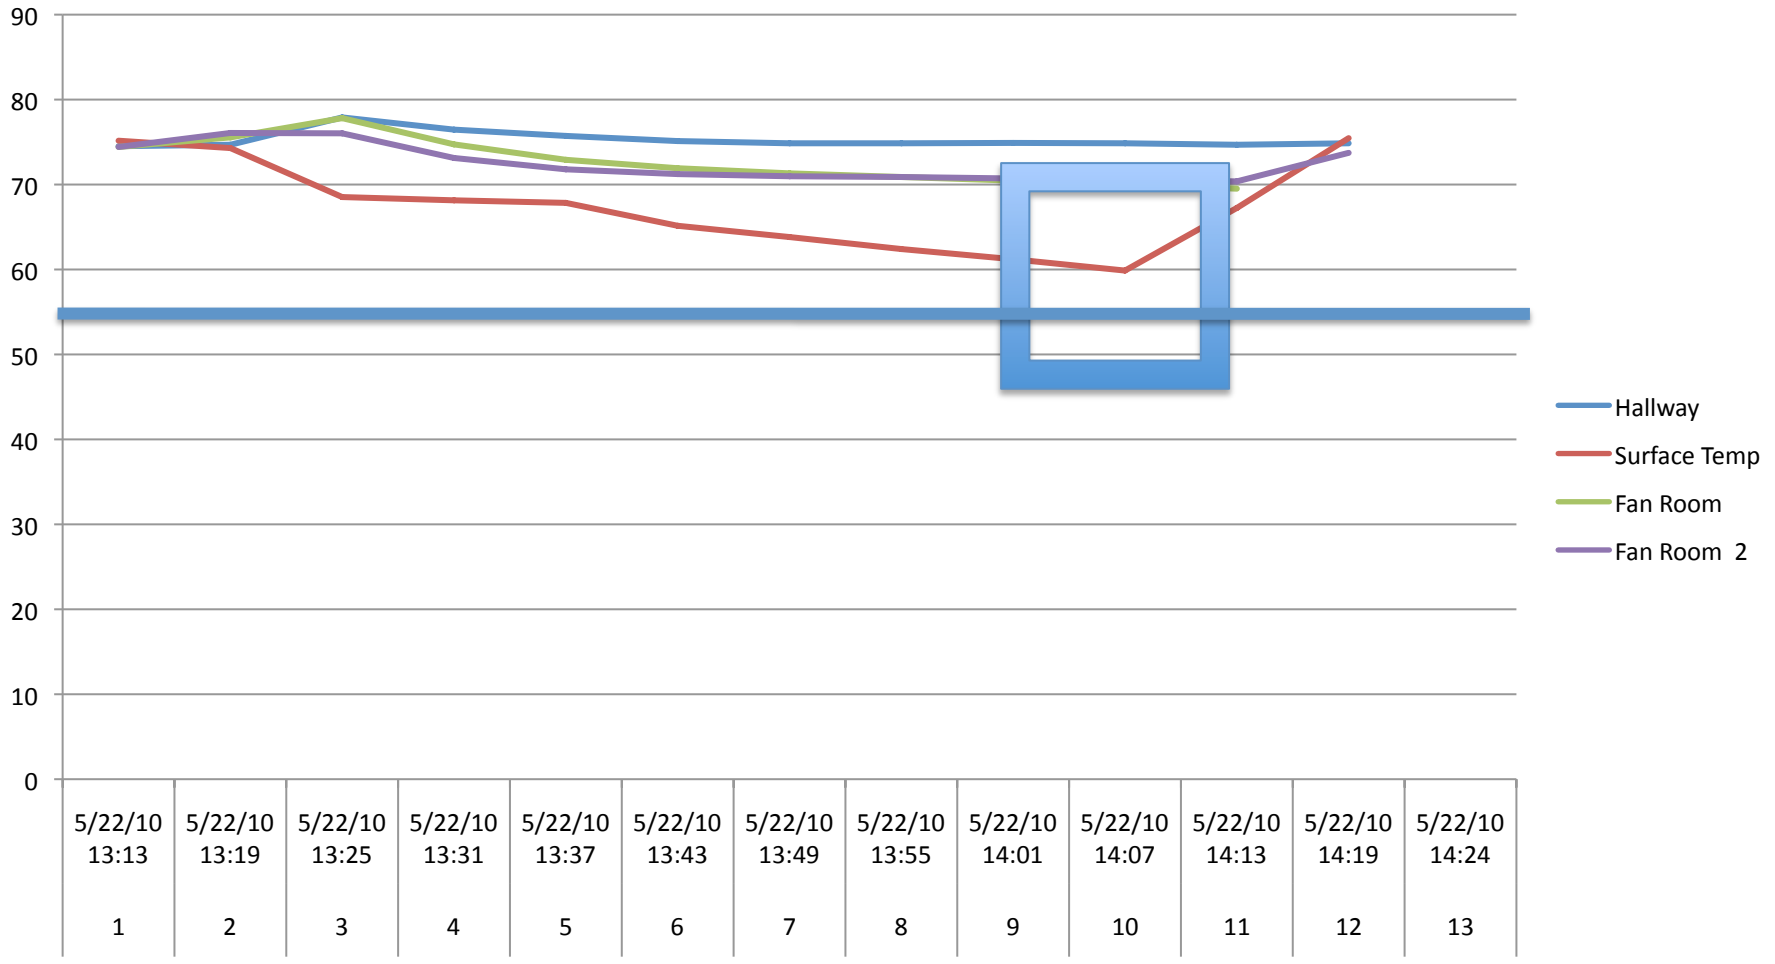
Data Analysis
 Comparison of Different Temperature Readings
 (between design intention and actual)

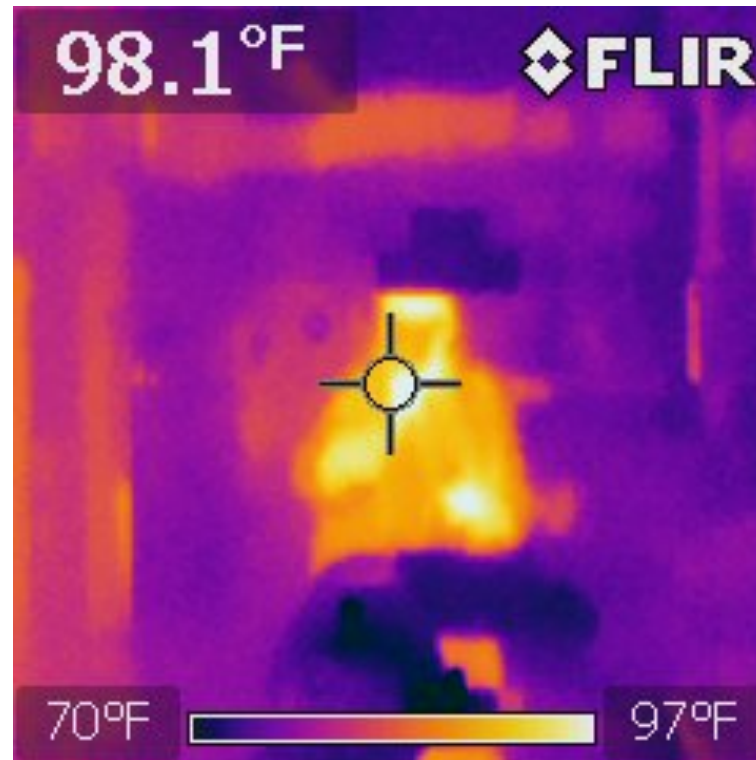
AHU surface temperature is closer to the supply air temperature than the room air temperature.

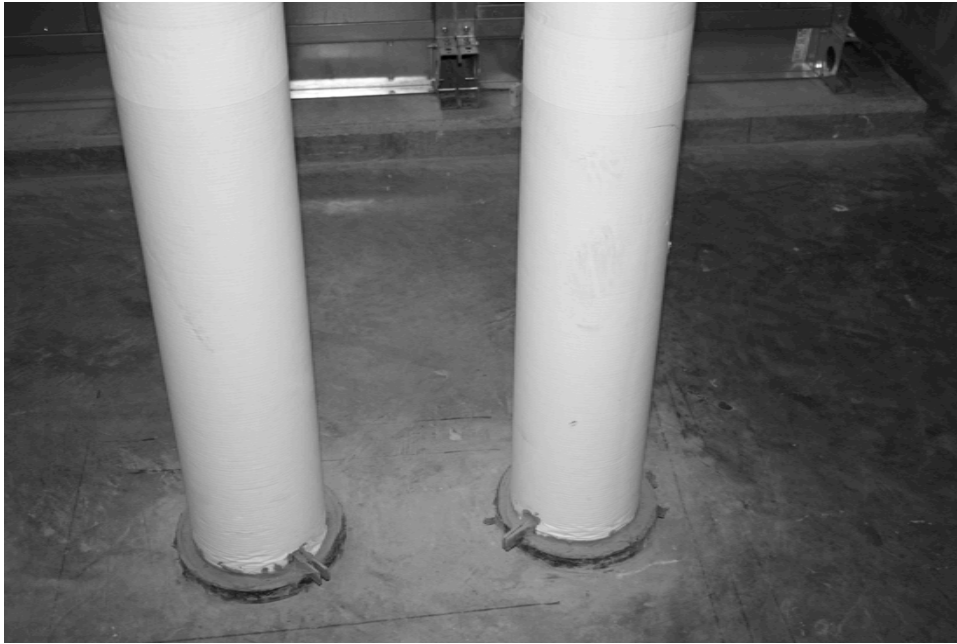
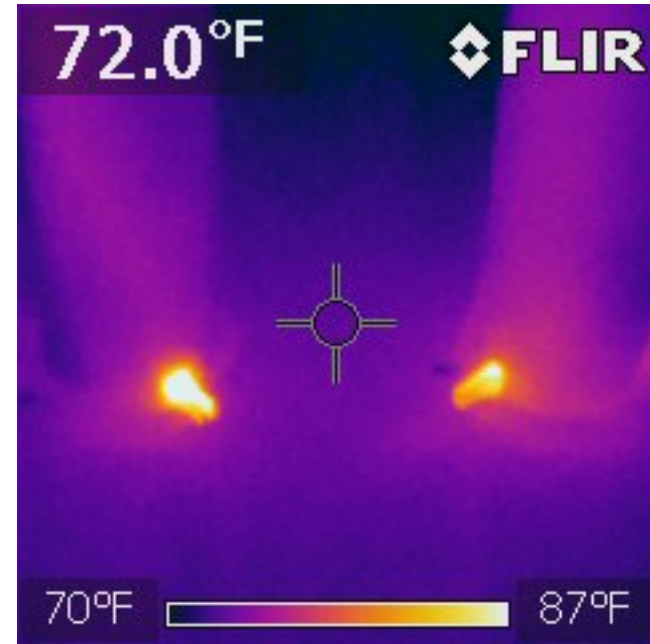
Inspired by Dr. Kwok – the team presents another hypothesis for consideration – the labels on the supply and return hot water piping are reversed.
