| ARCH 570 | NATURAL LIGHTNING- PORTFOLIO |

| Andrew | Luja | Tyler |

Suffolk Community Hall

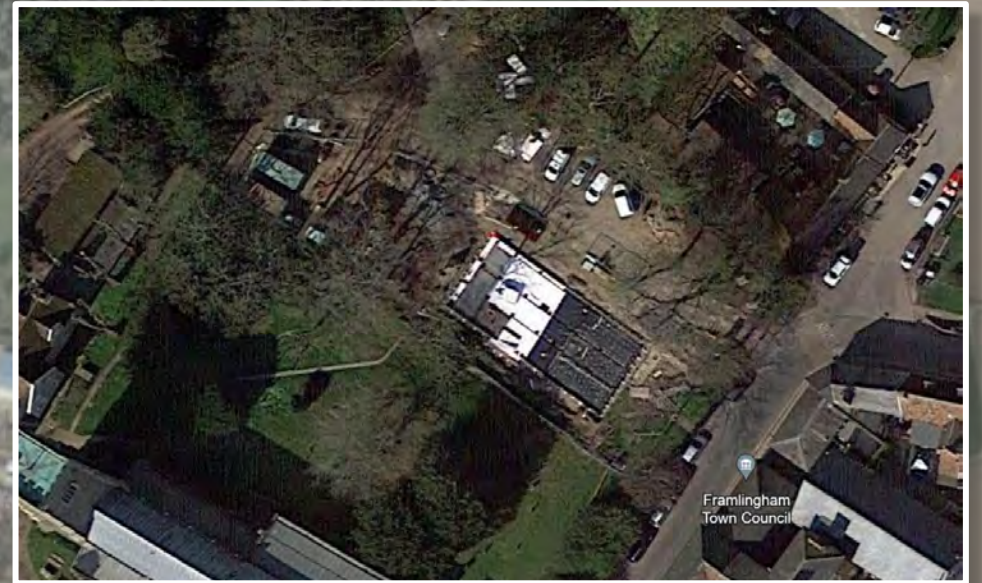
- **City:**
 - Framlingham
- **Building orientation:**
 - NW-SE
- **Where:**
 - located on Church Street
- **Position:**
 - Elevated above the town

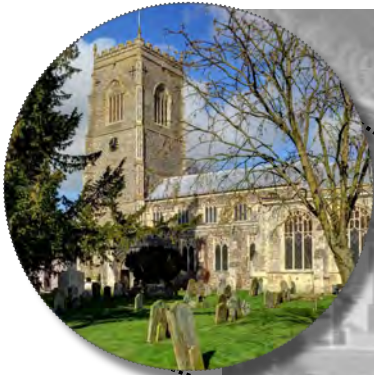
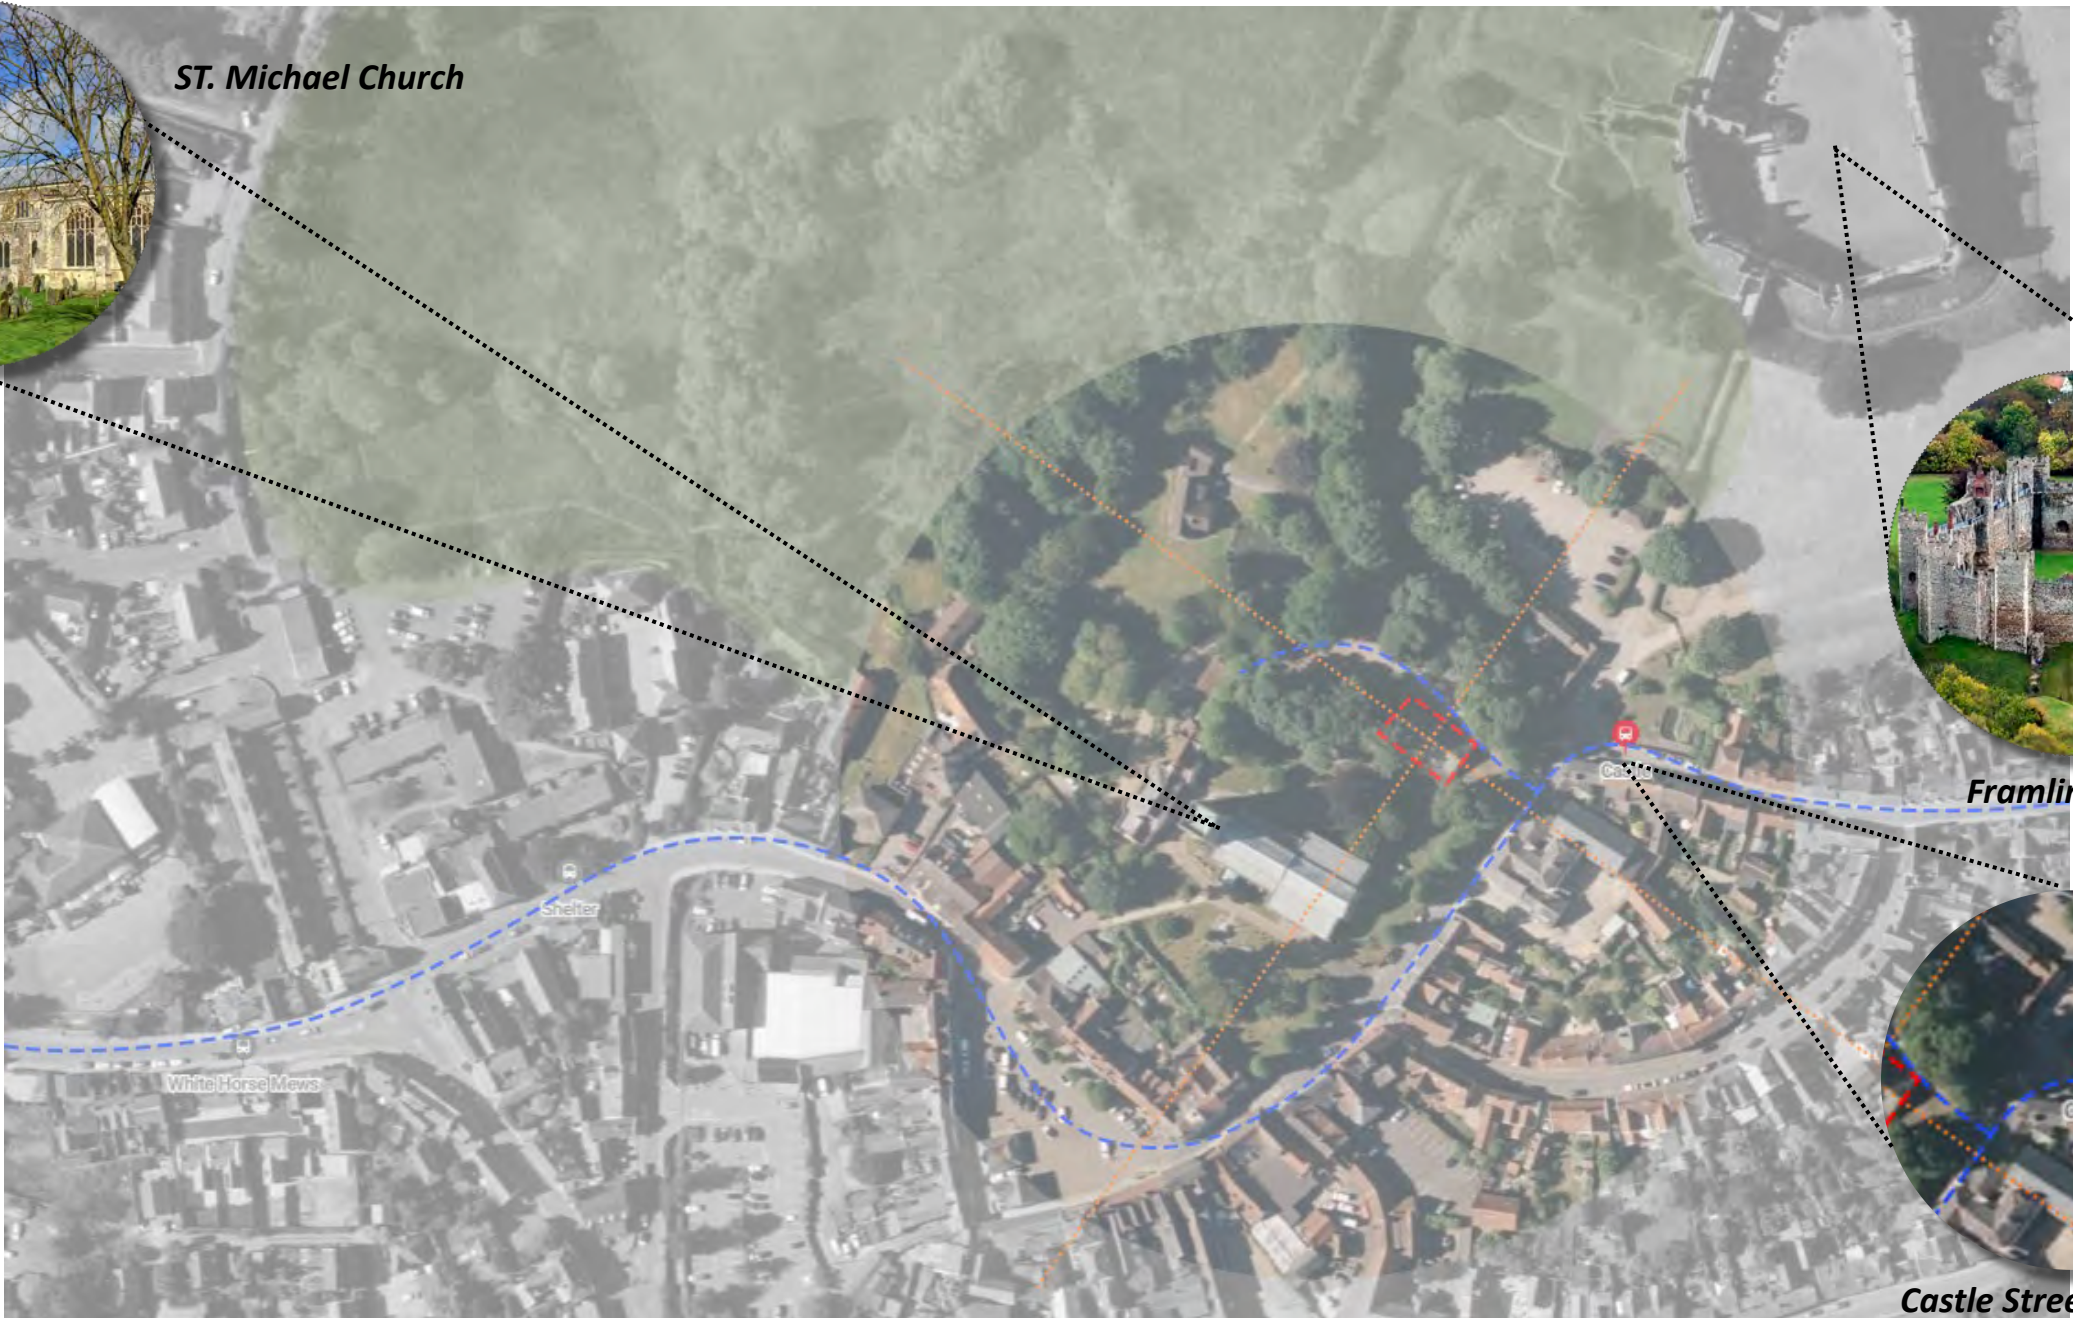
St. Michael Church

- Surrounding buildings:
 - St. Michaels church and Framlingham castle
- Site context:
 - located in sensitive archaeology area; old and mature trees covers large area of the site; church car parking in southeast; small road in the north façade
- Across the street:
 - Framlingham village hall and common room café
- Transit:
 - Within walking distance

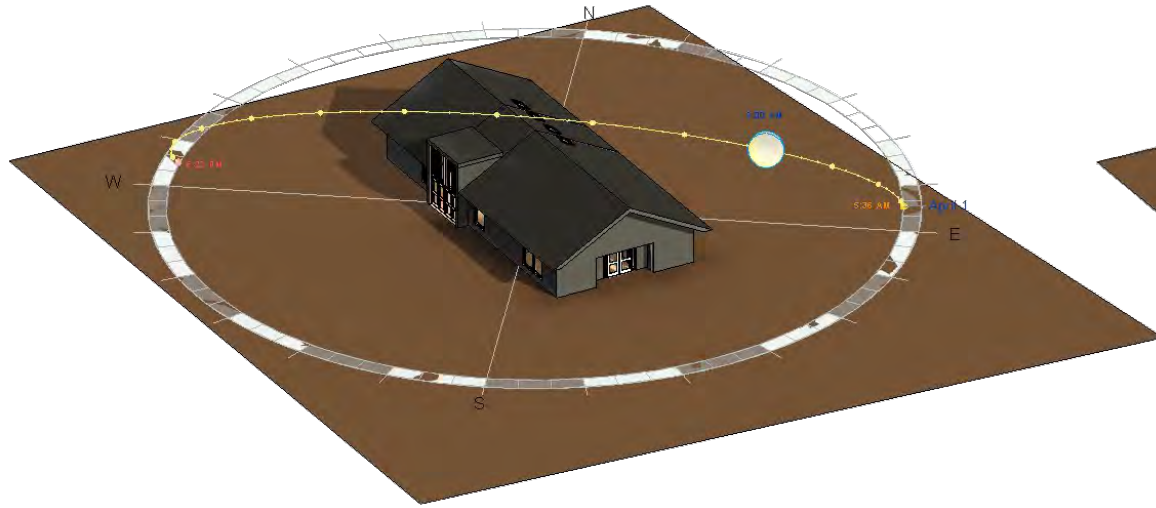
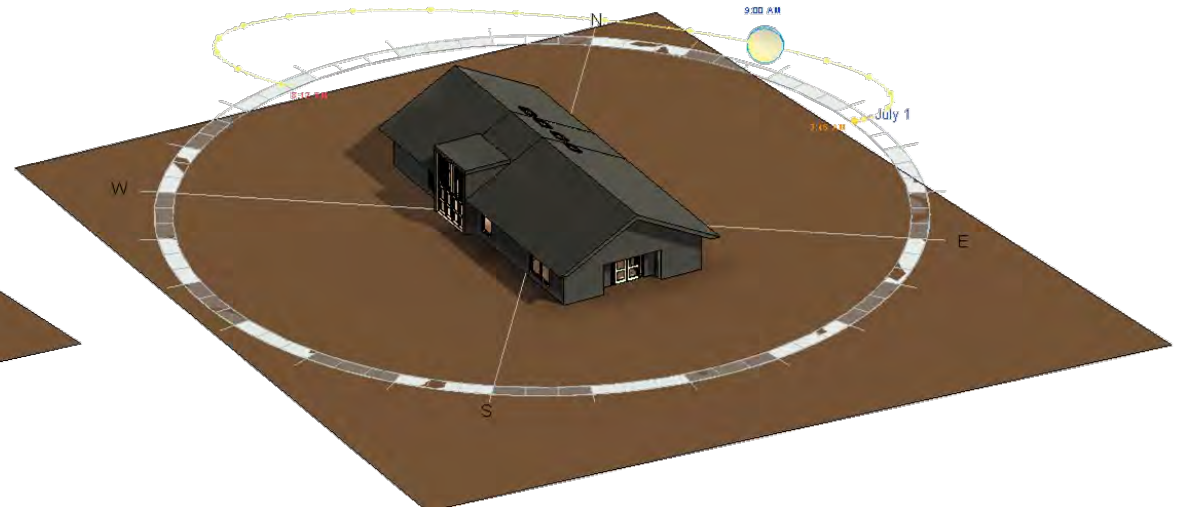
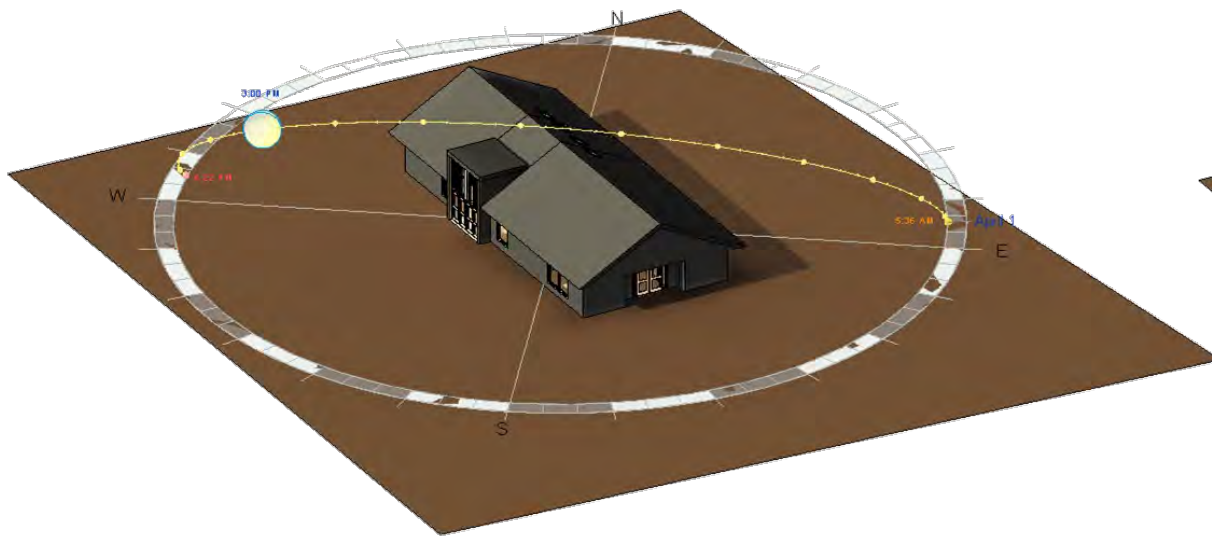
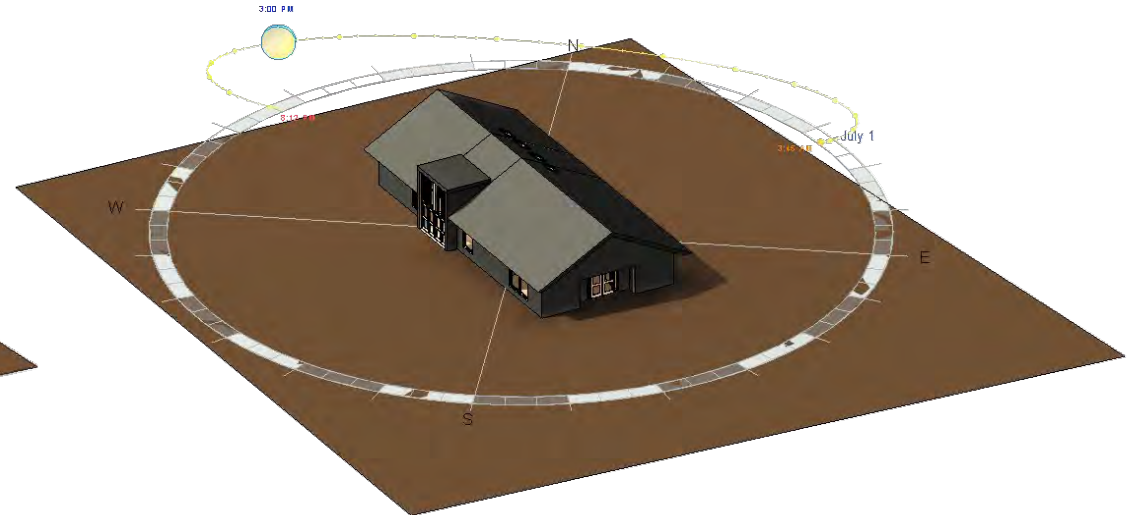
SUN PATTERNS (Spring/ Summer)

April

July

9:00 AM

3:00 PM

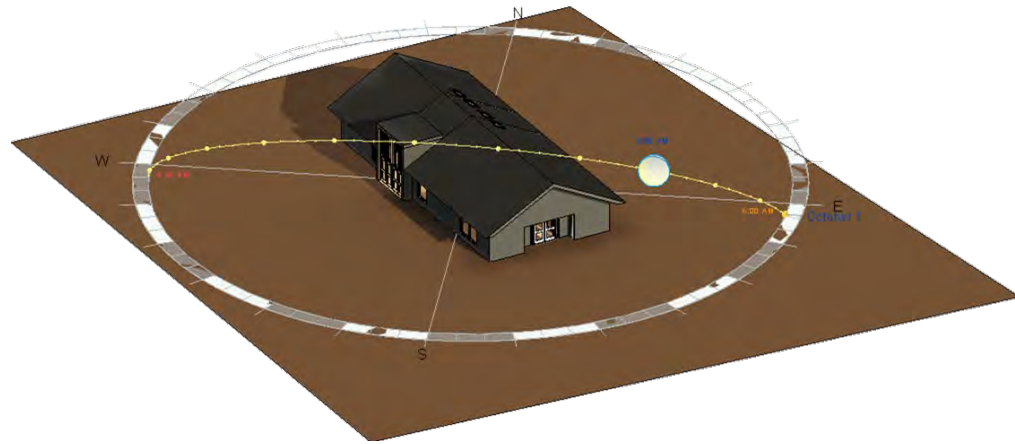
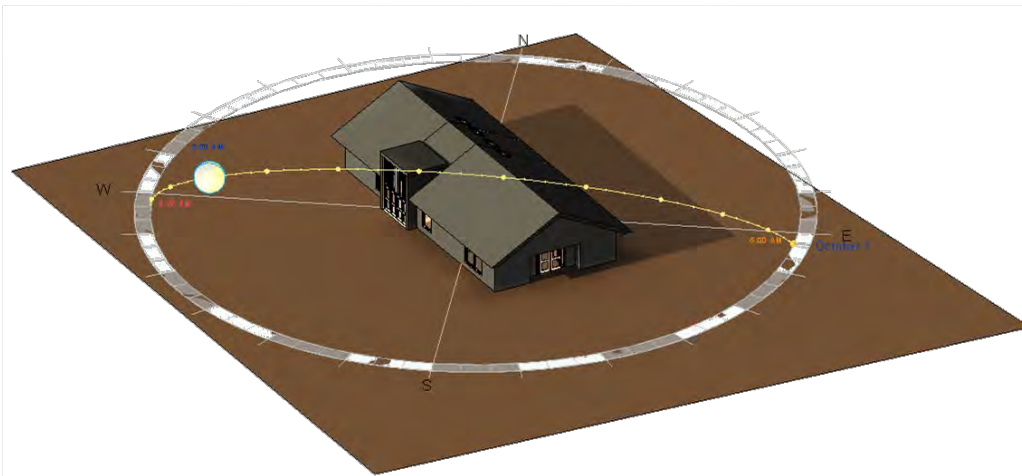
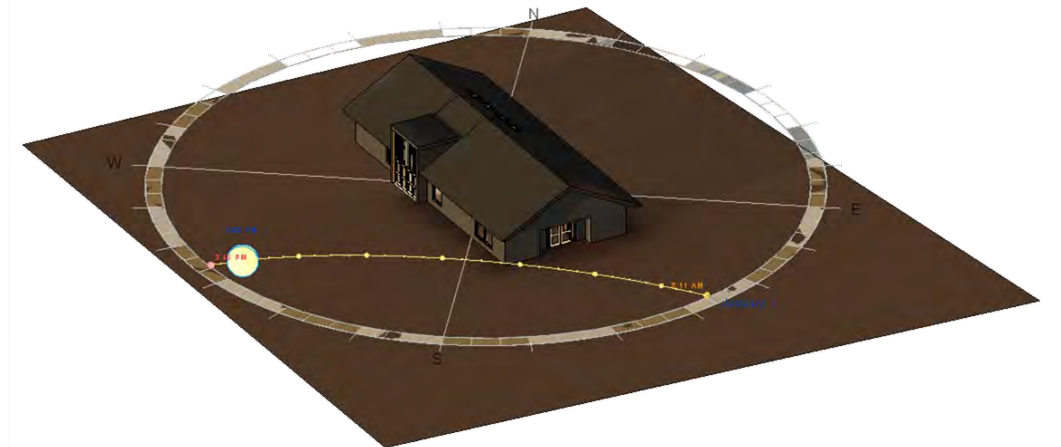
SUN PATTERNS (Fall/ Winter)

October

January

9:00 AM

3:00 PM

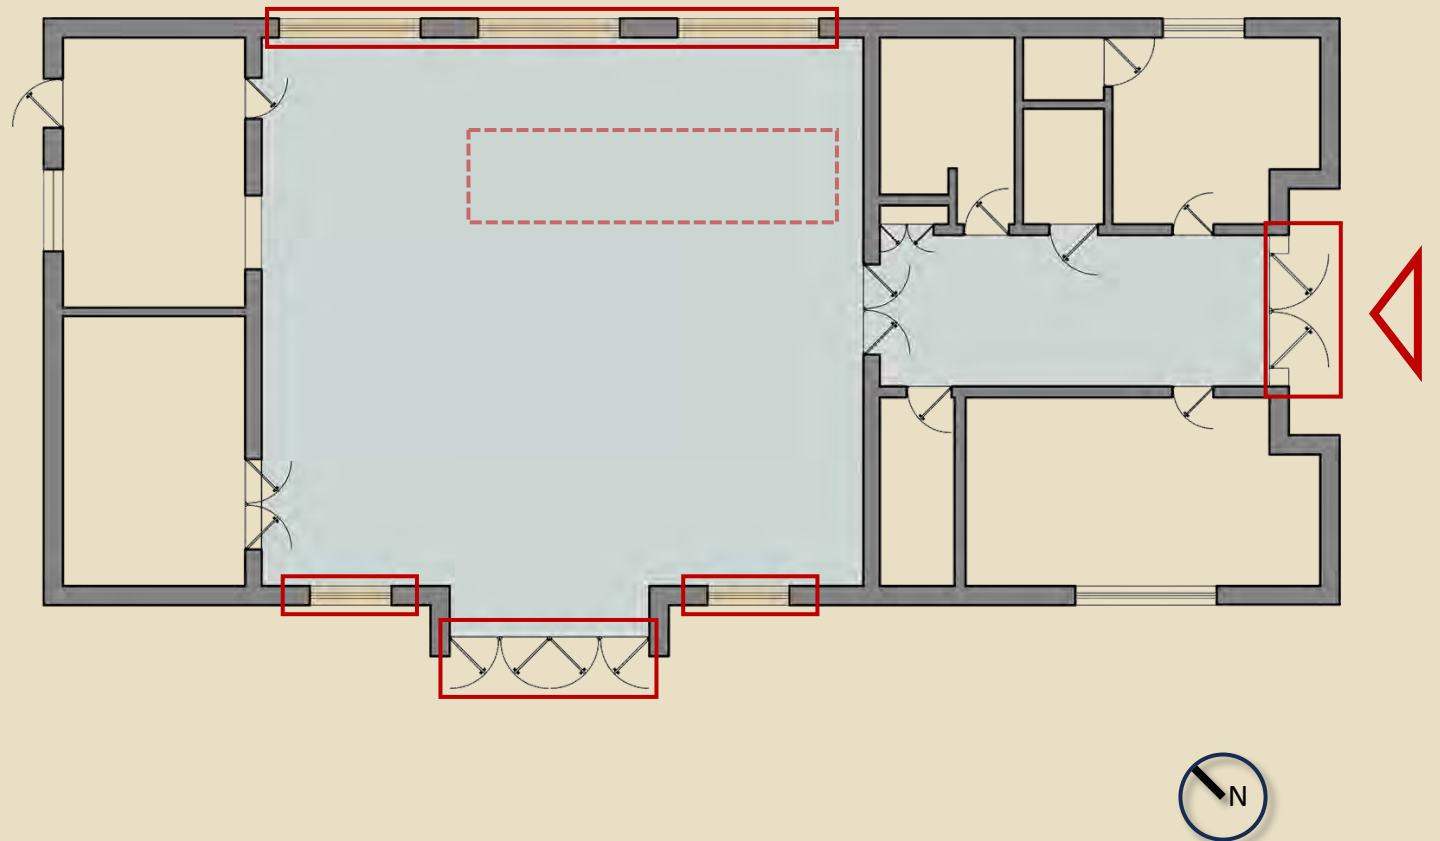
Floor Plan

- Areas of Focus:

- Community Room, Entrance Hall...

- Natural Lighting Elements:

- North and South glazing
- North Oriented Skylights
- Main entrance door is glass
- All windows and doors are double glazed

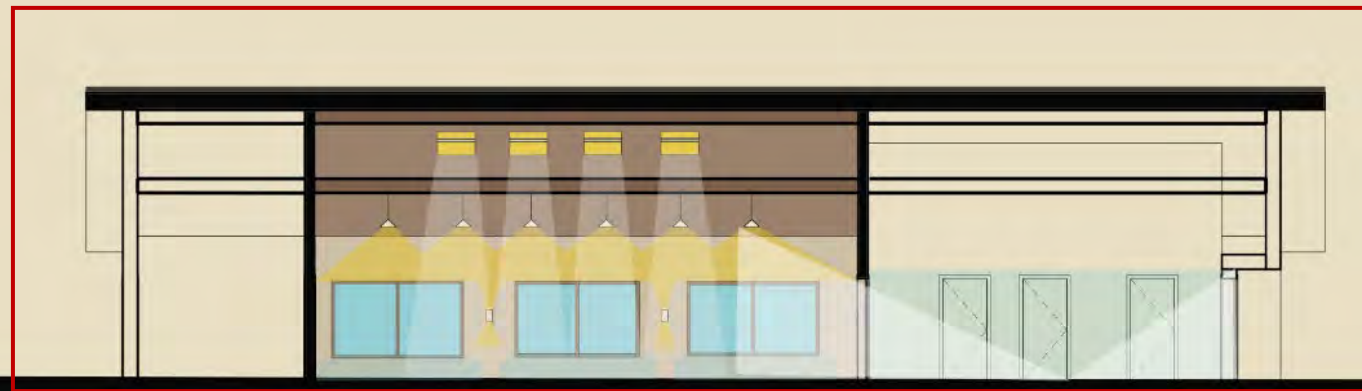
Lighting in Section

- Section A

- Glare off floor from the NW and SE Glazing
- Shading from roof overhang on NW and SE

- Section B

- Glare going down SE hallway from glazing on doors
- Overuse of electric lighting fixtures hanging from beams causing a well-lit space to become too bright

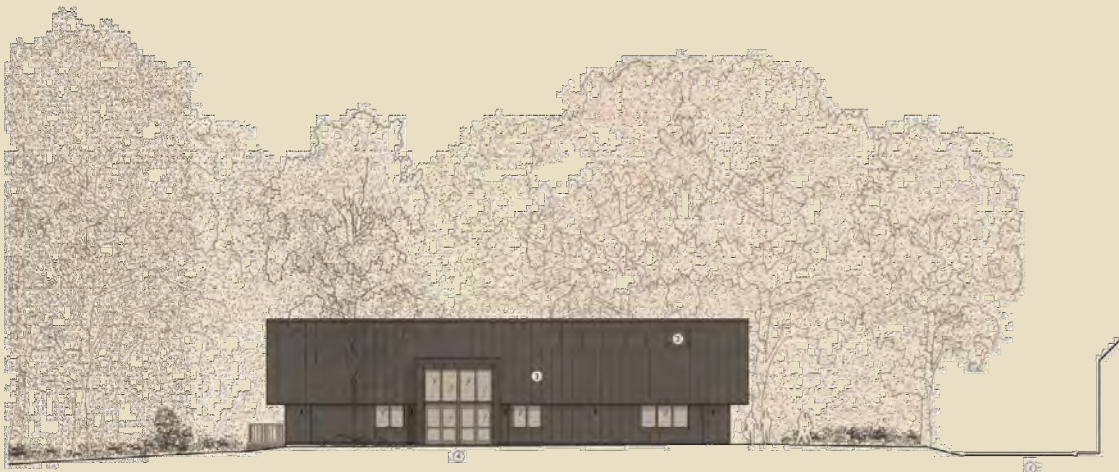
Elevations

Material and Light

- Outdoor material: Black zinc clad around walls and roofs
- Indoor Material: Poplar plywood panel walls and wood fiber ceilings.

KEY
1. Glass Panel
2. Porcelain
3. Black zinc cladding
4. Oak wood siding

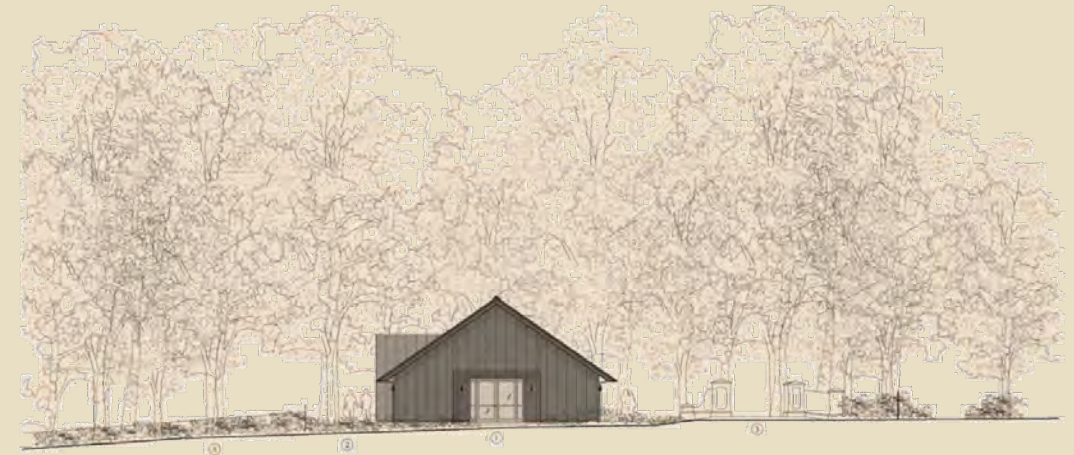
KEY
1. Glass Panel
2. Porcelain
3. Black zinc cladding
4. Oak wood siding

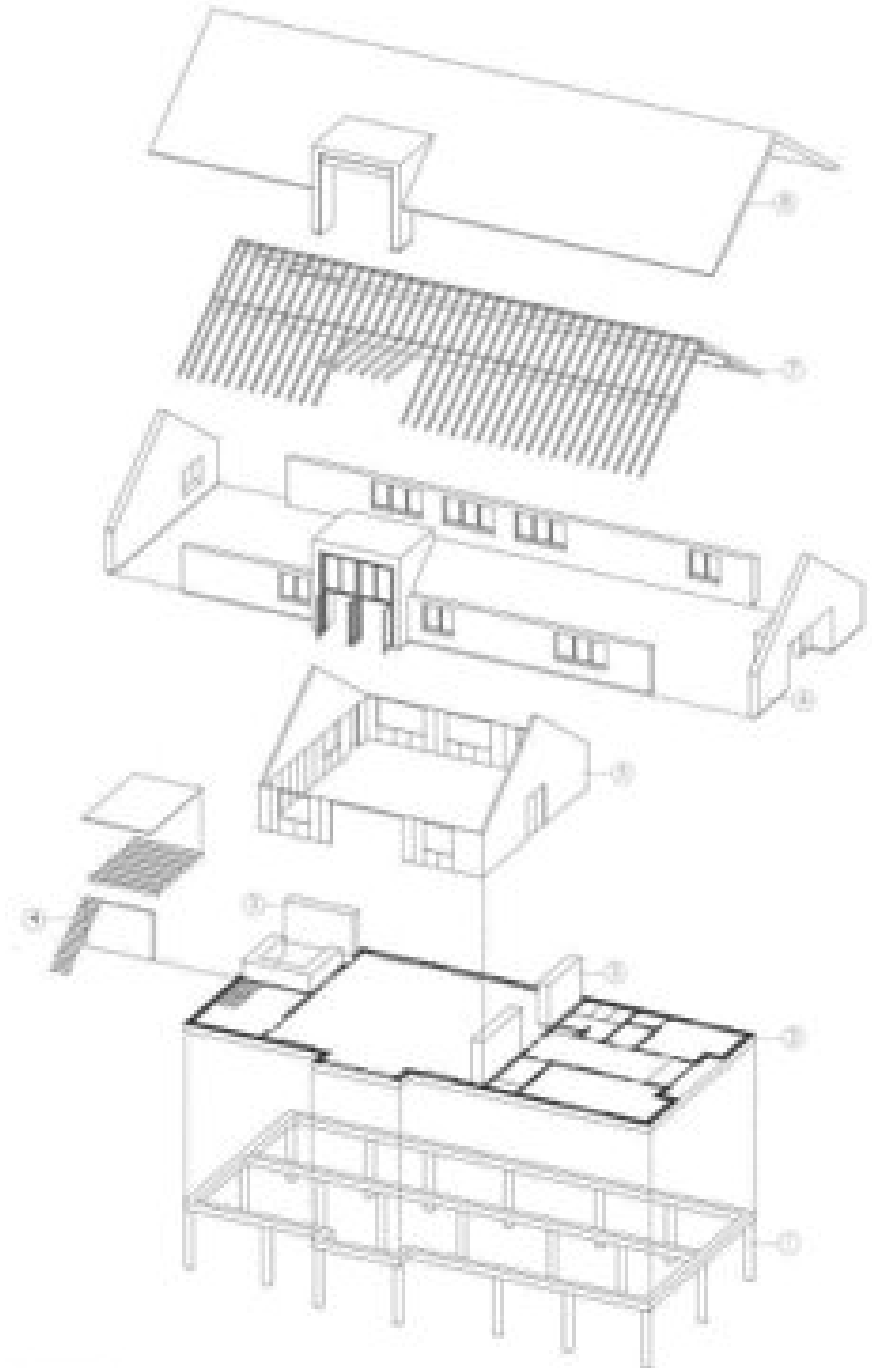
- KEY
- 1 Wall foundation
 - 2 Concrete slab
 - 3 Joists
 - 4 Slab for insulation
 - 5 Thermal protection
 - 6 Timber frame walls
 - 7 Timber roof structure
 - 8 Work into roof decking

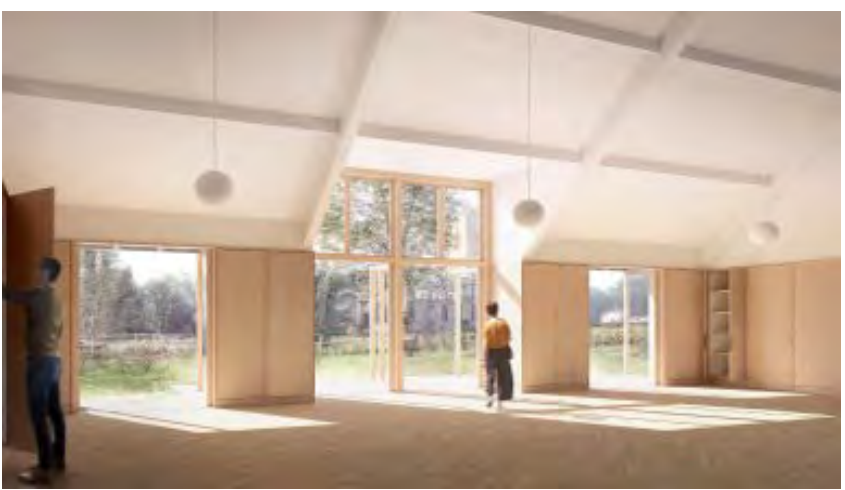
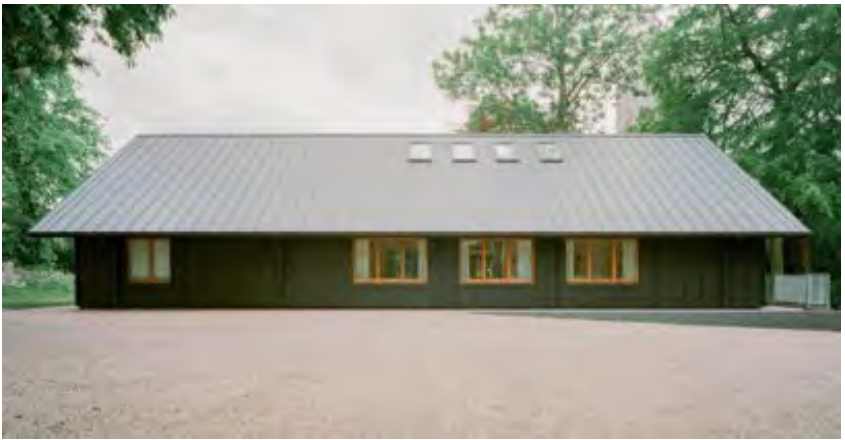
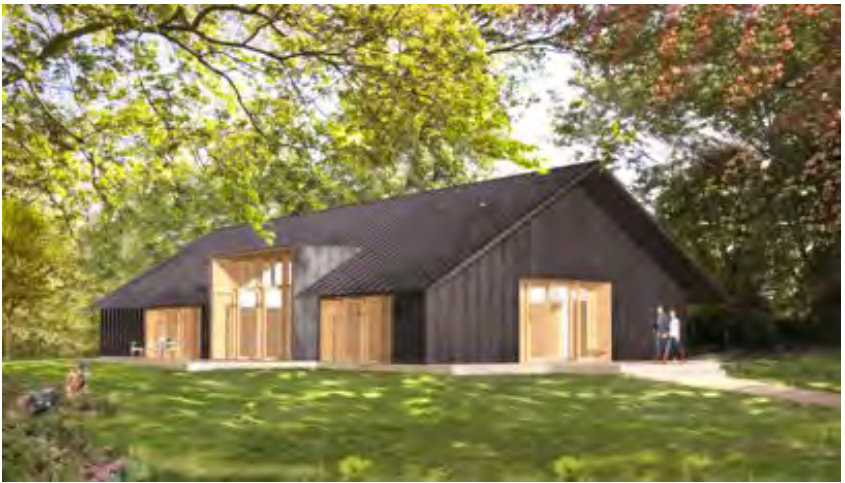
Natural Lighting in the Building

Pros:

- Significant natural light
 - North opening gives soft light throughout the area (not too harsh)
 - South window provides natural lightning (may be shading to reduce brightness and harshness in the space or reducing the window size to some extent)
- Building orientation (NW & SE)
- Material choices

Cons:

- Glare is prevalent
- Window Sizes
- Exterior too Dark underneath overhang on NE and SW

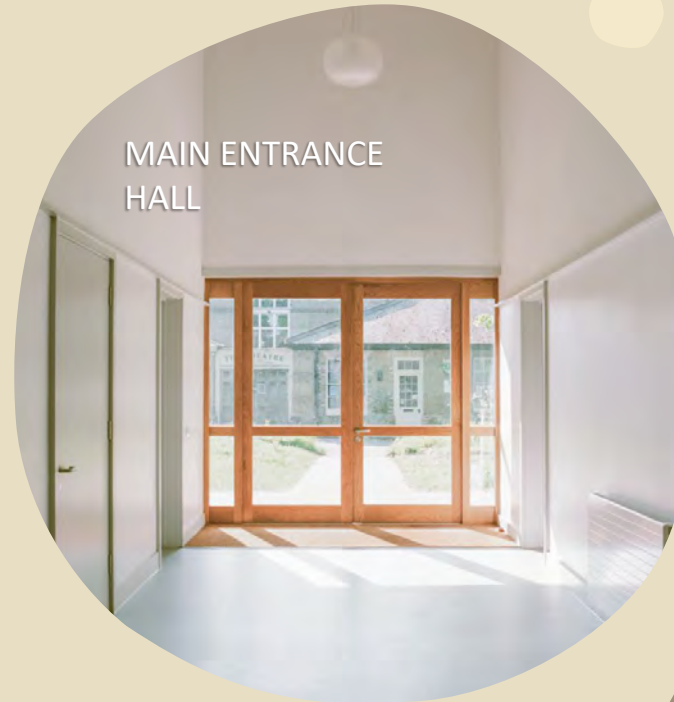
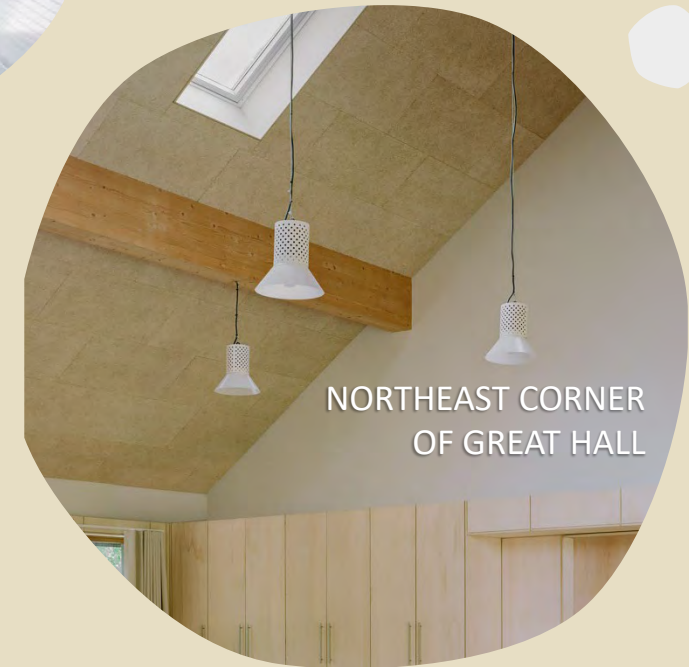
Electrical Lighting in the Building

Pros

- Lighting is there
- ...could work smarter

Cons

- It works harder...
- Distracting
- Non expressive

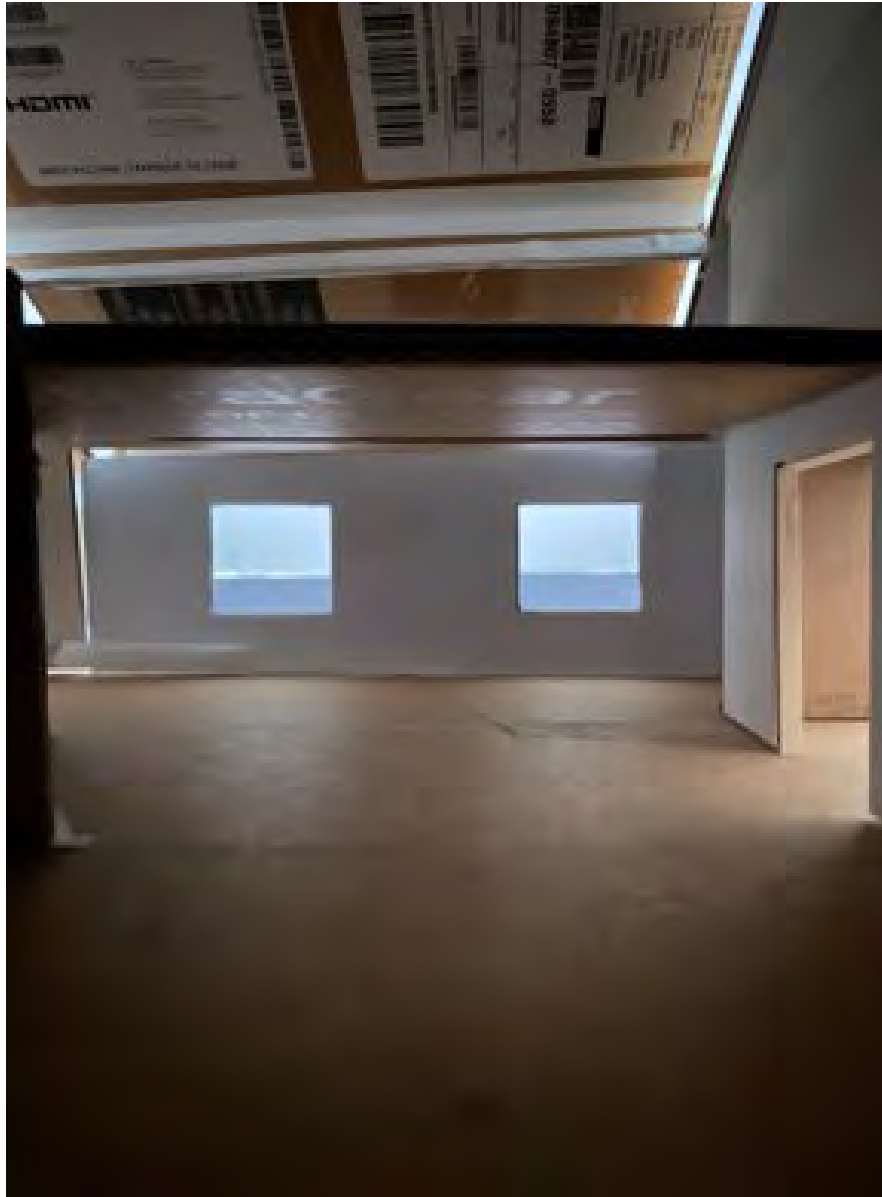
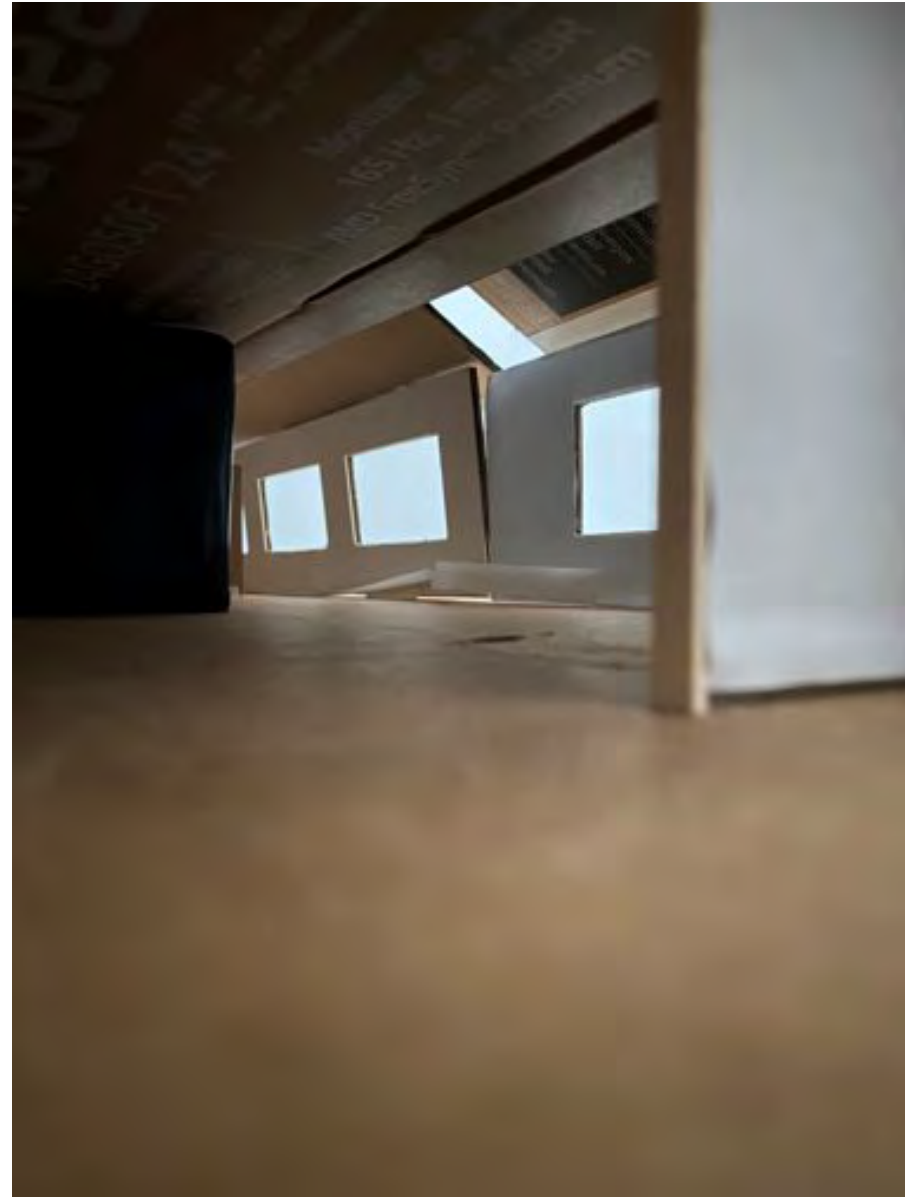
Testing New Clerestories

FINAL DESIGN
