Alaska Department of Transportation & Public Facilities

Use of Advanced Technology for Quality Assurance in Alaska
Rich Giessel

Idaho Asphalt Conference: October 25, 2018

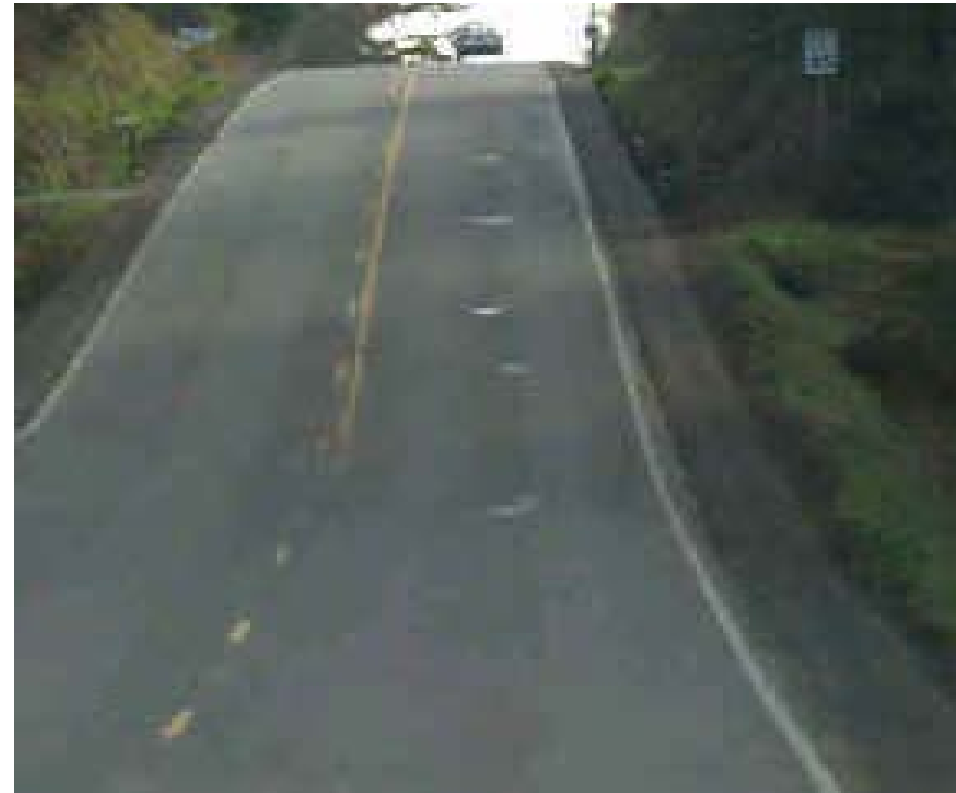
Cold Spots - Infrared vs B&W Photo

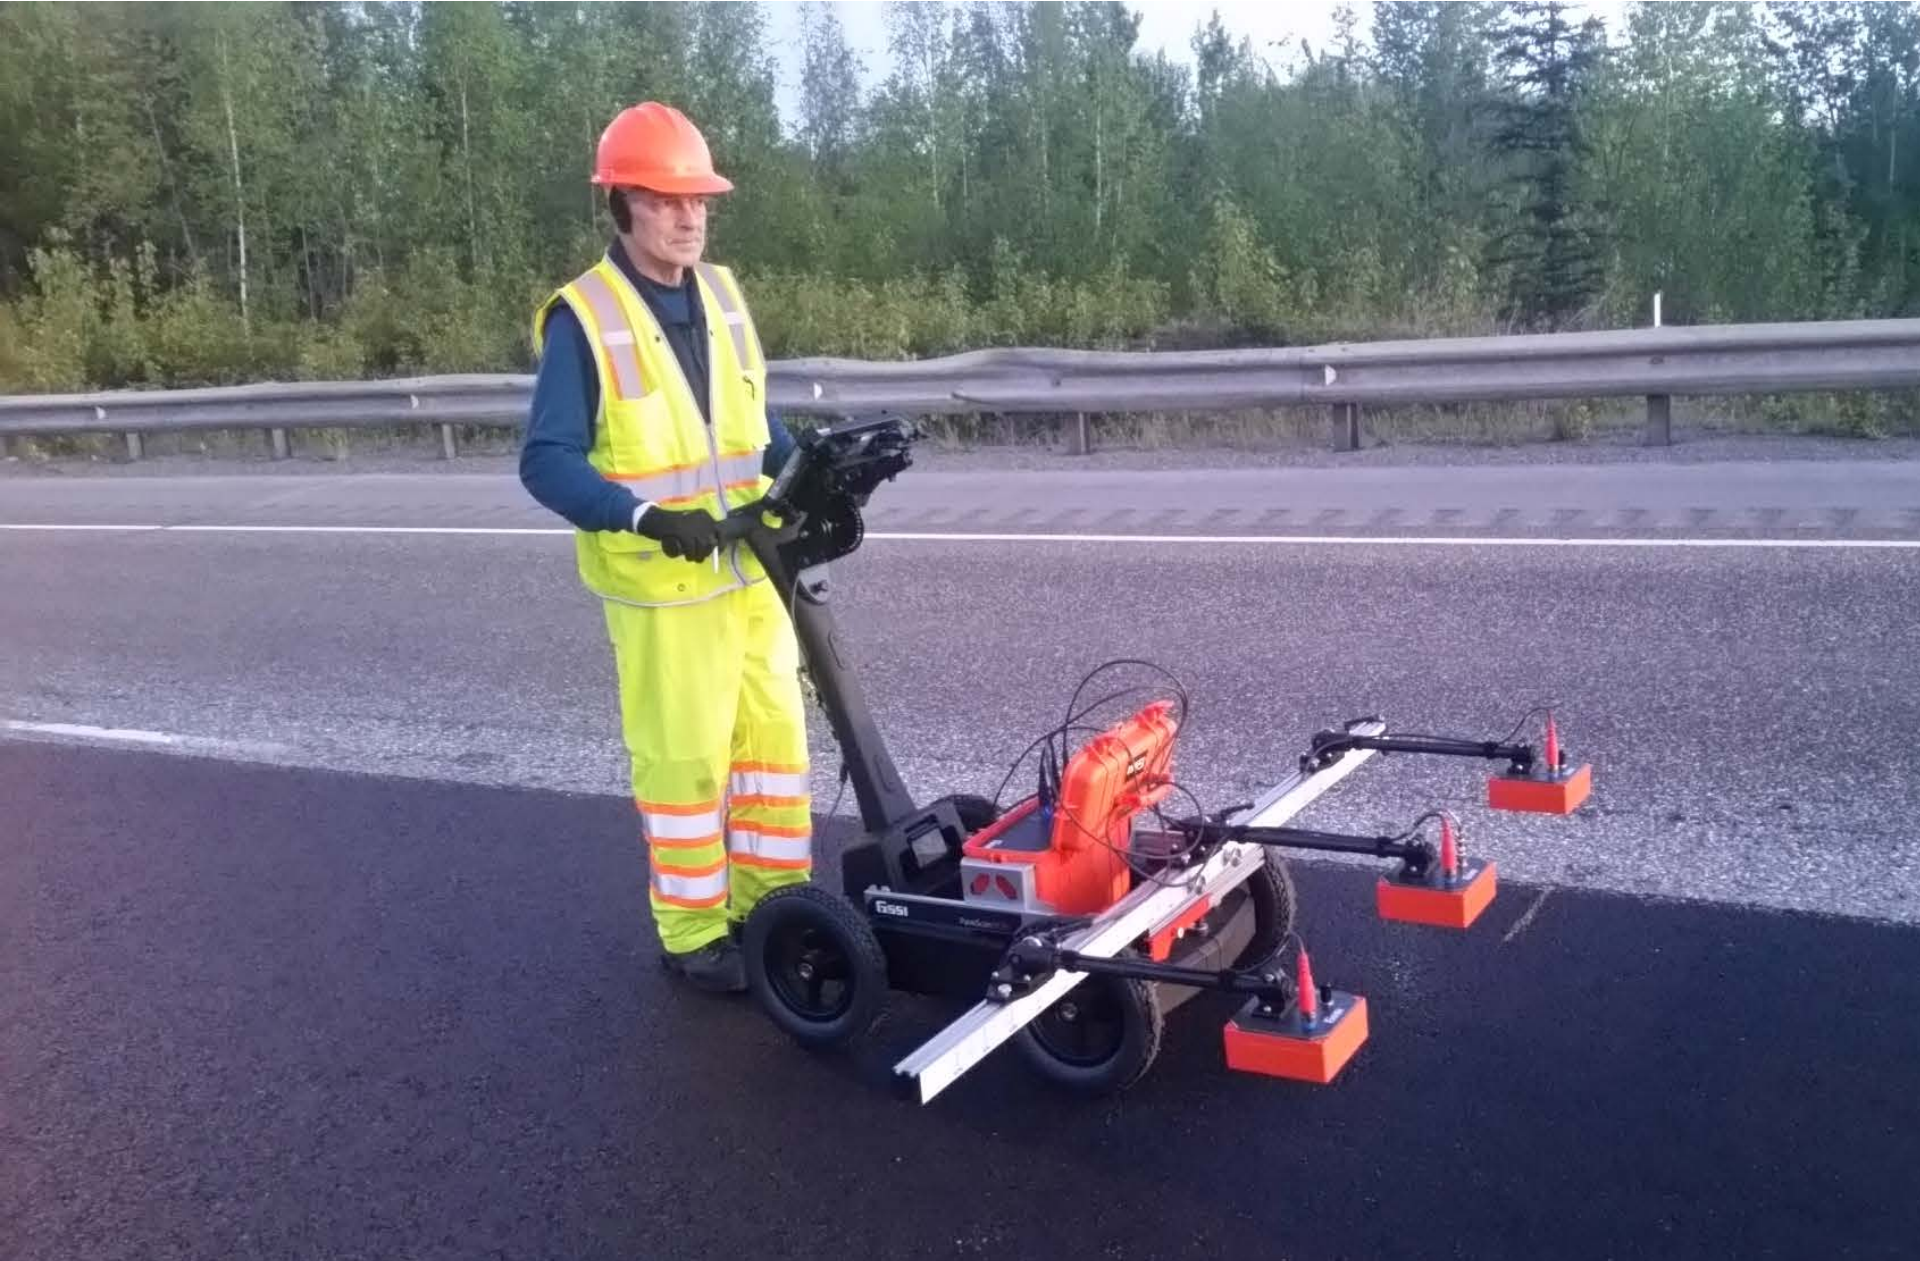
DPS - PaveScan RDM (2017)

- PaveScan Rolling Density Meter Provides:
 - Geo-located Data
 - 400,000 pulses per second processed with equivalent time sampling to produce 60 scans/sec
 - 60 scans (dielectric readings) per second recorded to Raw Data File
 - =10 Dielectric readings per foot of travel at 6 ft/sec (~ 4 mph walking speed) per antenna

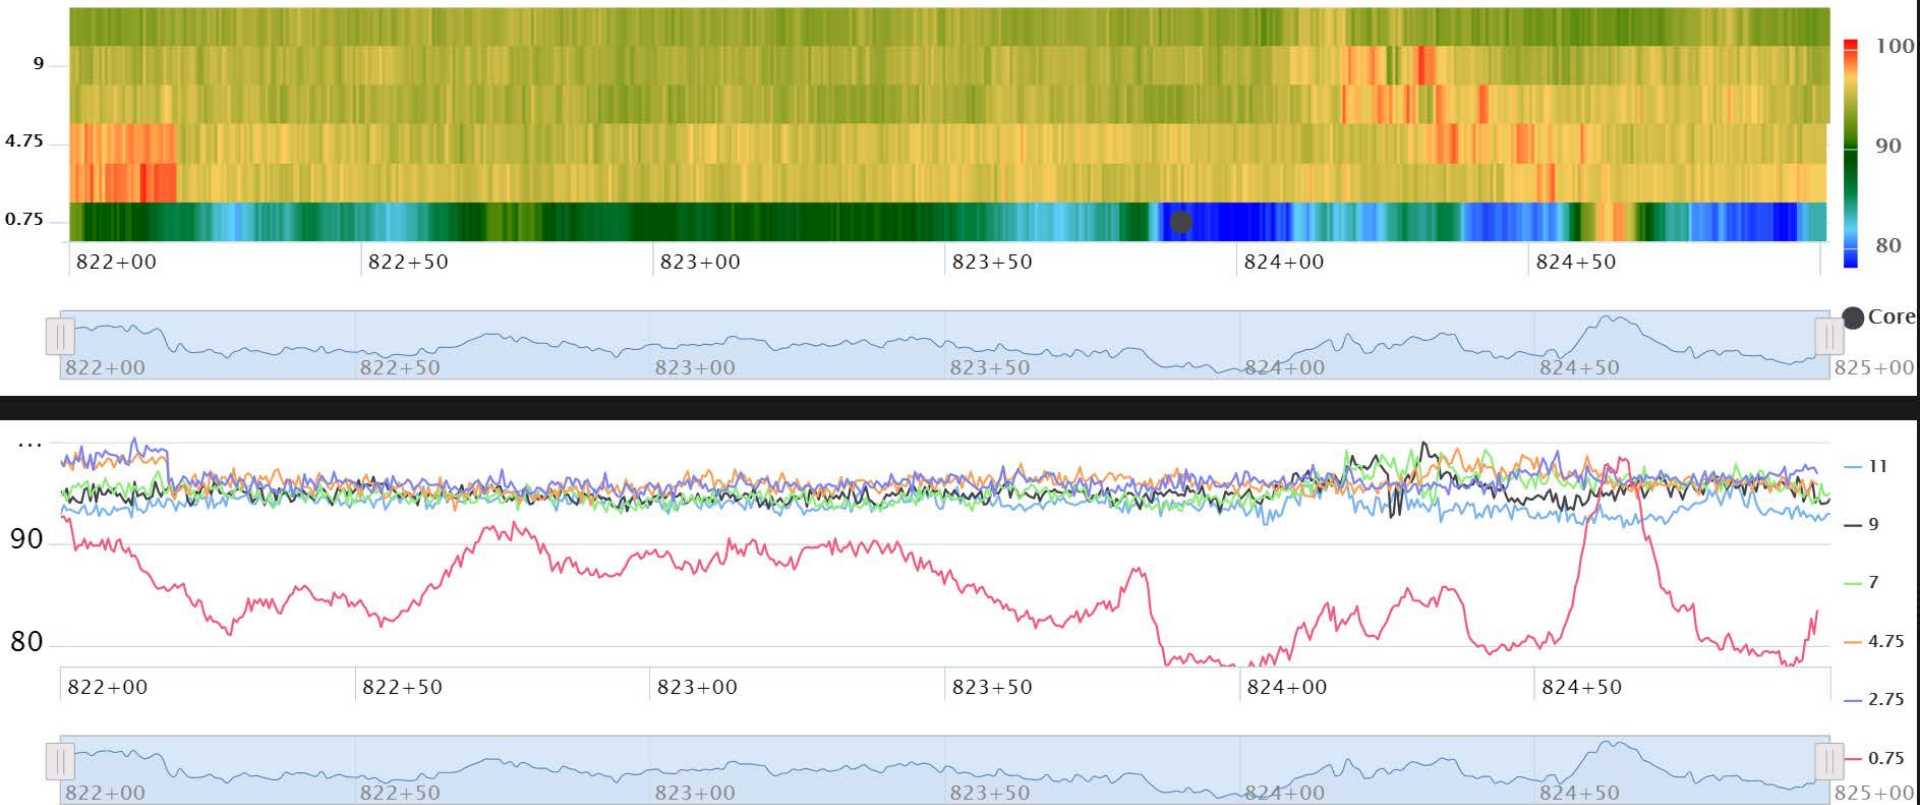
Low Density Adjacent Rumble Strip

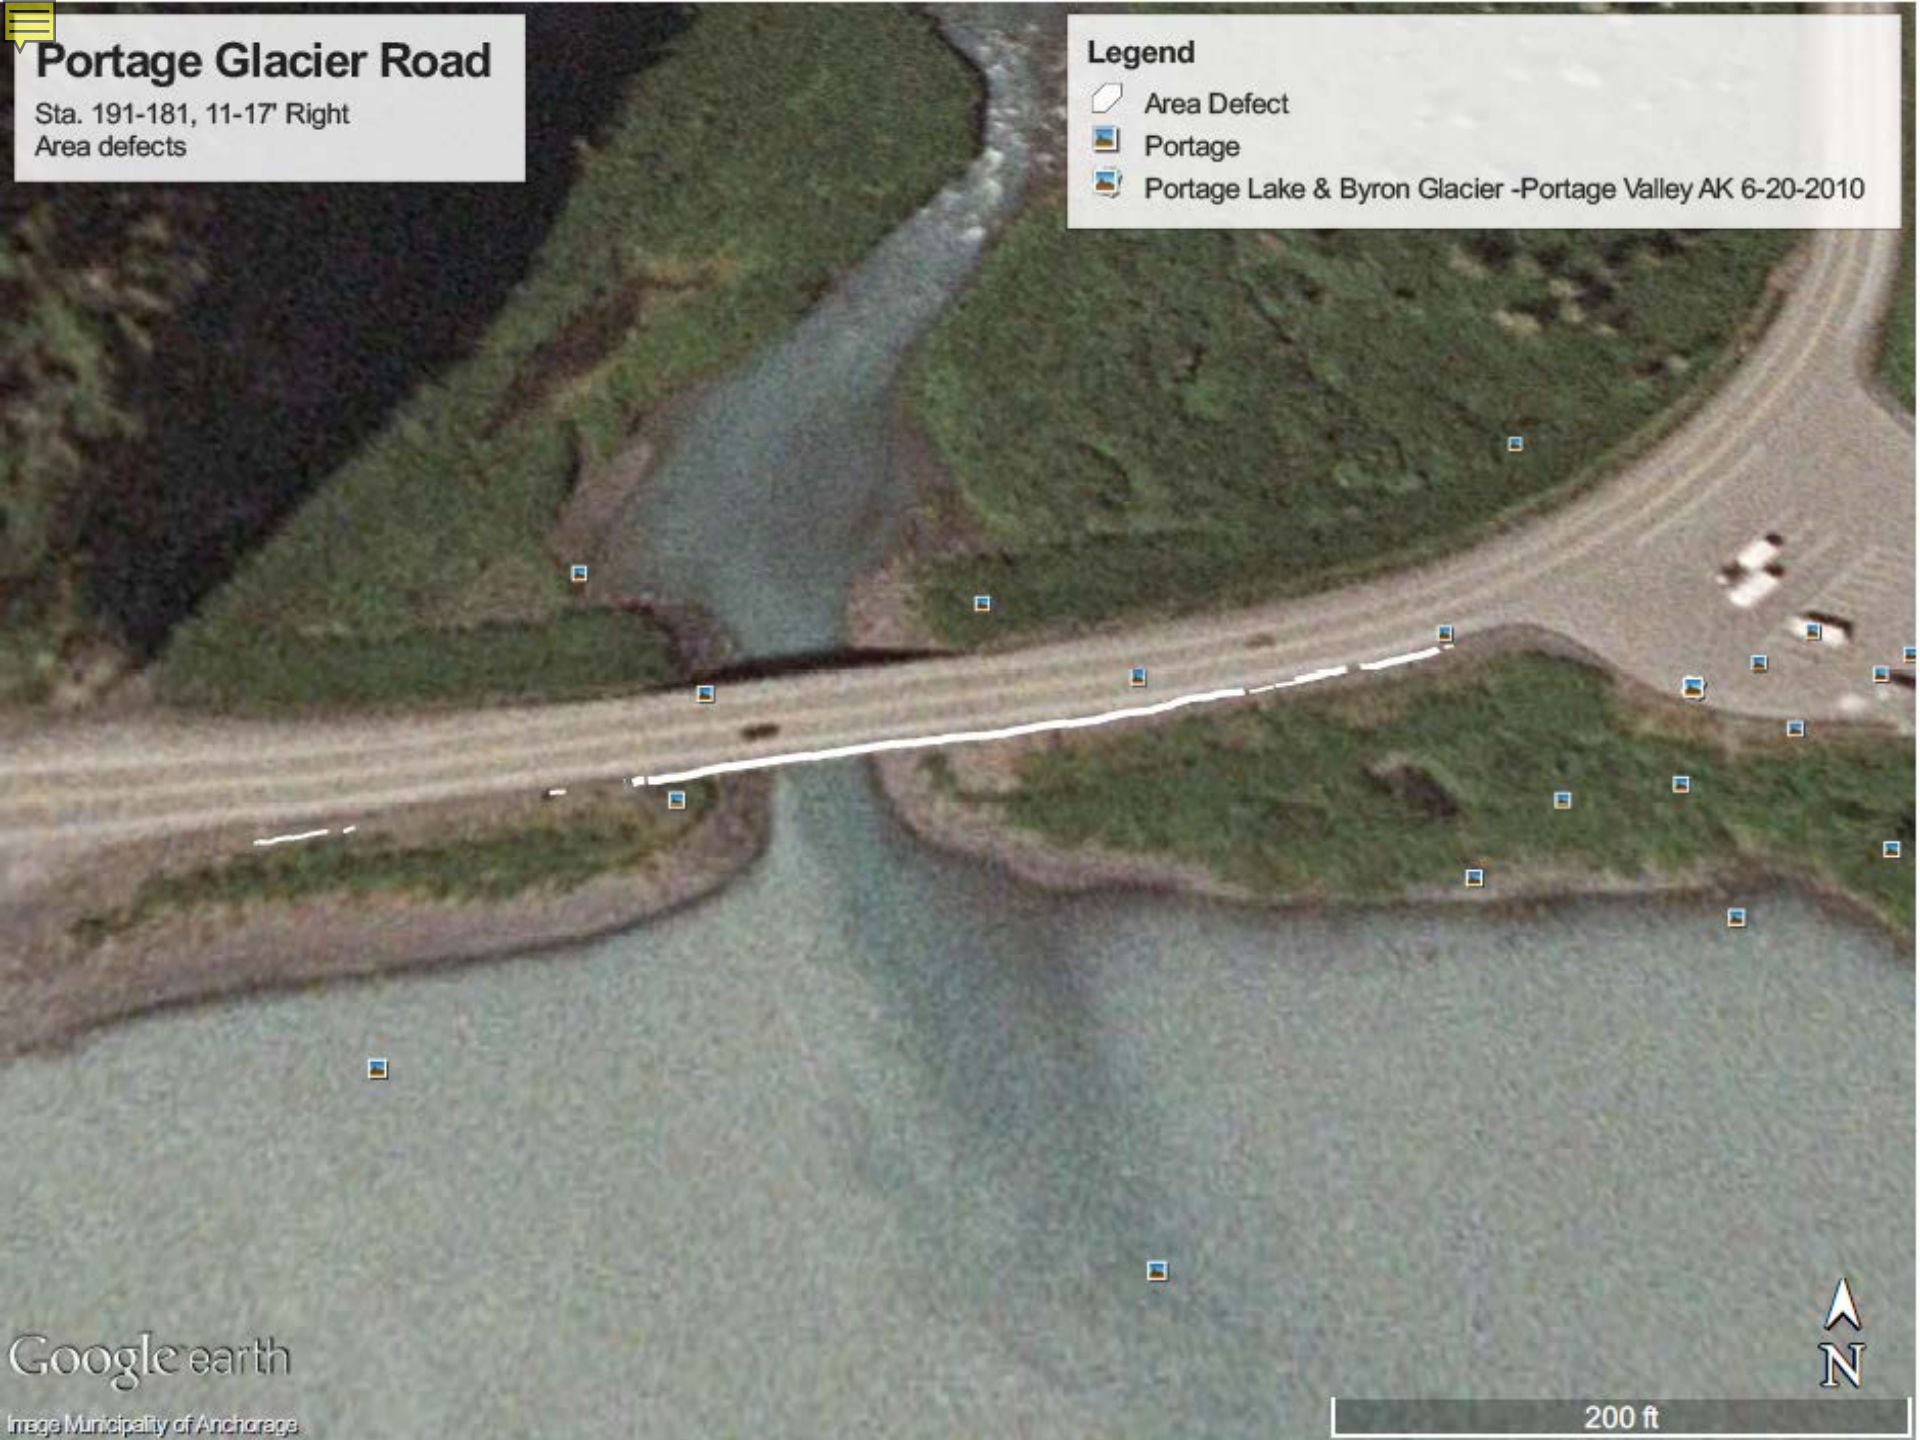
Sta. 191-181, 11-17' Right
Area defects

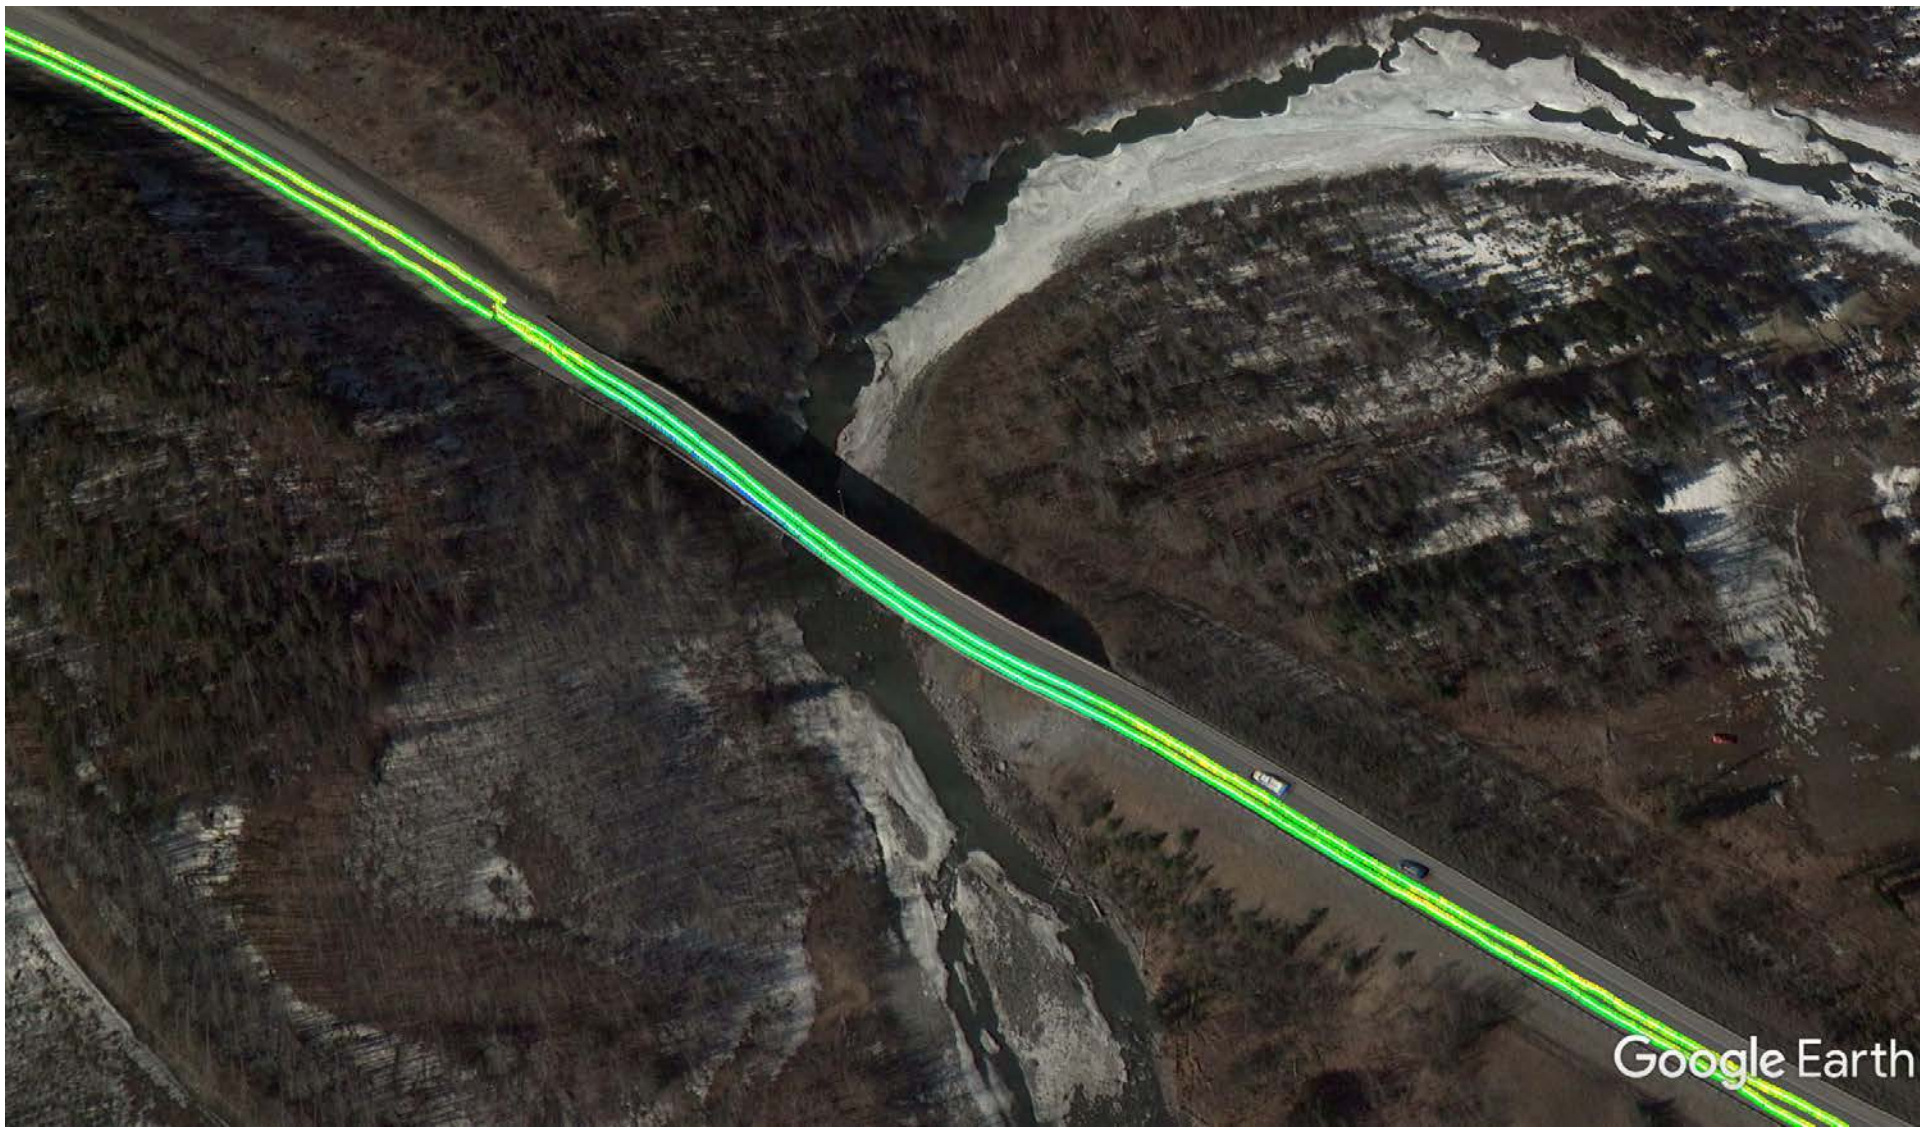
Glenn Hwy at Eagle River Bridge Lane 1 Compaction Coverage

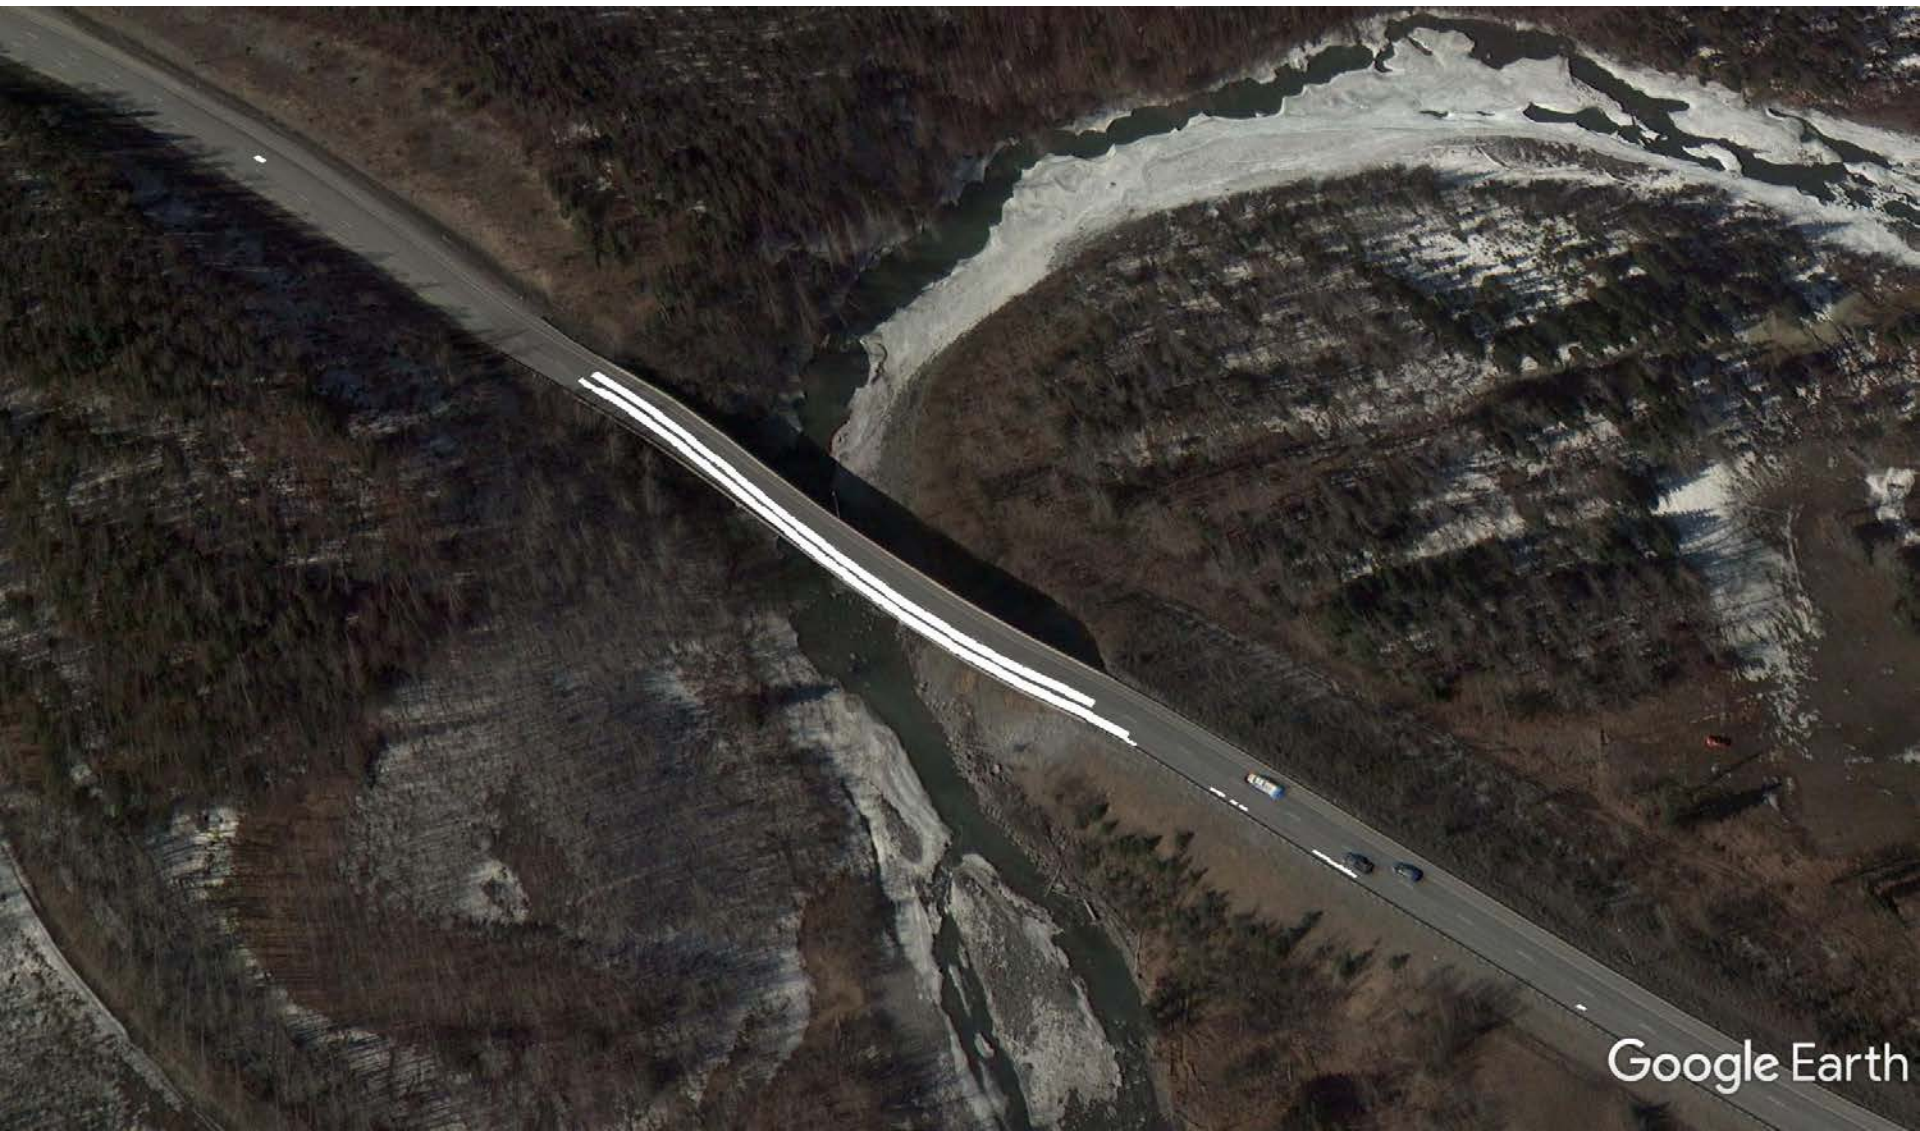
Glenn Hwy at Eagle River Bridge Lane 1 Area Defects

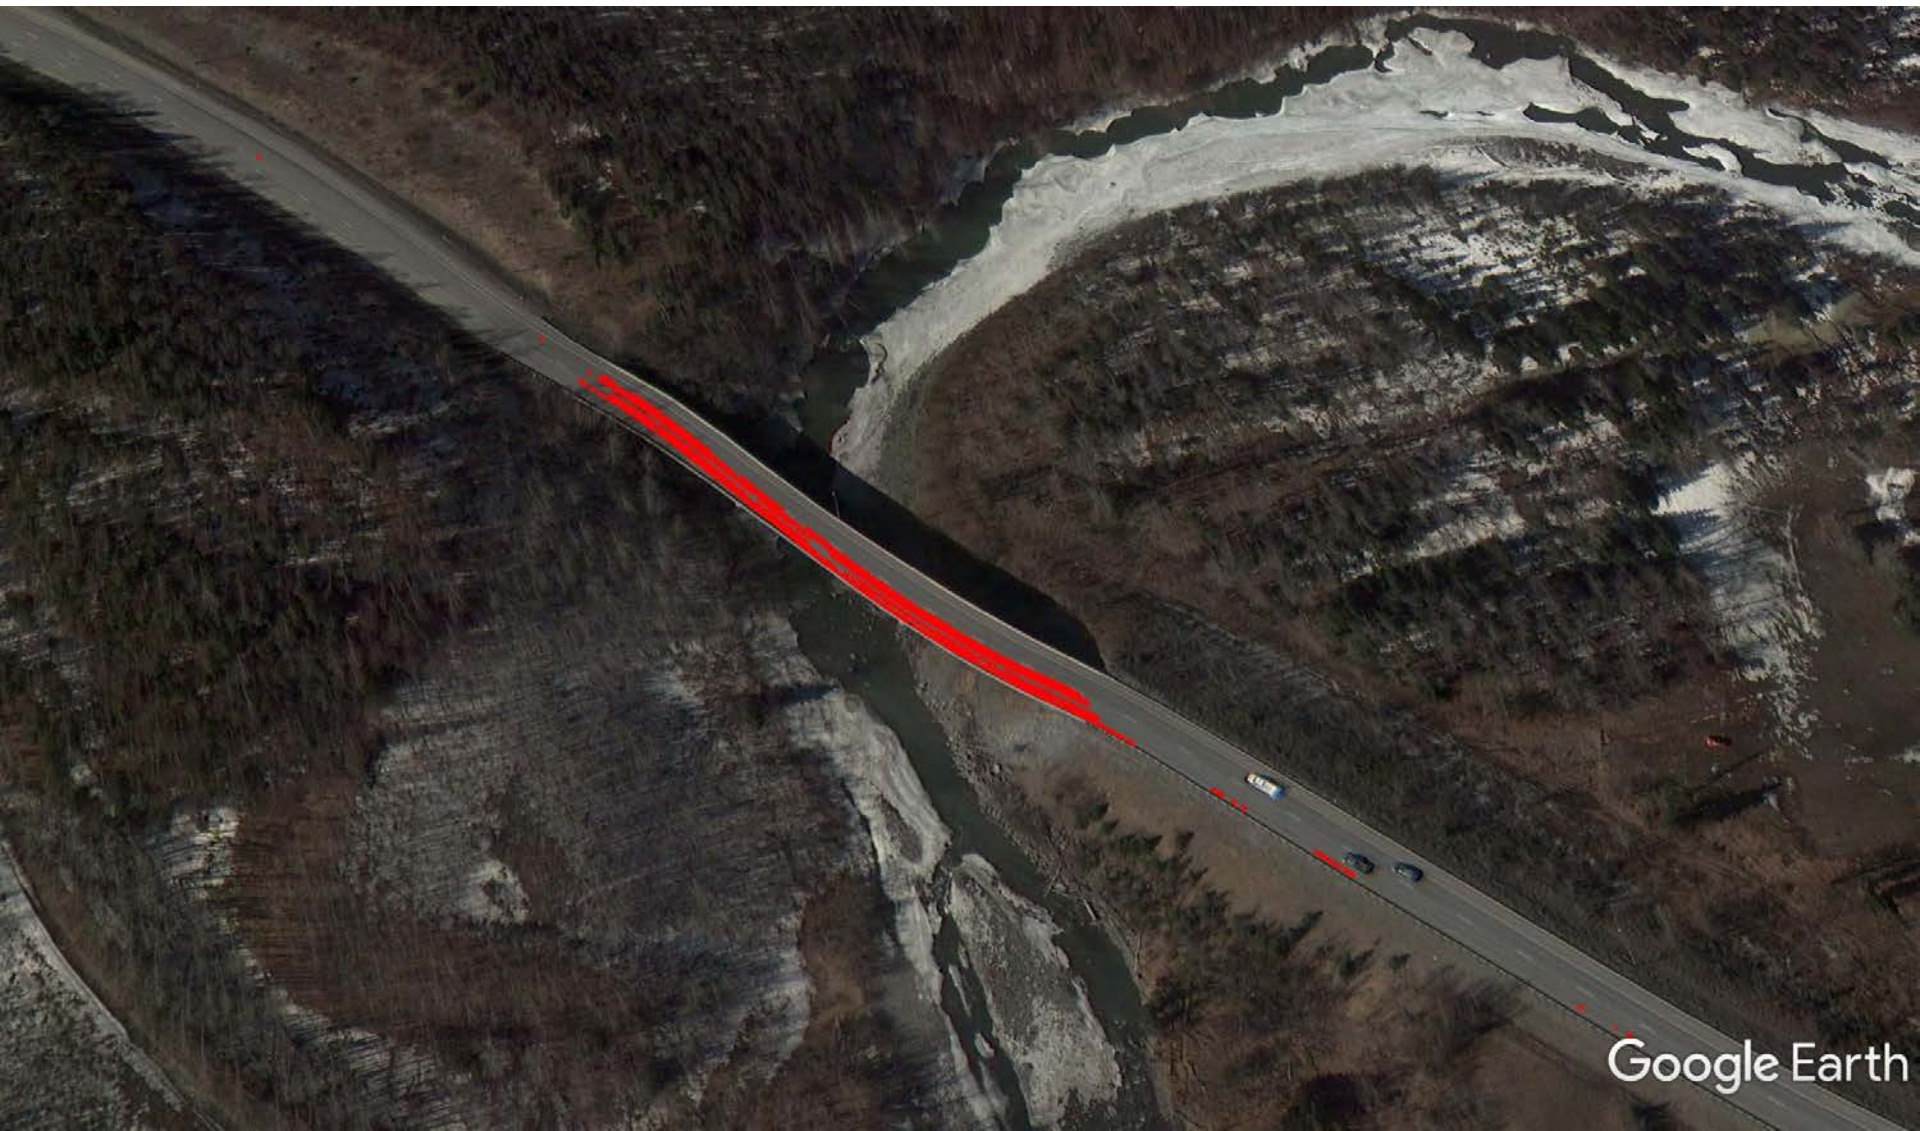
Glenn Hwy at Eagle River Bridge Lane 1 Linear Defects
