Building Performance Study for Education

Arch 571/Building Performance Evaluation/ Spring 2018

Ruth Opatola and Sainaz Bajracharya

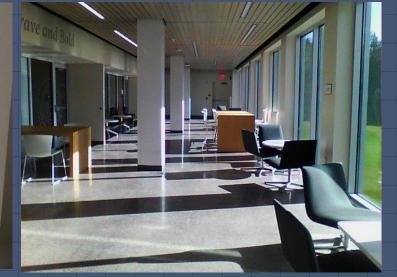
19th April 2018, 4:51 pm

Daylight enough, some light fixtures off(sensor working well) The ceiling light illuminated to 20%. Glare through shiny materials, white table and reflected columns West wall requires added shading to mitigate uneven lighting and glare issues

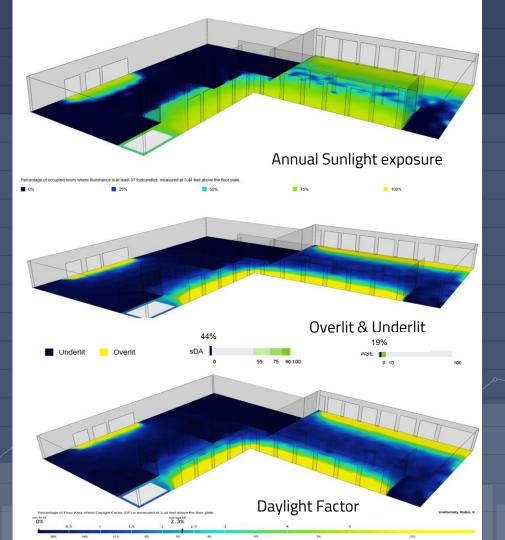
Sefaira Model

Illuminance Level : 37 footcandles

Overlit 93 footcandles of direct light for more than 250 occupied hours per year- 44%

Less than 28 footcandles for more than 50% of occupied hours – 19%

Daylight Factor :2.35%

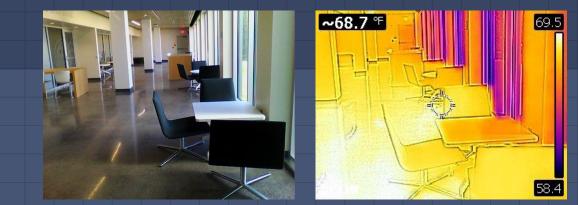
Morning Max.Temp : 68.7 °F

The windows requires shadings as it penetrate lot of unwanted light producing glare during A bright day. The LED ceiling lights reflects from shiny, glossy finishes in a cloudy day.
