WWAMI Building Performance Analysis

General Building Information

ARCHITECT:
FLAD Architects

LOCATION:
U of Idaho, Moscow, ID

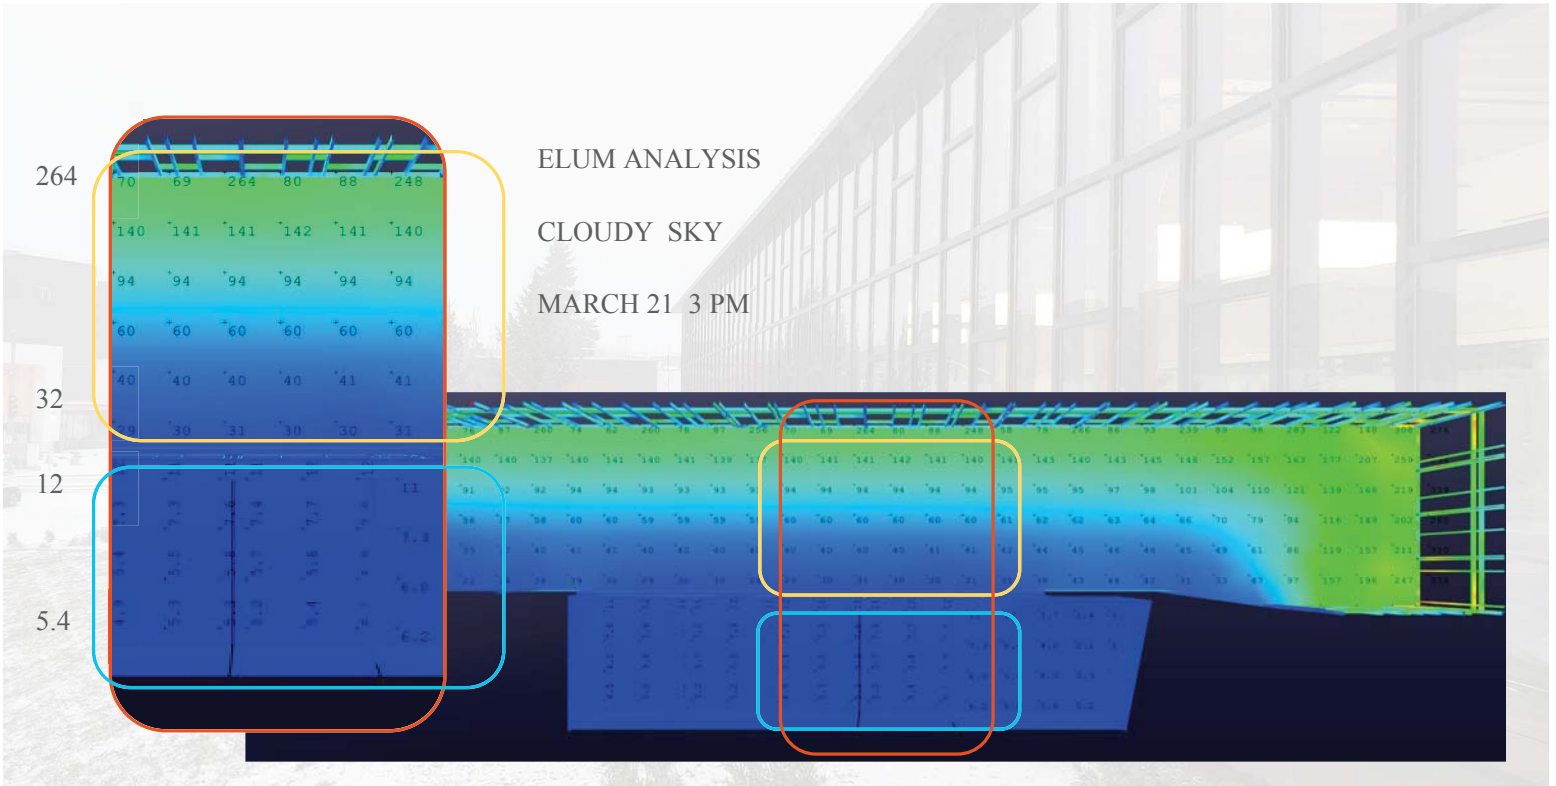
FINDINGS: We found that our hypothesis was for the most part wrong and the natural daylighting in the office spaces was either within range of recommended levels or slightly below.

- Towards the back of office spaces natural light is usually slightly below recommended levels-small amount of electric light could easily offset this.
- Easternmost offices get especially dark during morning
- With current lighting system in building when lights are on the levels are far above recommended range- a lighting system which produces lower FC would be better energy wise & for the human senses
- On sunny days there is slightly less natural light in the building than on overcast days

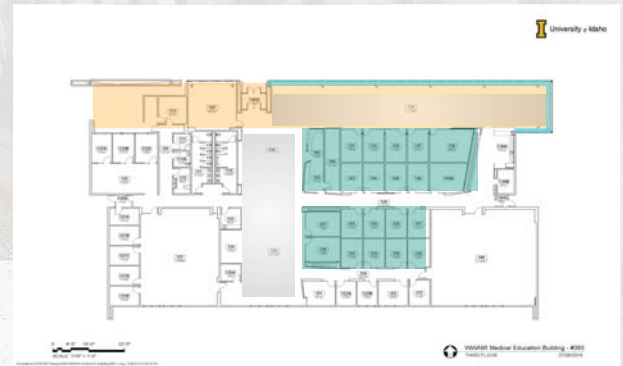
2. The north lounge area is more susceptible to temperature changes due to external conditions

It appears that the glass curtain wall is struggling to hold in heat as it is the coldest surface in the room.

The window mullions are the coldest surface in the room and seem to be thermal bridges allowing the heat from the inside to escape.

This may result in increased usage of the heating systems and a slightly colder space.

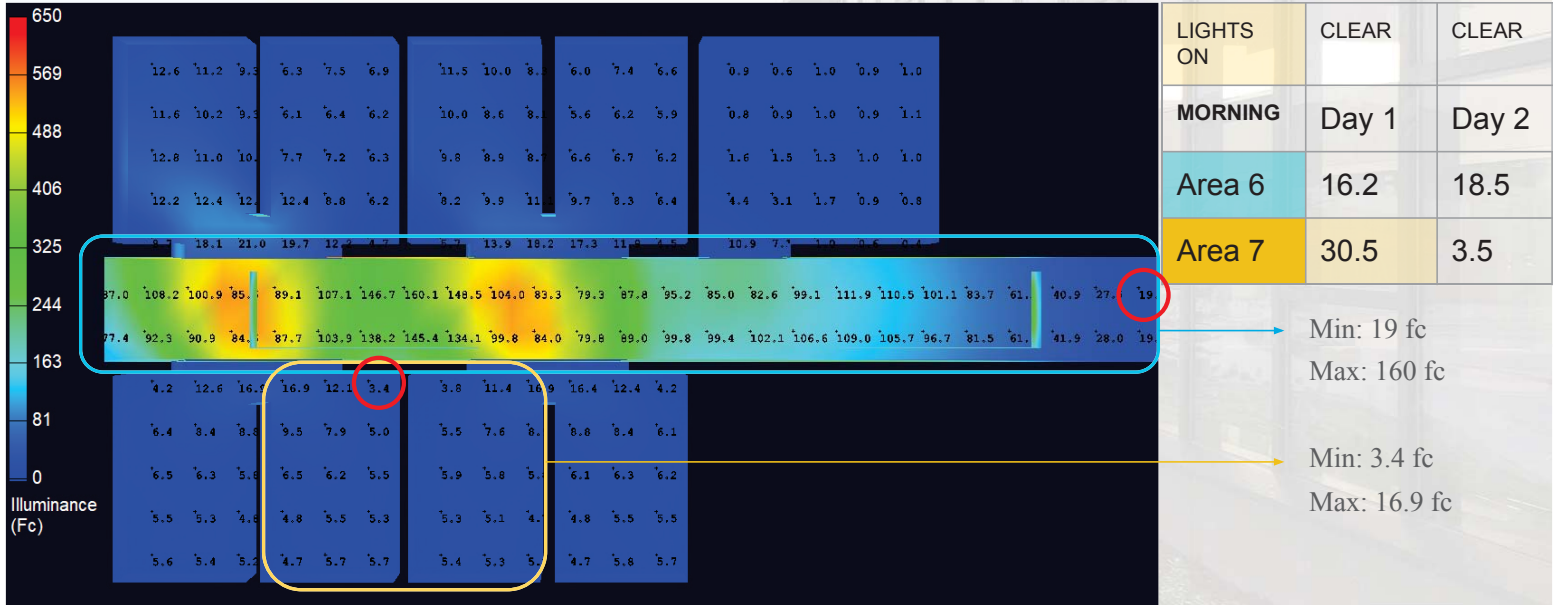
CLEAR SKY CONDITION - FEB 21 - 9AM

When we compare the hallway under the skylights to the interior of the offices, it shows that they don't get a sufficient amount of daylight from the skylights.

FINDINGS: The experiments taken place by both methods prove that the skylights only provide sufficient daylighting for the hallway and insufficient daylighting for the offices.

- The fact that levels of daylighting in the hallway are always excessively higher than the recommended illuminance range for corridor area (10 fc) under clear sky condition. It still has more than needed daylighting during overcast noon time and only experiences sufficient daylight during overcast morning and afternoon time (11-12 fc). This findings could be the based line for setting an appropriate scheme of electric lighting for the hallway and saving energy.
- However the skylights are not helping in delivering enough daylight to sufficiently light up the offices even under clear noon sky. The dependence on electric lighting is highly required to sufficiently light up this area.

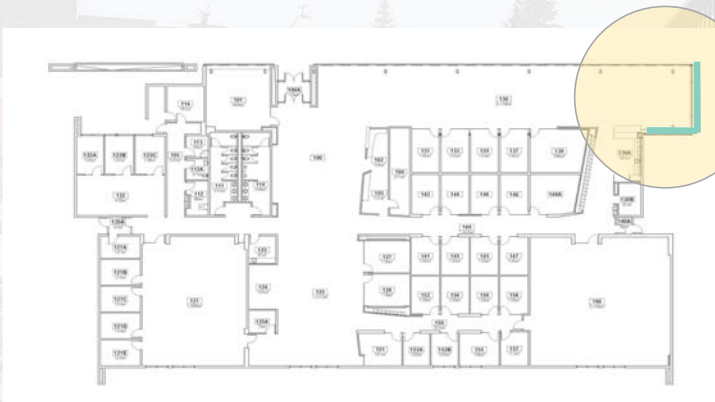
The Eastern section of the front lounge area is surrounded by glass walls on 3 sides. It gets a lot of direct sunlight in the morning. Due to the amount of direct sunlight that area gets, we assumed that it would produce more uncomfortable amounts of glare earlier in the morning and lessen throughout the day.

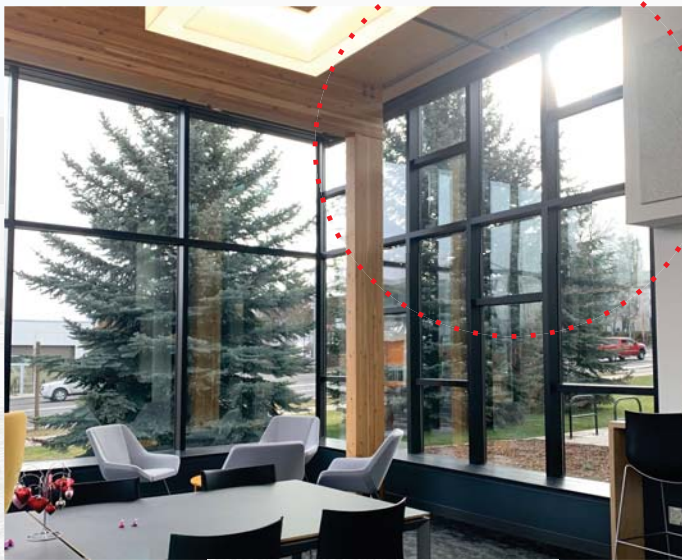
Sunny day - 9:30am

3.04 TO 1
YES

The East and South facing glass wall cause most glare (and heat) in the morning on sunny day. It is more comfortable on cloudy days and in the afternoon.

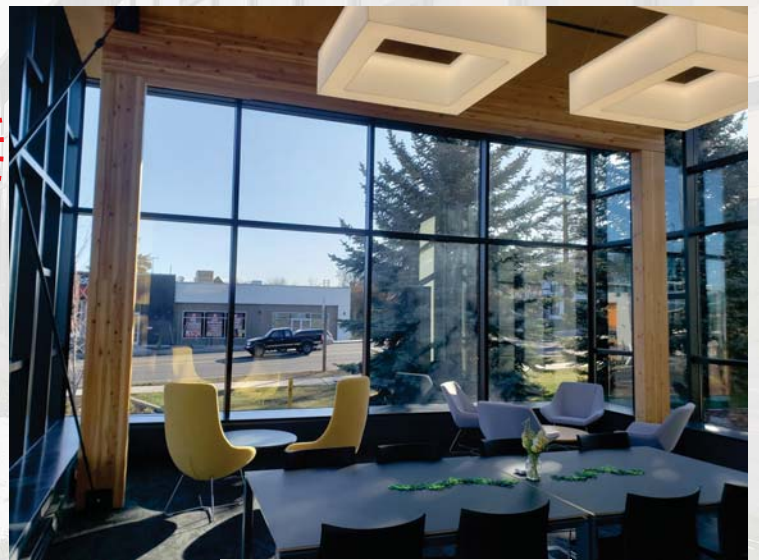
Cloudy day-10:00am

2.90 TO 1
MAYBE
