CLEVELAND TOOL DAY

CLEVELAND ENVIRONMENTAL CENTER

Preliminary Observations:

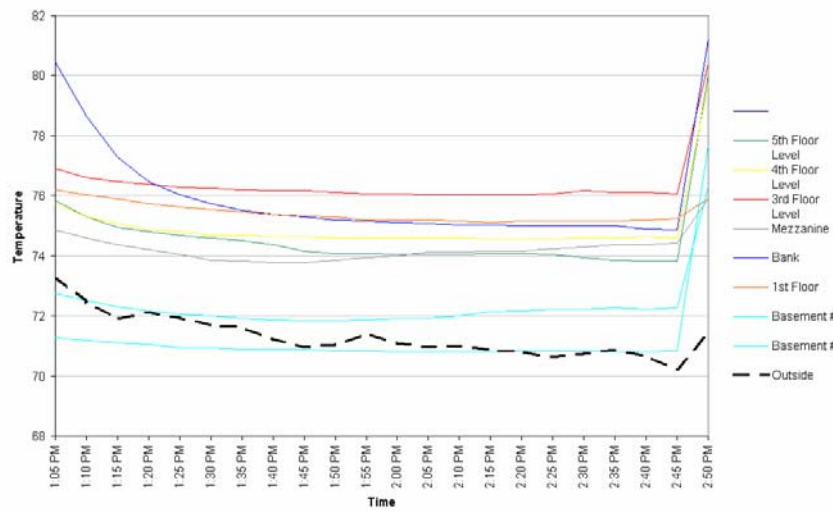
Temperature Over Time vs. Floor

- *The upper floors had higher relative humidity levels than the basement.*
- *The basement was slightly cooler than the rest of the building.*

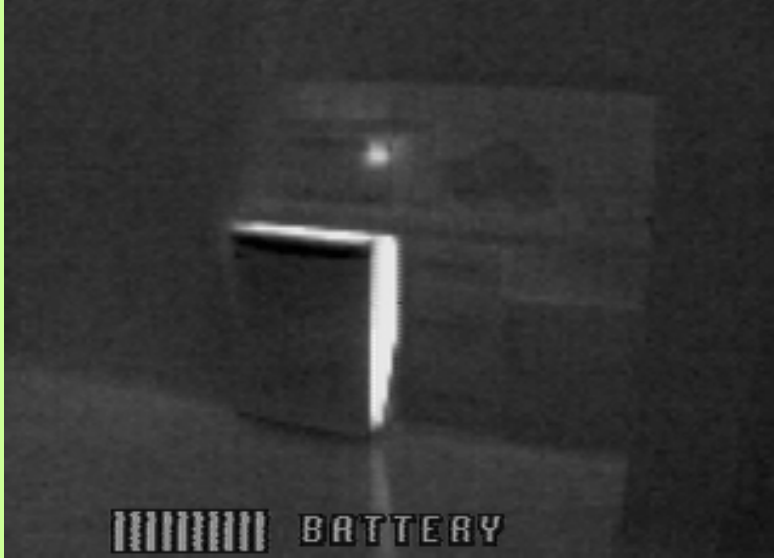
Watch where you put your sensor
