TEAM	Pink	10.5 Good Buddy!
<p>GTF Trainers: Jon Meendinger; University of Oregon Jason Zook; University of Oregon</p> <p>Team Members: Larry Koss; Kosmos Enterprises, Florida Vikram Sami; Lord, Aeck & Sargent Architecture, Georgia</p>

TEAM	Pink	
		Hypothesis
<p><i>The light sensors in the north-facing offices of the building do not step down the lights when light levels on the work surfaces are in the range of 200–500 lux.</i></p>

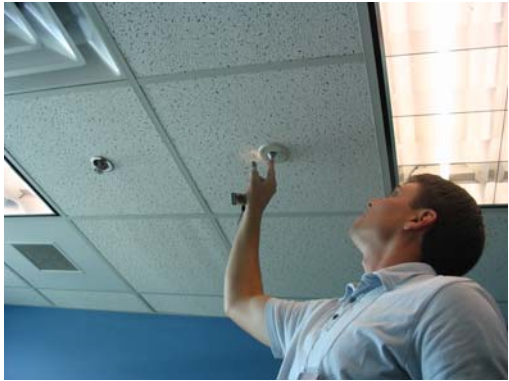
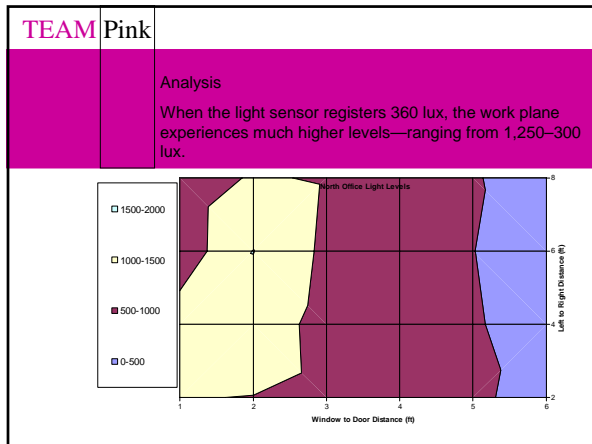
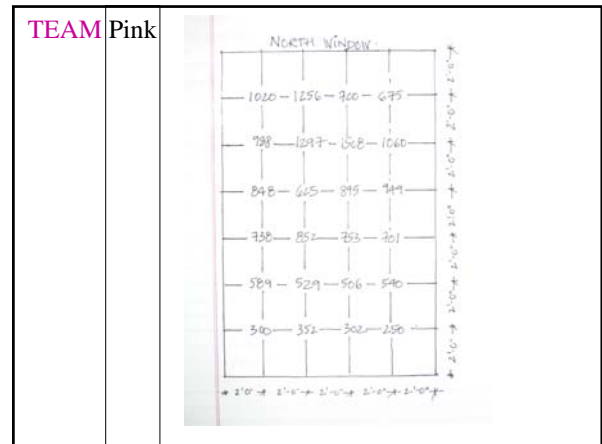
TEAM	Pink	
Conclusions		
<ul style="list-style-type: none"> • The lights step down fully (to 25%) only when the photosensors see a light level of 1,145 lux. • At the time of measurement, the photosensors were seeing only 360 lux, while the rest of the room was seeing light levels above 500 lux (except for the last 2 feet). • The daylight factor at the front of the room is around 6%, and it is around 2% at the back of the room. • We conclude that the photosensors need to be recalibrated. A more detailed study would be necessary to estimate levels of calibration, setback points, and estimated energy savings. • Another study could have looked at how much light the light fittings added to the room.
